PRELIMINARY REPORT

Classification:	Accident
Aircraft type and registration:	Boeing 737-800, TC-JGE
Number and type of engines:	2 CFM-56-7B26 turbofan engines
Year of manufacture:	2002
Date and time: ¹	25 February 2009, 10.26 hrs
Location:	1,5 km North of runway 18R "Polderbaan" Amsterdam Airport Schiphol
Type of flight:	Commercial air transport (passengers)
Occupants:	crew - 7 passengers - 128
Fatalities:	crew - 4 passengers - 5
Injuries:	crew - 3 passengers - 83
Nature of damage:	Aircraft destroyed
Information source:	Dutch Safety Board

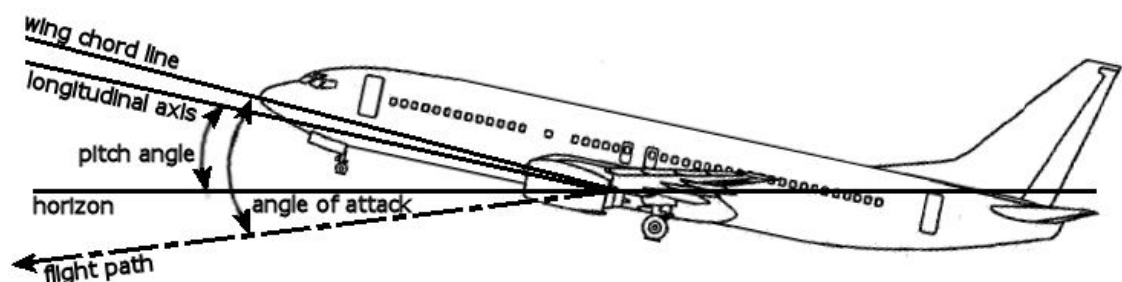
The stick shakers activated at approximately 460 feet, warning the crew that the angle of attack (AOA) was too high. The data of the digital flight data recorder show that the thrust levers were immediately advanced but moved back to idle. When the thrust levers returned to idle, the autothrottle was disengaged. Whether these actions were performed by the crew or automatically is still under investigation. At that moment, the speed was approximately 110 knots, the pitch angle was approximately 11° Aircraft Nose Up (ANU) and the recorded AOA was approximately 20°.

At 420 feet the autopilot was disengaged by the crew and attempts were made to recover the correct flight position by itching the aircraft. At 310 feet a negative nose position was reached of 8° beneath horizon. Almost simultaneously the thrust levers were advanced to their most forward position after which the aircraft ascended somewhat and the nose position increased.
