The Dutch Safety Board

Occurrence #: 2006088 **Classification:** Serious incident

Date:	06-08-2006	Cockpit crew:	2
Place:	Amsterdam Schiphol Airport	Cabin crew:	4
Aircraft registration:	TC-SKB	Passengers:	Unknown
Aircraft model:	Boeing 737-400	Injuries:	None
Type of aircraft:	Passenger aircraft	Lighting conditions:	Darkness
Type of flight:	Commercial air transport, passenger		
Phase of operation:	Taxiing		
Damage to aircraft:	Serious

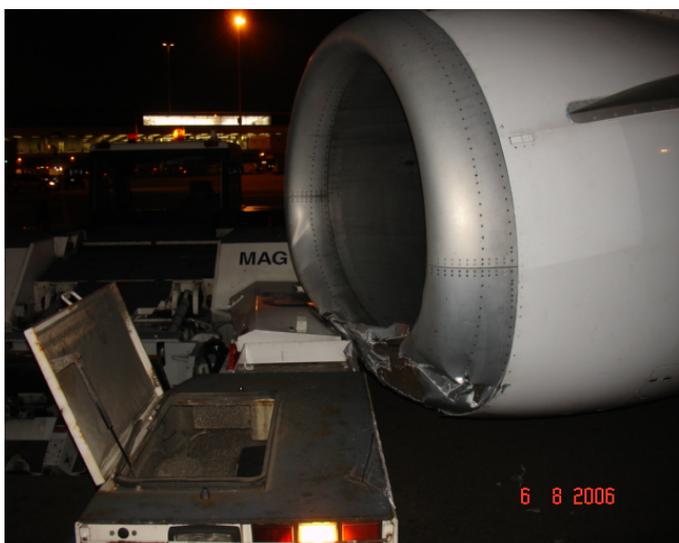
Because the aircraft had moved forward the distance between the tug, in front of the right-hand engine, and the aircraft became approximately 2.5 meter. The tug driver did not drive the tug away immediately, because it was dark and the gate was poorly illuminated. According to the tug driver he was more visible for the crew at his present position. He then stepped on the foot-board of his tug to show the steering by-pass pin to the crew. Thereafter he wanted to enter the cabin of the tug to drive away, but he saw that the aircraft was moving forward. He left the tug and ran away towards the stairs of the gate. The right-hand engine of the aircraft collided with the tug. This was at approximately 21.22. The first officer stated that when he saw the tug driver showing the pin, he also saw that the tug was still in front of the right-hand engine. He described this as a 'wrong picture' and instructed the captain to stop, but the captain had already added power and the right-hand engine of the aircraft hit the tug.

Picture 1: The tug in contact with the engine
(Source: AAS).

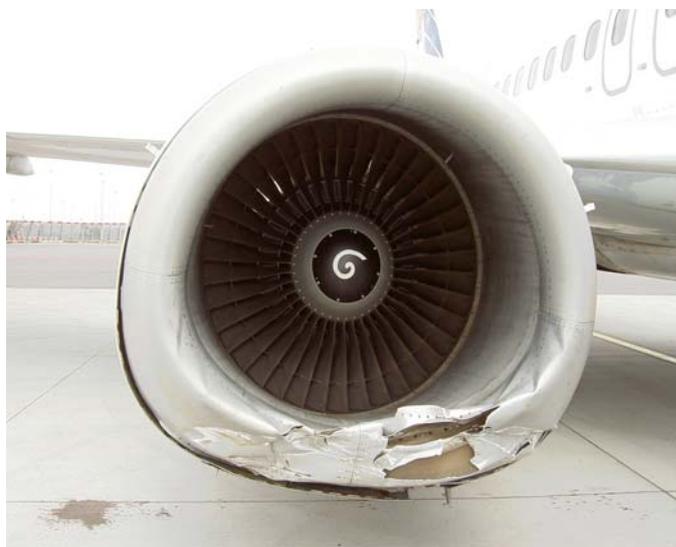
As a result of the collision the cowling of the right-hand engine was damaged and the cord of the tug driver's headset was sucked into the engine and damaged two fan blades out of limits. Two other fan blades were damaged within limits, but had to be reworked. The tug sustained some dents.

Picture 2: The damage to the engine nacelle.
