## RUNWAY OVERRUN

Identification number:	2010077
Classification:	Serious incident
Date, time <sup>2</sup> of occurrence:	2 October 2010, 19.06 hours
Location of occurrence:	Amsterdam Schiphol Airport
Aircraft registration:	TC-TJF
Aircraft model:	Boeing 737-4Y0
Type of aircraft:	Twin-engined passenger aircraft
Type of flight:	Passenger flight
Phase of operation:	Landing
Damage to aircraft:	Minor
Cockpit crew:	6
Passengers:	167
Injuries:	None
Other damage:	None
Lighting conditions:	Dusk

## SUMMARY

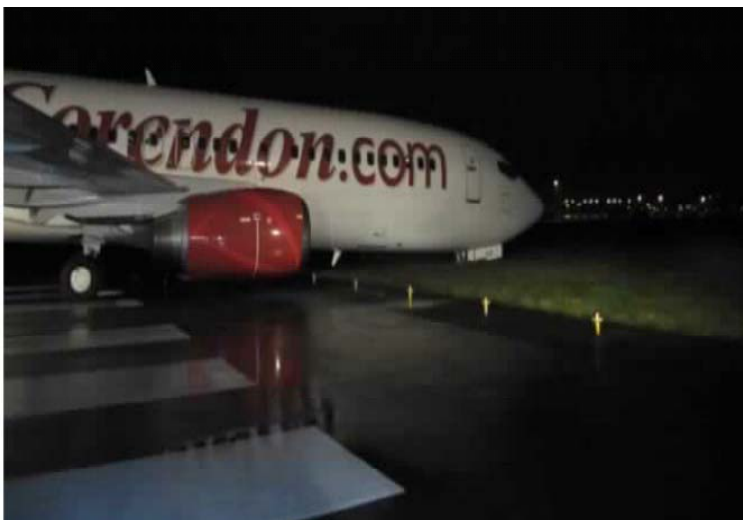
The aircraft passed the runway threshold and the landing flare was initiated. According to both pilots, the aircraft remained 'floating' above the runway at approximately 30 feet. After touchdown the auto-brake system activated, the spoilers and speed brakes were deployed and full reverse was selected. As the aircraft approached the end of the runway maximum manual braking was applied but the aircraft overran the runway by about nine metres. None of the crew and passengers onboard sustained any injuries. The aircraft suffered minor nose wheel damage.

Figure 1: TC-TJF after overrunning Runway 22 with its nose off the paved surface  
(Source: Amsterdam Airport Schiphol)

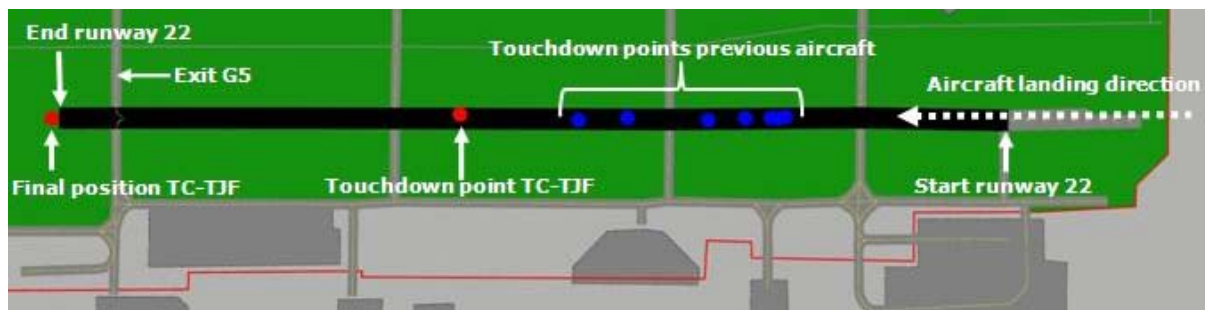
Figure 2: runway 22 at Amsterdam Schiphol Airport with the touchdown points of aircraft (blue) which landed prior to the event flight (red)

Ground radar data was used to determine the point where the aircraft touched down on the runway. Previous aircraft landed on Runway 22 approximately a third along the runway (figure 2). According to radar data, the touchdown of TC-TJF was approximately 860 metres before the runway end, approximately half the runway length.

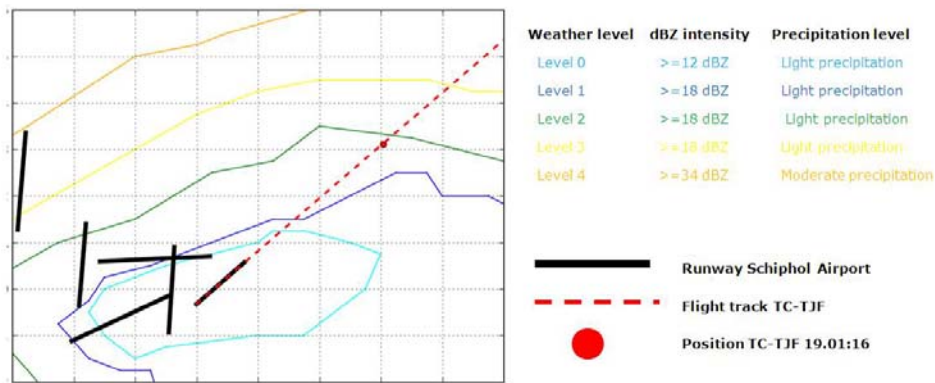
Analysis of the weather data and the precipitation radar showed that a low cloud base and rain were present during the final stages of the approach. The precipitation radar showed that the aircraft was descending from 500 feet while it crossed an area of moderate to light precipitation. (figure 3). According to calculations performed by the Royal Netherlands Meteorological Institute (KNMI) the presence of clouds and rain would make the visual range (slant visibility) around 2 kilometres at an altitude of approximately 500 feet. This, together with the light conditions, influenced the visual range of the flight crew.

Figure 3: weather radar at 19.01:16 hours with TC-TJF flight track and runways at Amsterdam Schiphol Airport

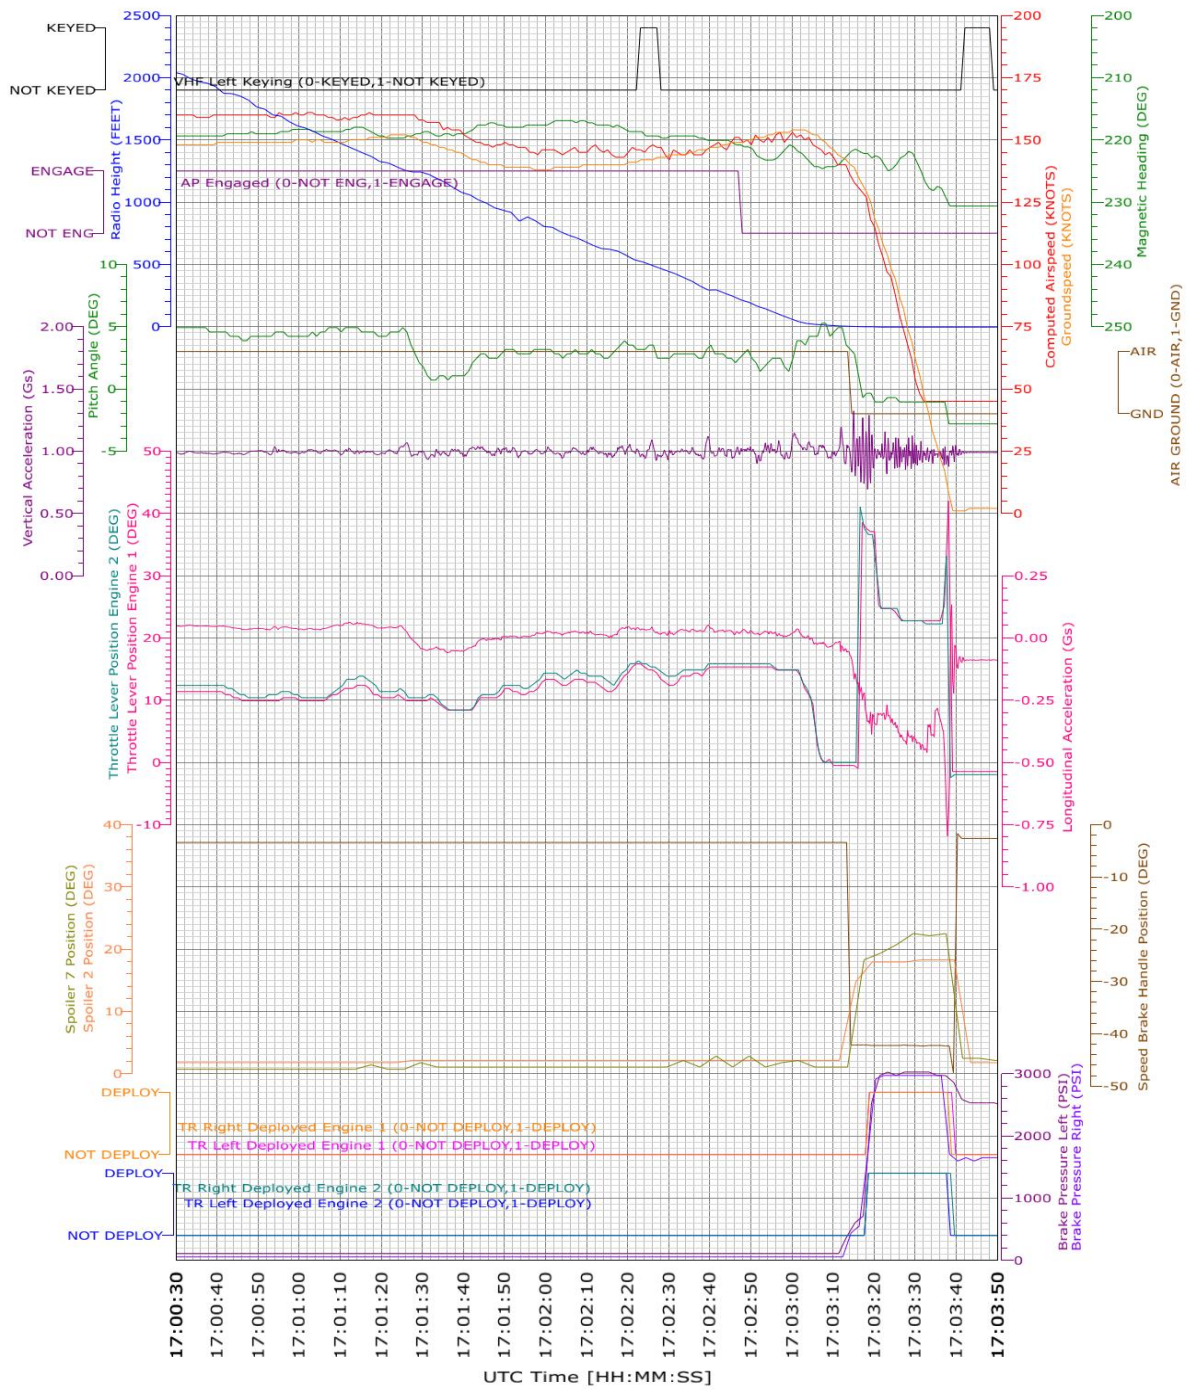
Figure 4: graph of 21 relevant parameters from the quick access recorder
