# Aircraft crashes into the North Sea

*The Hague, December 2016*

| Aircraft registration: | G-ZOGT |
| Make of aircraft: | Cirrus SR20 |

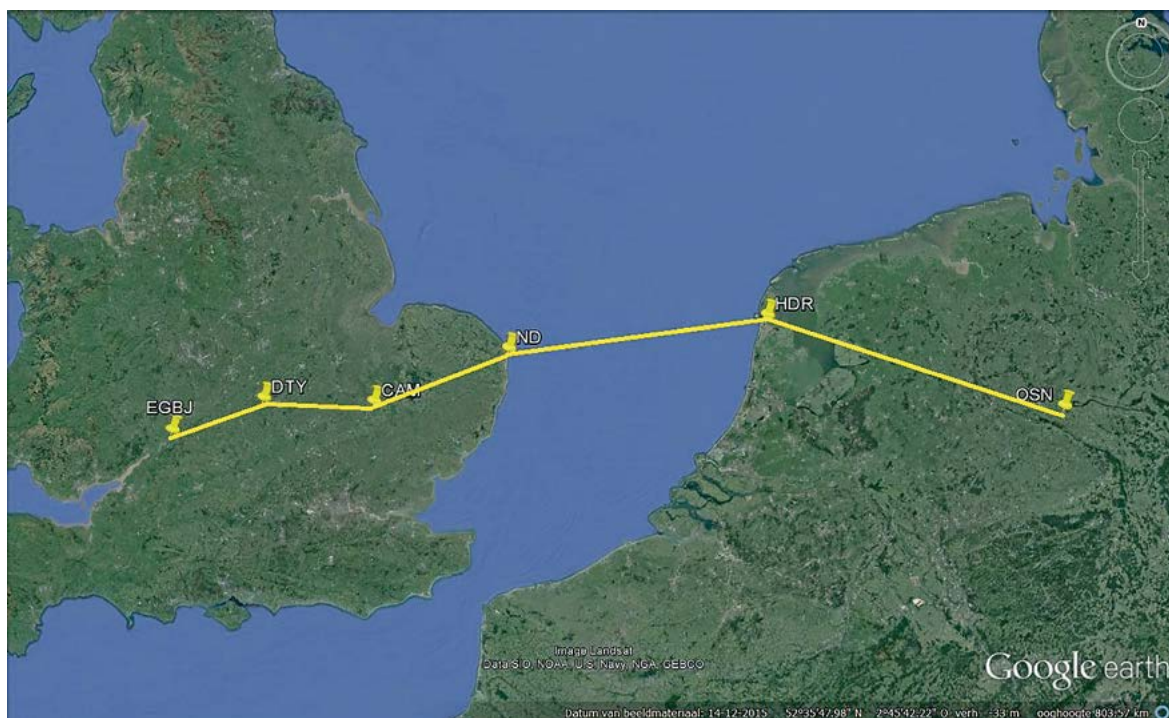
Figure 1: Route of G-ZOGT according to the flight plan. (Source: Google Earth)

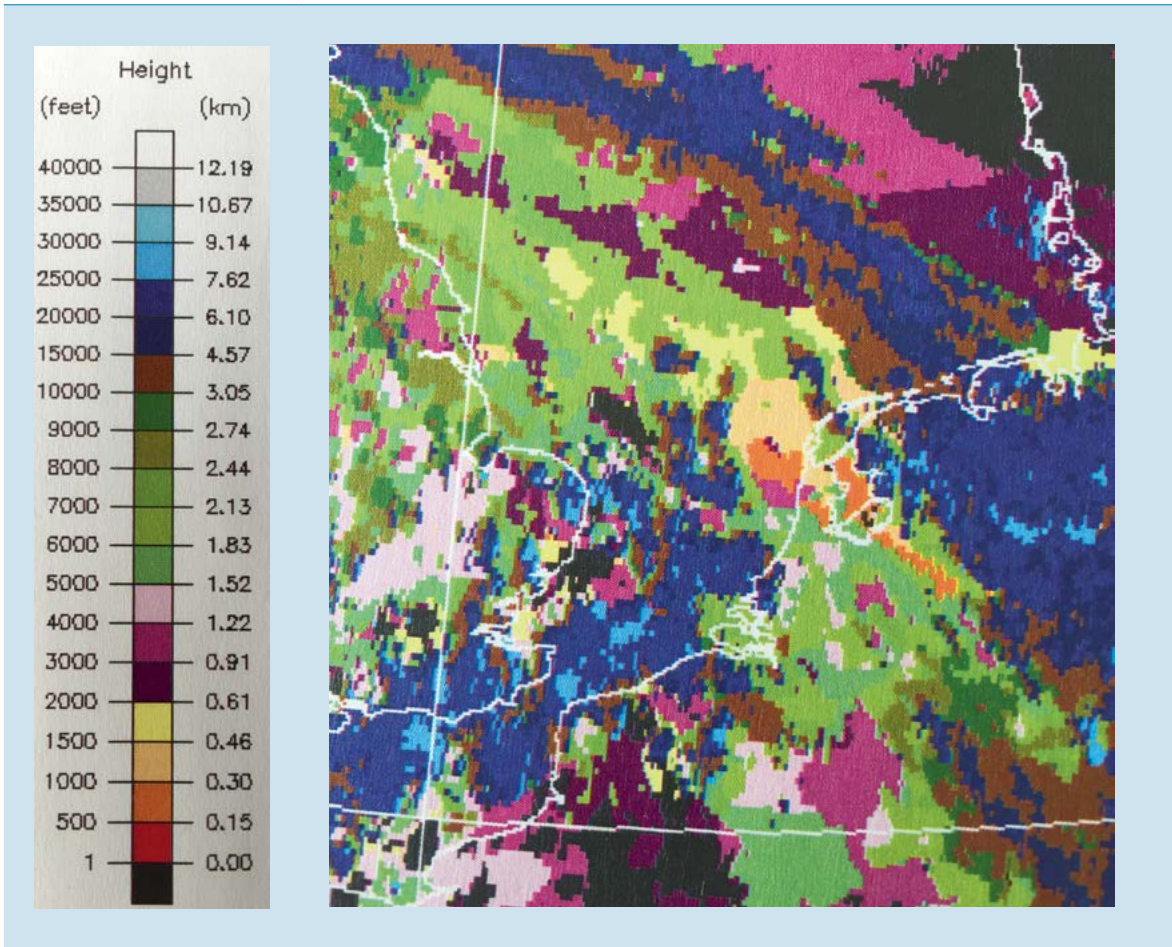
From satellite images on the day of the accident at 14.00, it appears that the tops of the clouds at the accident location were between 500 and 1000 feet.

Figure 2: Satellite images of the tops of the clouds above the flying area. (Source: Met Office)

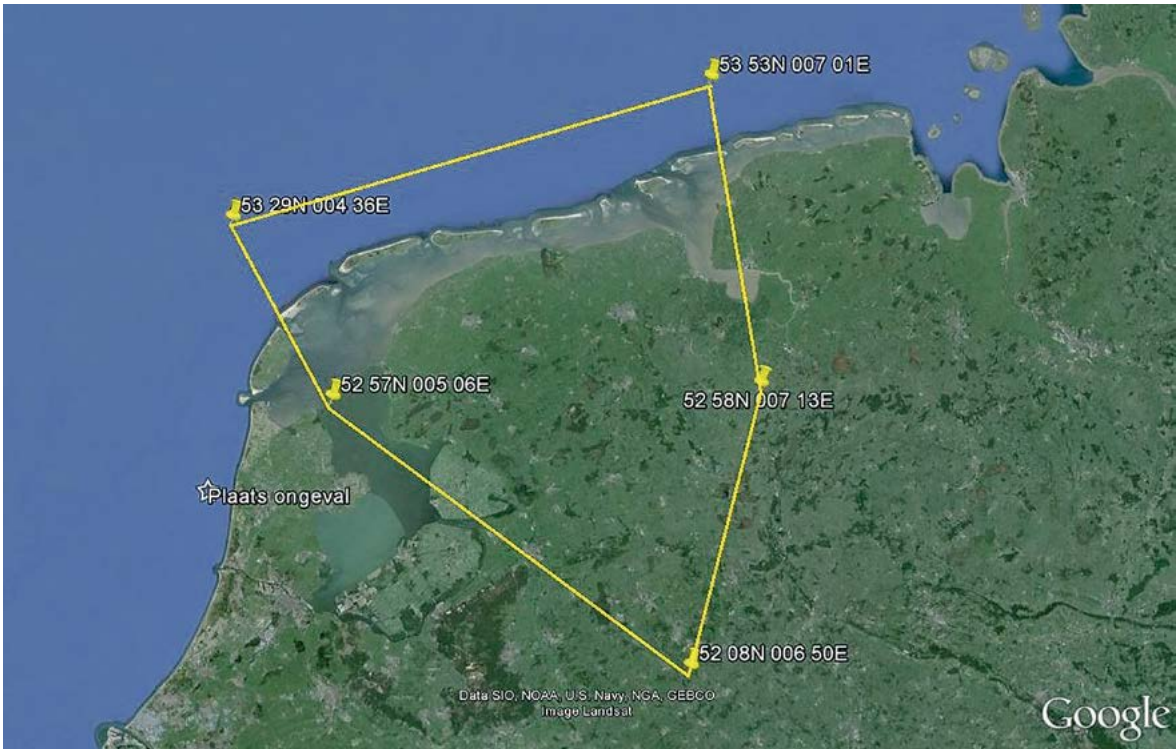
At the time of the accident, a SIGMET<sup>4</sup> was in force for part of the Dutch airspace. This SIGMET was valid from 12.45 to 16.45 and concerned a warning for serious ice formation (freezing rain) from the surface to 2500 feet. This applied in the area that extended to the following positions: 52°08'N 006°50'E - 52°57'N 005°06'E - 53°29'N 004°36'E - 53°53'N 007°01'E - 52°58'N 007°13'E (see Figure 3).

Figure 3: Area to which the SIGMET applied. (Source: Google earth)

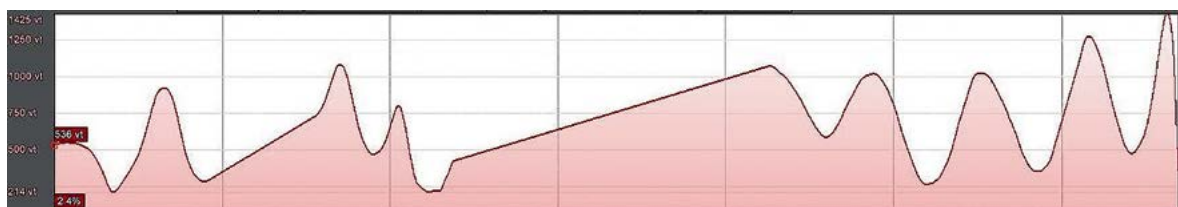
From 13.48:19, when the aircraft was flying over the North Sea at around 14 NM to the west of the Dutch coast, the EGPWS generated a 'pull up' and 'terrain' warning. These warnings were generated because G-ZOGT was in a steep descent, in which it approached the surface of the water to within 214 feet. The descent then became a climb, followed a short time later by a steep descent. This pattern repeated itself several times. In the process, the altitude of the aircraft varied between 214 and 1428 feet above the surface of the water. During each descent, the warnings 'sink rate' and 'pull up' were generated.

Figure 4: Altitude profile during the activation of the EGPWS over the North Sea.

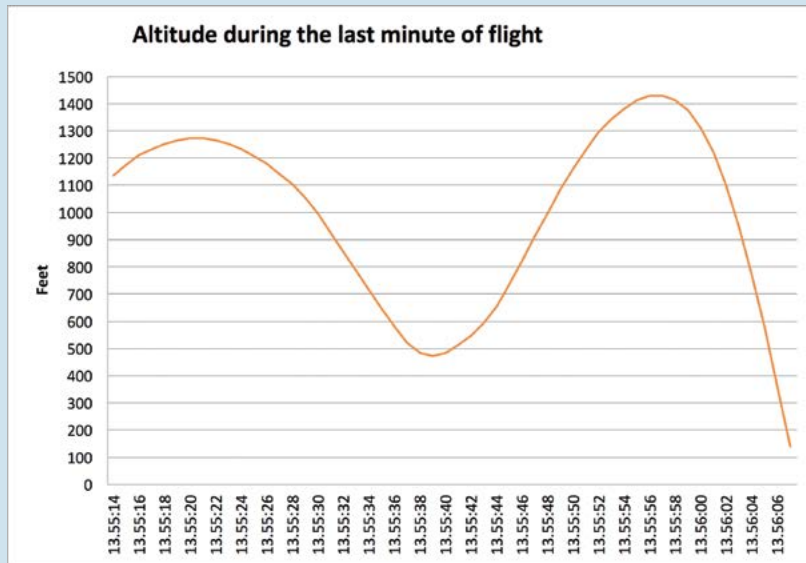
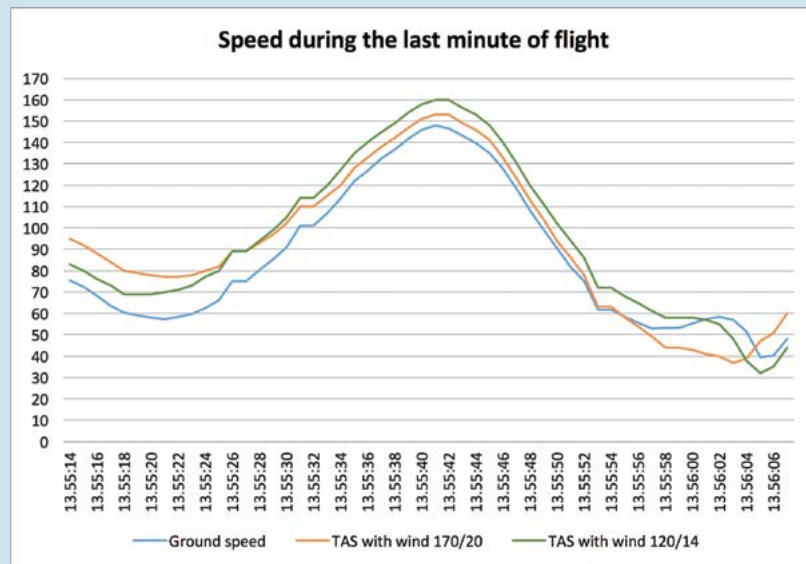
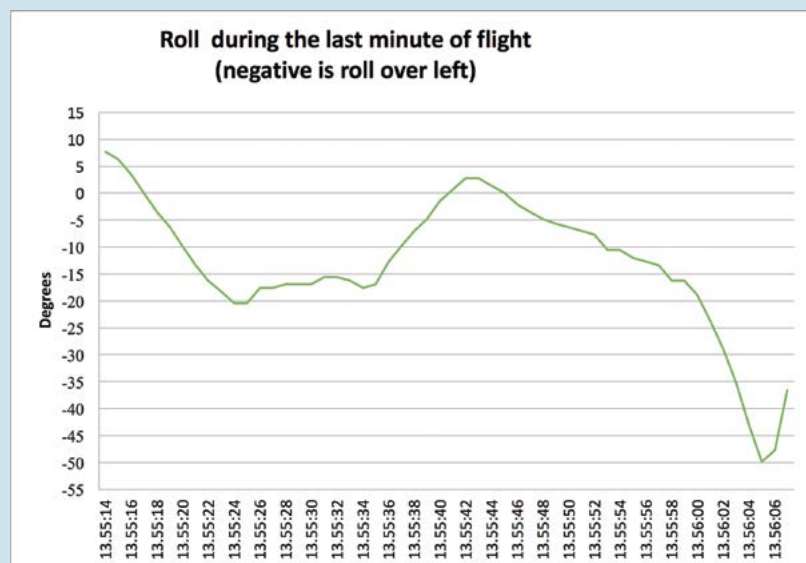
The speed, altitude, and the rolling of G-ZOGT from 13.55:14 are shown in the diagrams below. The ground speed has been converted to the true air speed using wind data. Information from the KNMI (170/20) and from Den Helder Airport 'De Kooy' (120/14) has been used for this.

Figure 5: Graphs of the altitude, speed, and roll of G-ZOGT during the final minute of the flight.

The aircraft manual for the Cirrus SR20 lists the stalling speeds of the aircraft. These speeds depend on, among other things, the mass, the centre of gravity, and the roll. The stalling speed without flaps and with a roll of between 0 and 15 degrees lies between 66 and 68 knots calibrated airspeed, depending on the centre of gravity. From the speed graph, it appears that G-ZOGT fell below the stalling speed during the final part of the flight.

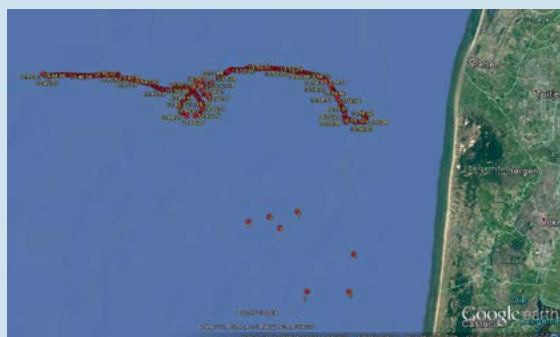
Both the radar images from LVNL and the data from the EGPWS show that G-ZOGT maintained a more or less constant easterly course from the time it entered Dutch airspace. At around 13.48:22, this course changed and the aircraft made a right turn of 360 degrees, resuming its original course at around 13.50:08. The time of this turn corresponds to the time that the pilot said to the FIS officer that he was flying around clouds. After this turn, G-ZOGT followed a southerly course. At around 13.52:00, the aircraft followed a more or less easterly course. This time is slightly later than the time at which the FIS officer gave the pilot the heading of 100 degrees. From 13.53:49, G-ZOGT turned slowly to the south until at around 13.55:10 it was flying on an almost southerly course. At around this time, the FIS officer warned the pilot for the first time about the presence of a wind farm that lay to the south and which reached a height of 400 feet. After some time, the course of G-ZOGT changed again, to the east. This happened after a second warning from the FIS officer about the wind farm. Several seconds later, the aircraft made a sharp turn to the left, after which it disappeared from the radar.

Figure 6: The route in Dutch airspace according to the radar data from LVNL (the dots under the route indicate the wind farm).

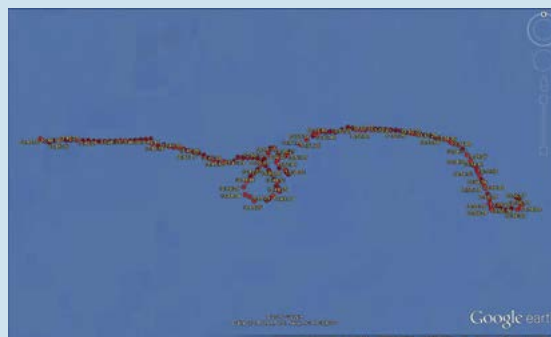
Figure 7: The route in Dutch airspace according to the radar data from the EGPWS.

From the flight profile, in the vertical, horizontal and lateral planes, it appears that the flight was not stable. This flight profile indicates that the automatic pilot was not activated at this time and that the pilot was therefore controlling the aircraft himself.
