DUTCH
SAFETY BOARD

Collision during pushback

The Hague, March 2022

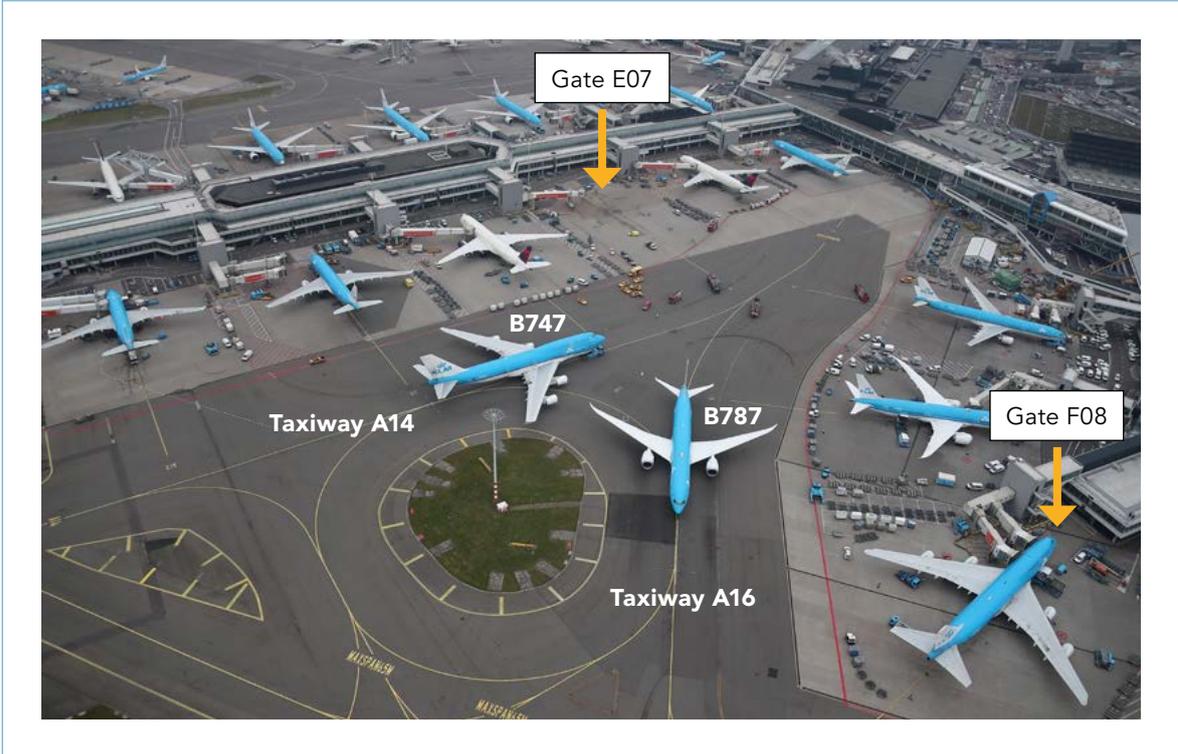
The pushback truck driver of the B747 pushed the aircraft onto taxiway A14, resulting in a collision between the two aircraft (see Figure 1). The right-hand wingtip of the B747 collided with the right horizontal stabiliser of the B787, resulting in damage to both aircraft.

Figure 1: Aircraft positions after the accident. (Source: Dutch aviation police)

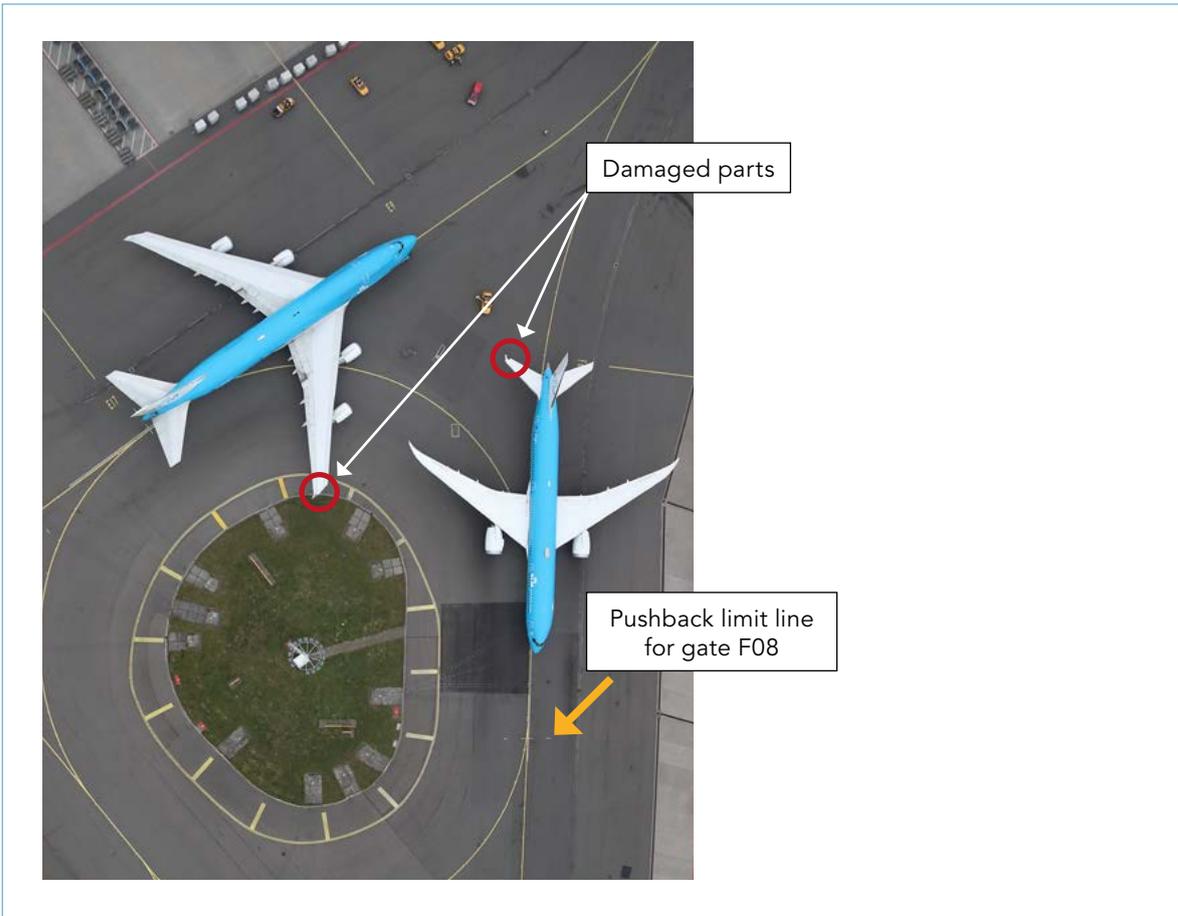
Figure 2: Top view of the position of the aircraft after the accident. (Source: Dutch aviation police)

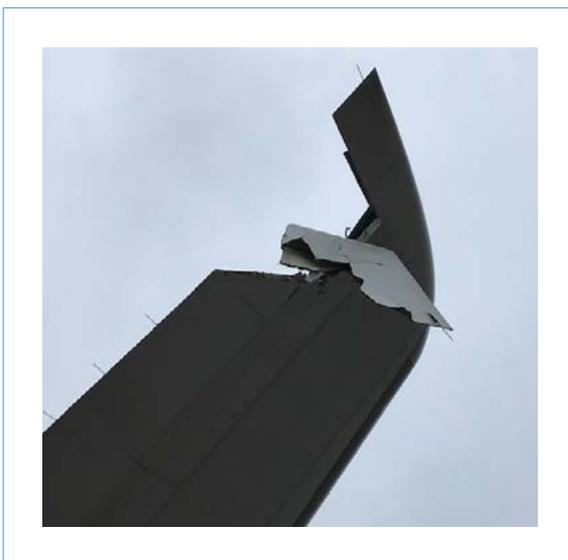
The B787's right horizontal stabiliser was substantially damaged (see Figure 3a), requiring a major repair according to the operator. The B747's right wingtip (winglet) was damaged (see Figure 3b), assessed to require a minor repair according to the operator.

Figure 3a: Damage to the B787's right horizontal stabiliser. (Source: Amsterdam Airport Schiphol)

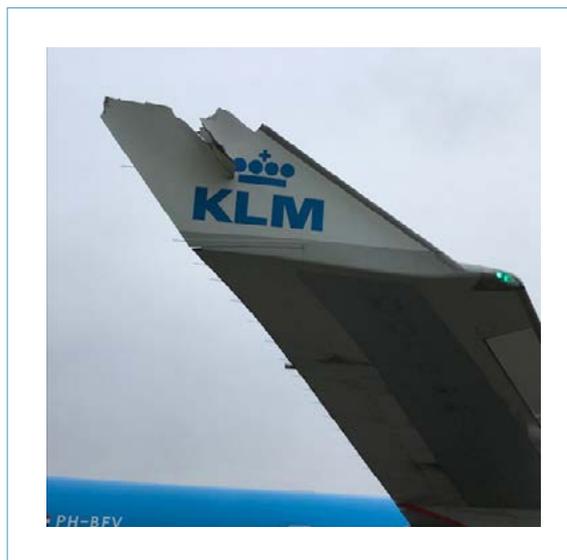
Figure 3b: Damage to the B747's right wingtip. (Source: Amsterdam Airport Schiphol)

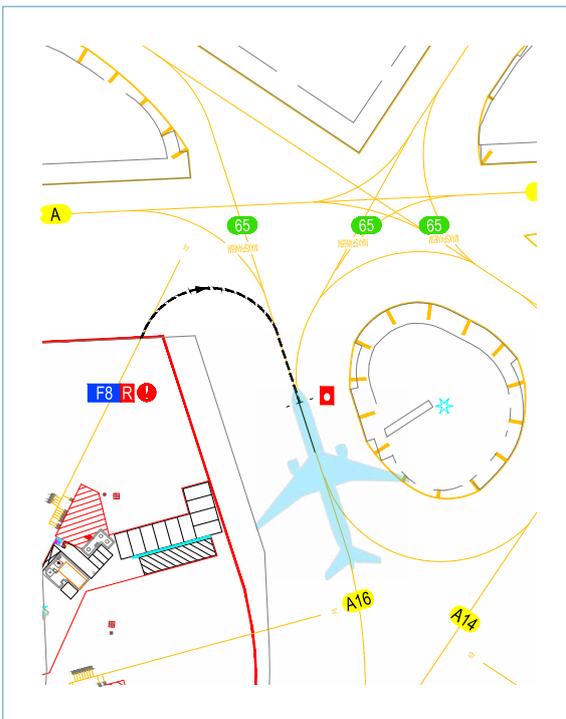
5 The pushback limit line at F08 on taxiway A16 provides the required separation margin for another aircraft to dock at that gate. However, this separation margin is estimated by some crews as inadequate. A long pushback provides more margin for the arriving aircraft and avoids the situation where the crew of the inbound aircraft might stop the docking manoeuvre and block a taxiway. (Source: ISMS investigation)

The B787 was parked at gate F08. The standard pushback direction onto taxiway A16 from the perspective of the pushback truck driver is right (see Figure 5). The B747 was parked at E07. The standard pushback direction from E07 onto taxiway A14 is right (see Figure 6). For E07 it is noted on the pushback chart that, after pushback, aircraft of category 5 and higher⁸ (which includes the Boeing 747-400), should be pulled onto taxiway A16 (i.e. a push-pull procedure).

Figure 5: Pushback procedure F08. (Source: Amsterdam Airport Schiphol)

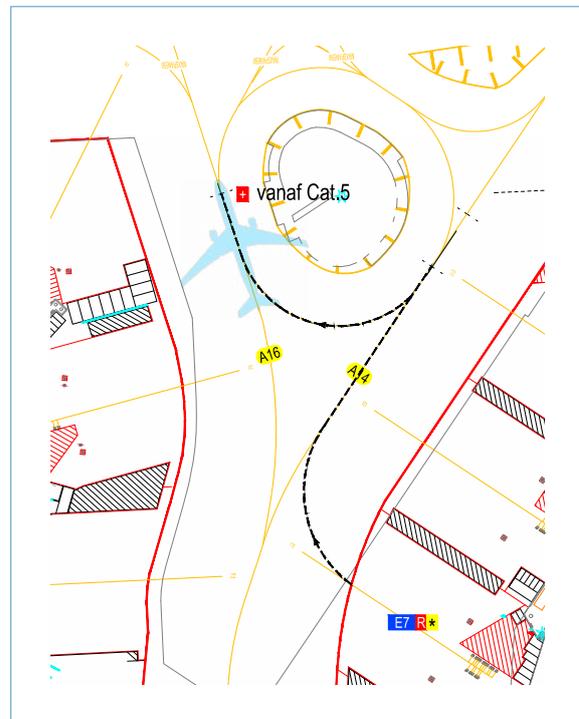
Figure 6: Pushback procedure E07 for category 5 aircraft and higher. (Source: Amsterdam Airport Schiphol)
