Breaking of mooring lines whilst mooring  
m.v. Edisongracht between two mooring buoys  
in the port of Soyo, Angola, 1 April 2010

The Hague, May 2011

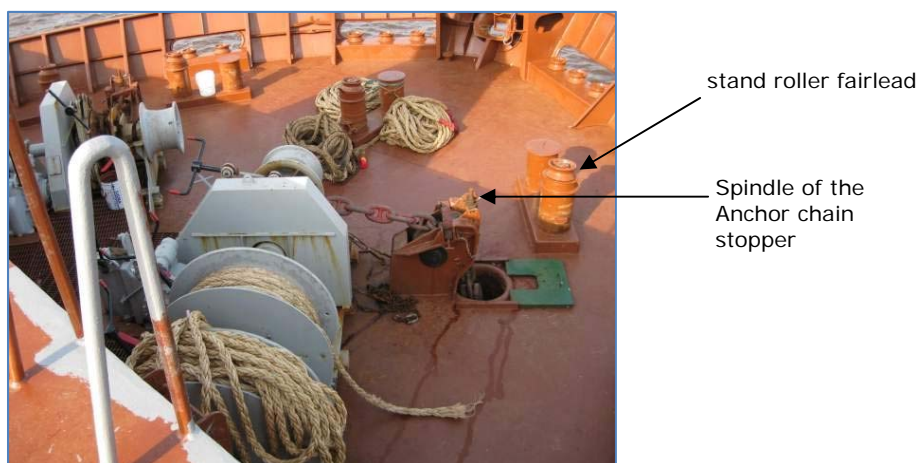
Figure 5: Photo of the foredeck of the m.v. Edisongracht

Despite all efforts, the vessel could not be kept in position with the assistance of the tugs after it had been positioned between the mooring buoys. Ultimately, as a result of the strong current the vessel drifted away from the front mooring buoy to the south and, later, to the south-east (see position 3 in figure 3). Due to this, the two mooring lines that were released through the centre lead were not directed straight ahead, but veered sharply to port. The crew could not keep both mooring lines under equal tension. Consequently, the starboard mooring line was put under considerable tension, slid off from the stand roller fairlead and hit with great force a spindle of the anchor chain stopper on deck (see figures 5 and 6).

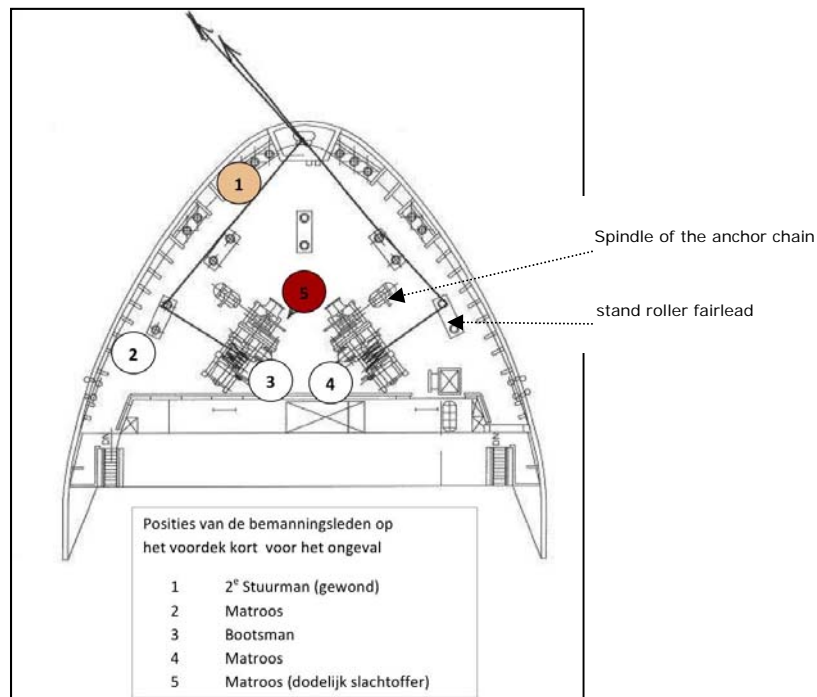
*Figure 6: Crew member positions and cover of the mooring lines just before the accident*

A number of crew members were still on the foredeck between the winches and the released mooring lines (see figure 6) whilst the tension on the starboard mooring line was further increasing as the vessel was drifting away due to the strong current. In case of a breaking mooring line, this is a very dangerous situation due to the unpredictable behaviour of a mooring line.

Only when the second officer noticed that the mooring line was at the point of breaking and he warned his colleagues about this, did the crew members try to find a safe place to go to. However, there turned out to be insufficient time for this. Due to the thickening and deformation of the mooring line connection (i.e. the splices, mooring lines' eyes and the shackle) the mooring line no longer fitted properly in the profile of the guide roller at that moment in time, due to which it slid off the stand roller fairlead and broke when hitting the spindle of the anchor chain stopper (see figure 5). The starboard mooring line swept over the deck after it broke.

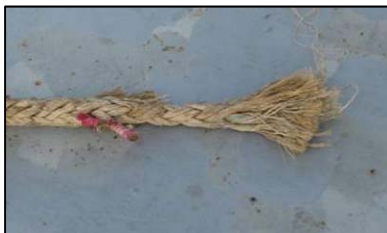
*Figure 7: Photo of the starboard mooring line fracture surface*

As a result, the mooring line immediately broke in half. The break occurred just behind the splice of the mooring line's eye. One of the AB's was fatally injured by parts that flew off the mooring line. The parts also hit the second officer, who fractured his upper leg and sustained a head injury from falling on the deck.

The fracture surface of the starboard mooring line was sharp, which indicates a local load (cutting and/or damage). The fracture surface of the port mooring line had a frayed end, which is typical for a fracture due to overloading.

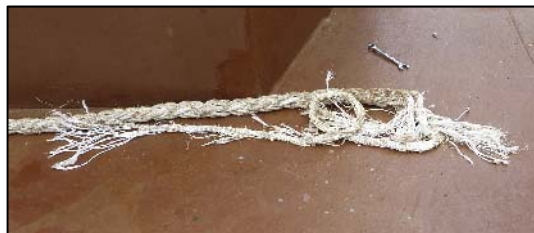
*Figure 8: Photo of the port mooring line fracture surface*

After this, the vessel was only secured by the mooring line from the port winch. The tension on this mooring line became too high and, ultimately, the line broke as a result of overloading. The end of the broken starboard mooring line showed a nearly straight sharp break (see figure 7). The port mooring line, on the other hand, showed a frayed break pattern (see figure 8).

Approximately five minutes after the starboard mooring line broke because it slid off the fairlead, the port mooring line also broke due to overloading.
