DUTCH  
SAFETY BOARD

# Stick shaker warning on ILS final

Eindhoven Airport 31 May 2013

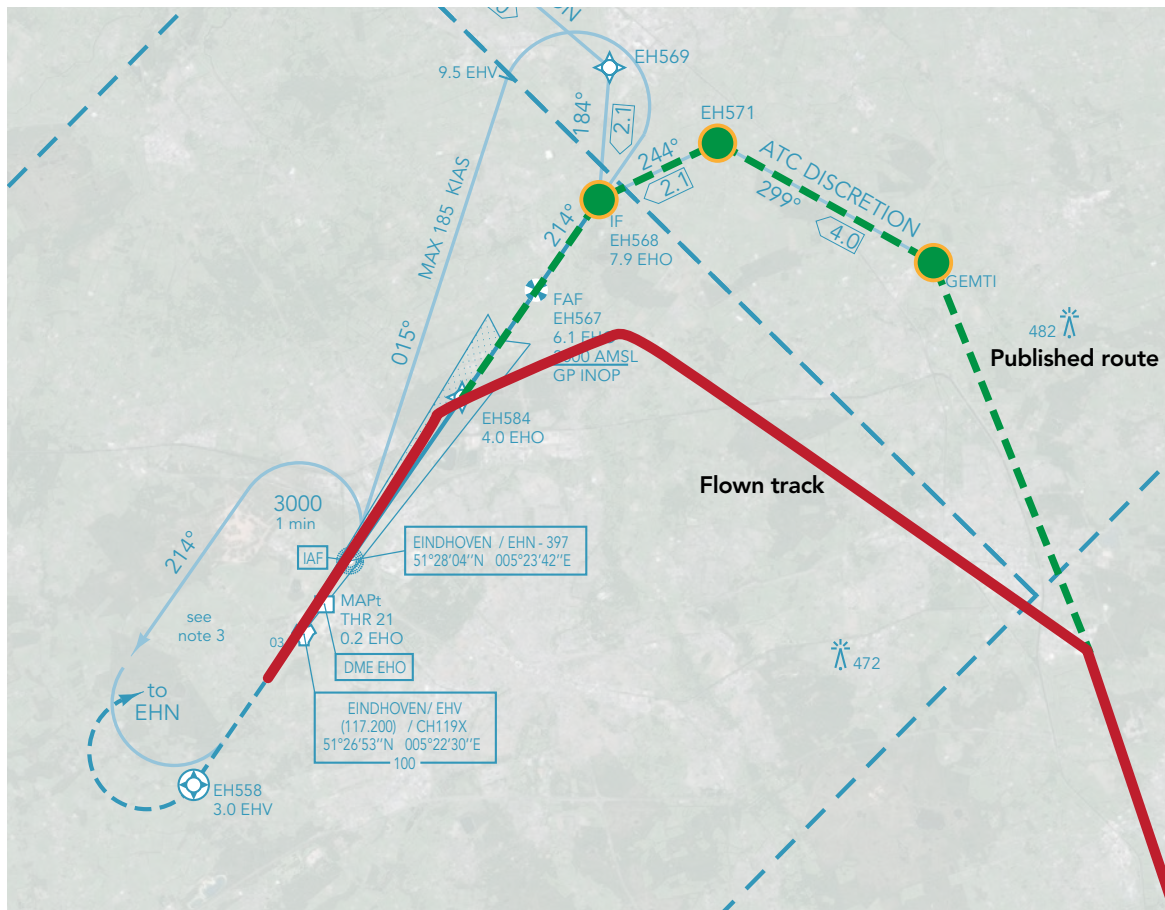
Figure 1: Top view of the published (green line) and the actual flown (red line) approach to Eindhoven Airport.

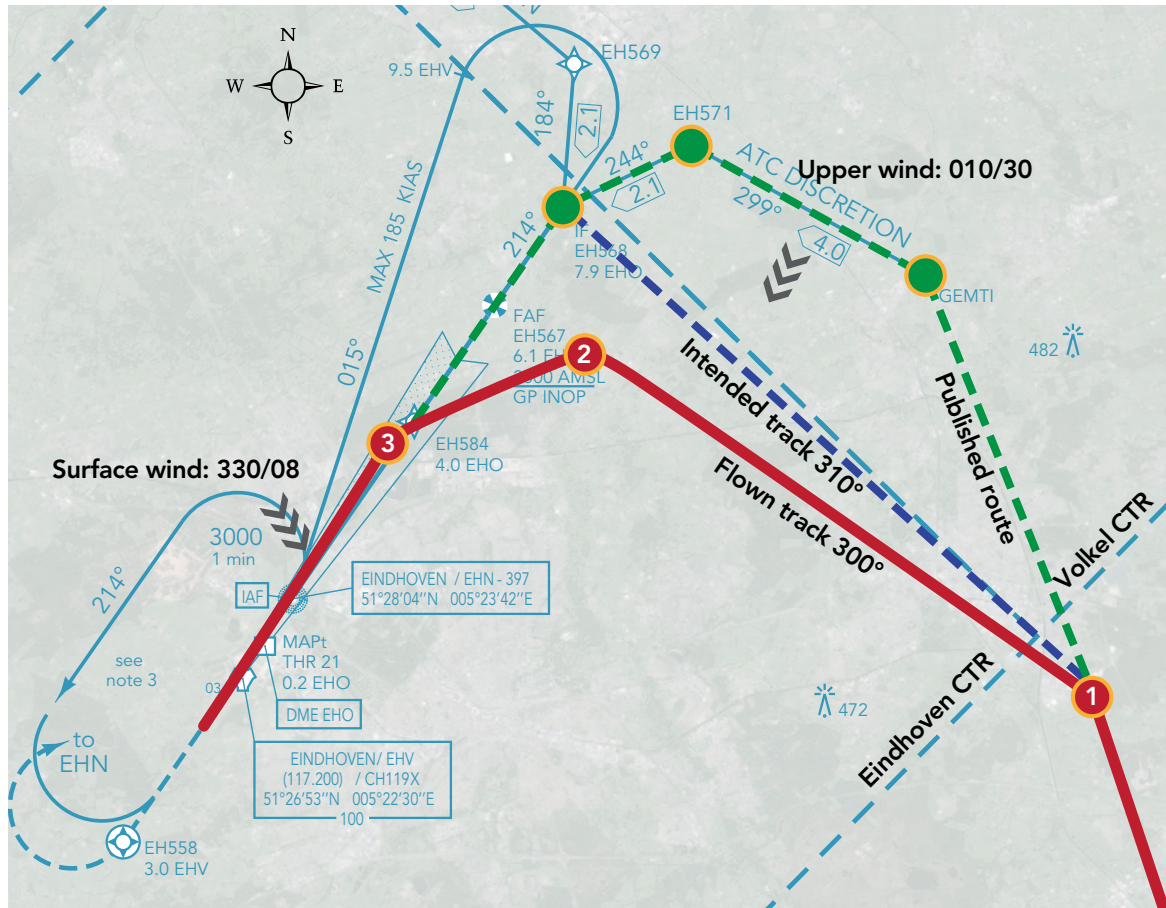
At 08.44:19, the aircraft was passing 4300 feet in the descent from 7000 feet to 3000 feet, 4 NM prior to reaching GEMTI (figure 4, position ①). The Eindhoven Arrival Controller instructed the flight crew to fly heading 310 degrees and descend to 2000 feet. This heading was generally used by Eindhoven arrival to guide aircraft coming from the South to fly a route from the intersection of Eindhoven control zone (Eindhoven CTR) and Volkel CTR in the southeast, to a position approximately 8 NM on ILS final (from position ① to

Figure 4: Top view of the planned (green line, published approach), the instructed (blue line) and the actual flown (red line) approach to Eindhoven Airport.

The radar vectors provided by Eindhoven Arrival Control and the winds on base leg and final resulted in a reduction of the ground distance the aircraft had to fly to the runway. These factors caused the aircraft to be high in altitude during the approach.

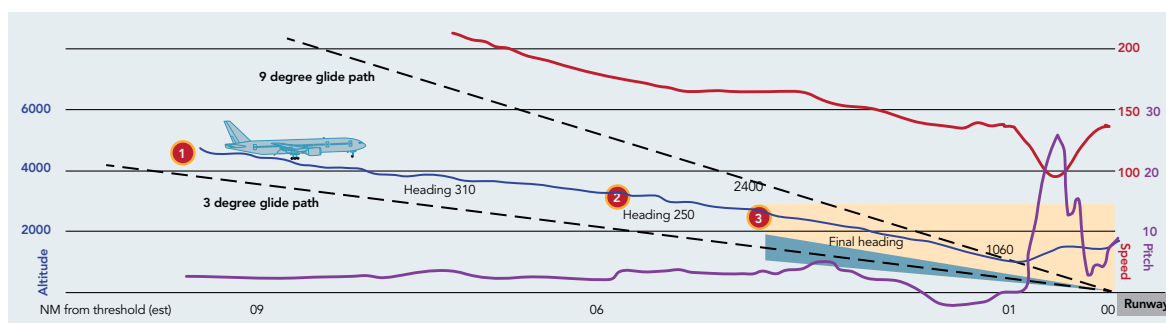
Figure 5: Schematic display of timeline and descent profile, detailed information is published in Appendix G. On the vertical height (left) speed and pitch (right) are depicted, on the horizontal the estimated distance from the runway threshold is shown.

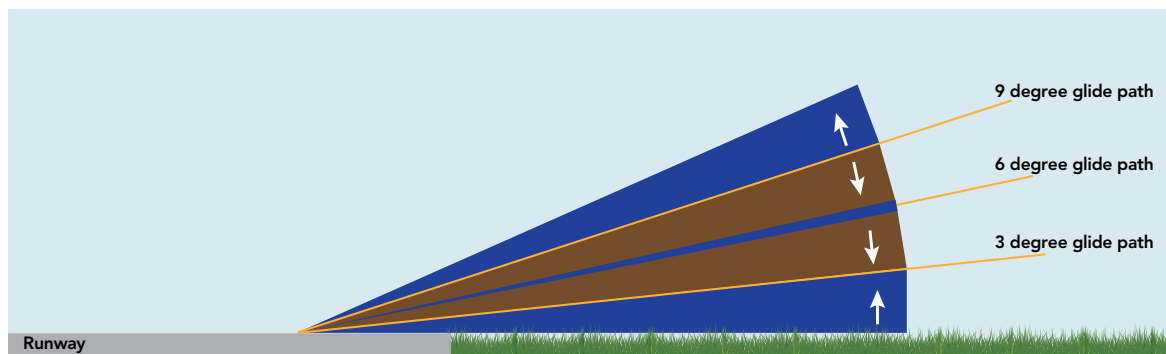
Analysis of the measurements show that between the 3 and 9 degree glide path, signal strength changes. For the pilot this can result in observable movement of the ILS glide slope marker on the primary flight display. At this time two important characteristics of the M-array ILS antenna 'glide slope field' have been identified:

1. A signal reversal was always present at approximately 9 degree glide path.
2. A signal reversal was sometimes present at approximately 6 degree glide path.<sup>21</sup>

Figure 1: Cross section view of the M-array ILS antenna system. Schematic overview of the "Fly up"(blue) and "Fly down"(brown) indication.

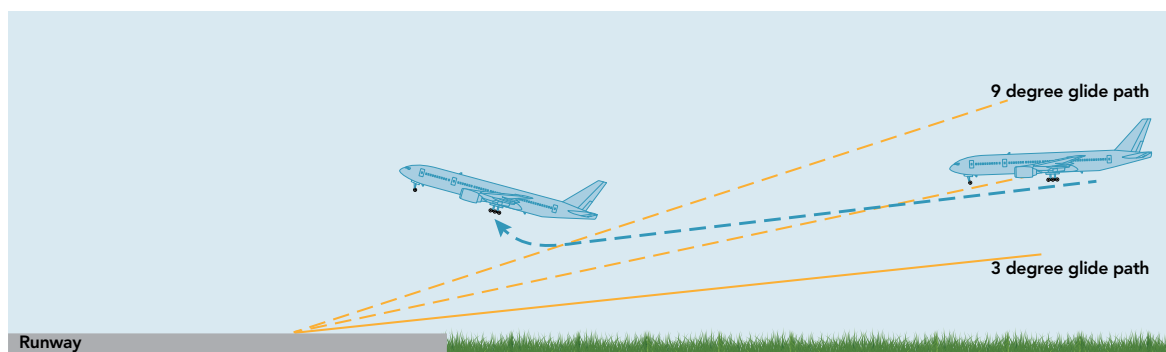
Figure 2: Example of glide slope capture with a pitch upset above 3 degree glide path.

Depending on the glide slope field, signal reversal occurs occasionally at 6 degree, and always at the 9 degree glide path. This reversal activates the glide slope capture mode after which the autopilot follows the glide slope signal without restrictions. During flight tests the reversal resulted in the automatic flight control system commanding a severe pitch-up. Immediate flight crew intervention was required to regain aircraft control.
