DUTCH
SAFETY BOARD

Pitch-up Upsets due to ILS False Glide Slope

The Hague, June 2014

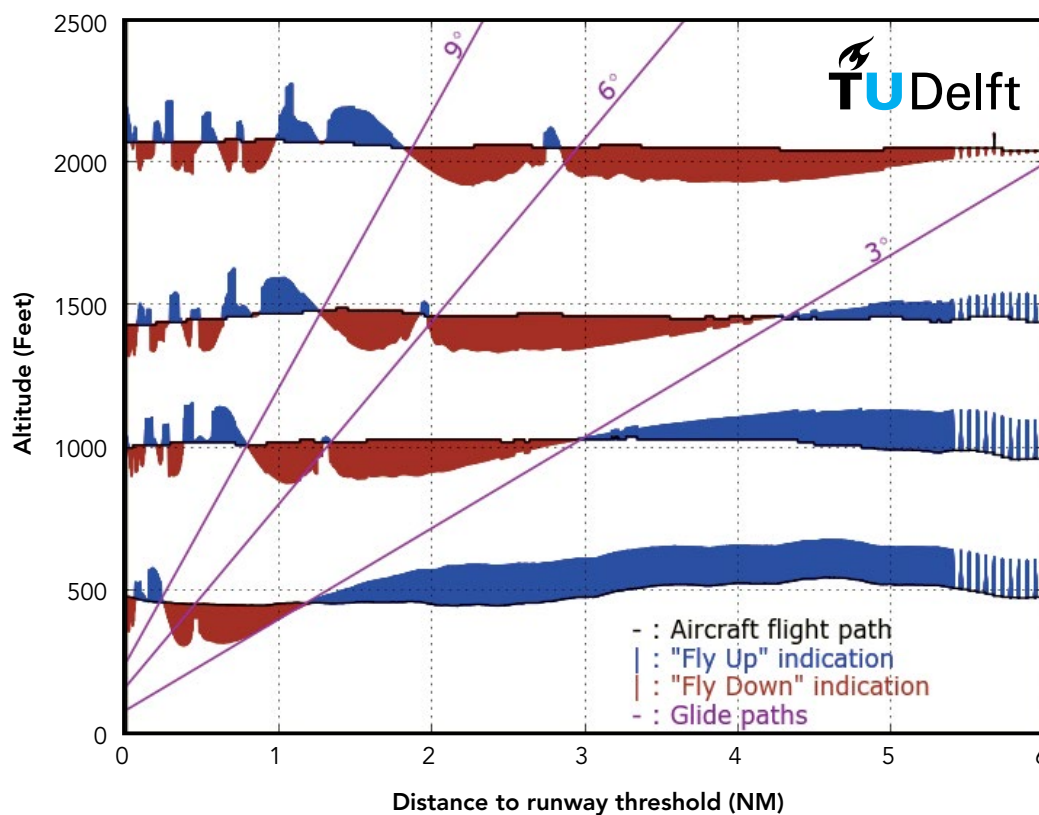
Figure 15: Different level flight measurements at Woensdrecht Air Base.

The measurements at Woensdrecht Air Base showed that a 'Fly Down' indication was measured between the 3 and 6 degree Glide Path. Around the 6 degree Glide Path a small 'Fly Up' indication area was present. This area triggered the Glide Slope capture logic in the aircraft instruments and the aircraft subsequently followed the 'Fly Up' command. Between approximately the 6 and 9 degree Glide Path a 'Fly Down' was measured. Hereafter a 'Fly Up' signal was measured. See Figure 15 for the results.

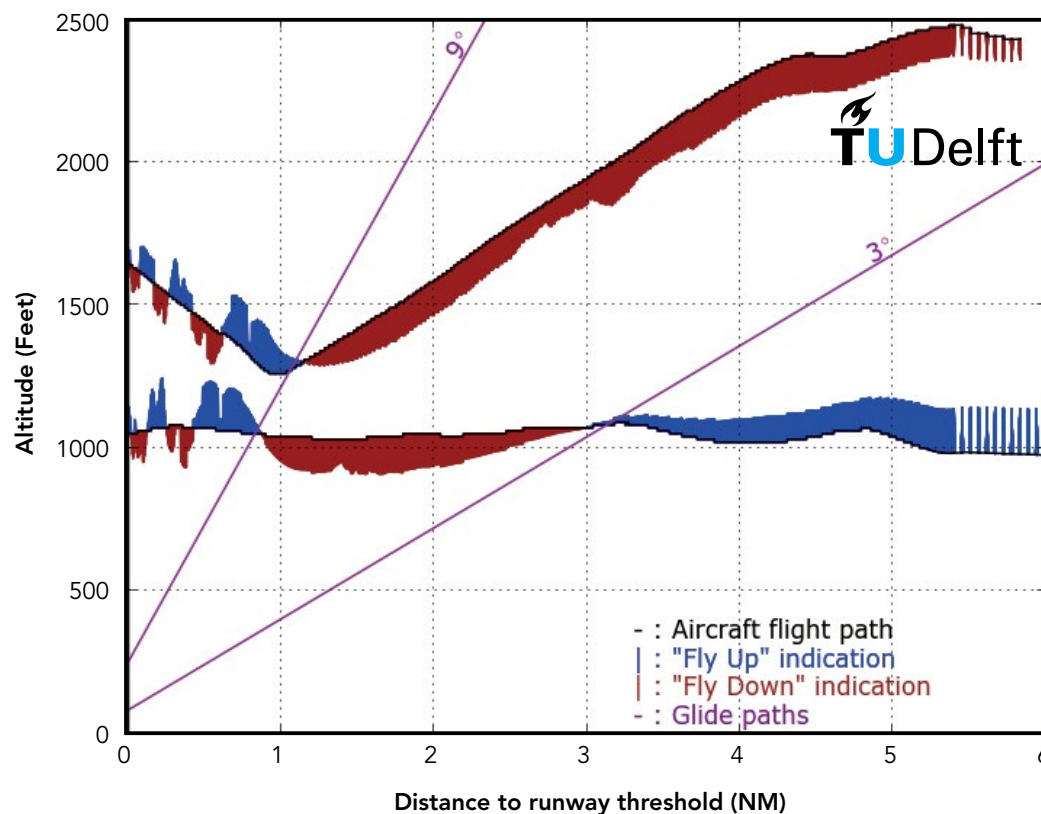
Figure 16: 1,000 feet level and diagonal run measurement flight at Eindhoven Airport Runway 21.

The horizontal measurements at Eindhoven Airport showed that a 'Fly Down' indication was measured between the 3 and 9 degree Glide Path. Between the 9 and 15 degree Glide Path a 'Fly Up' indication was present.

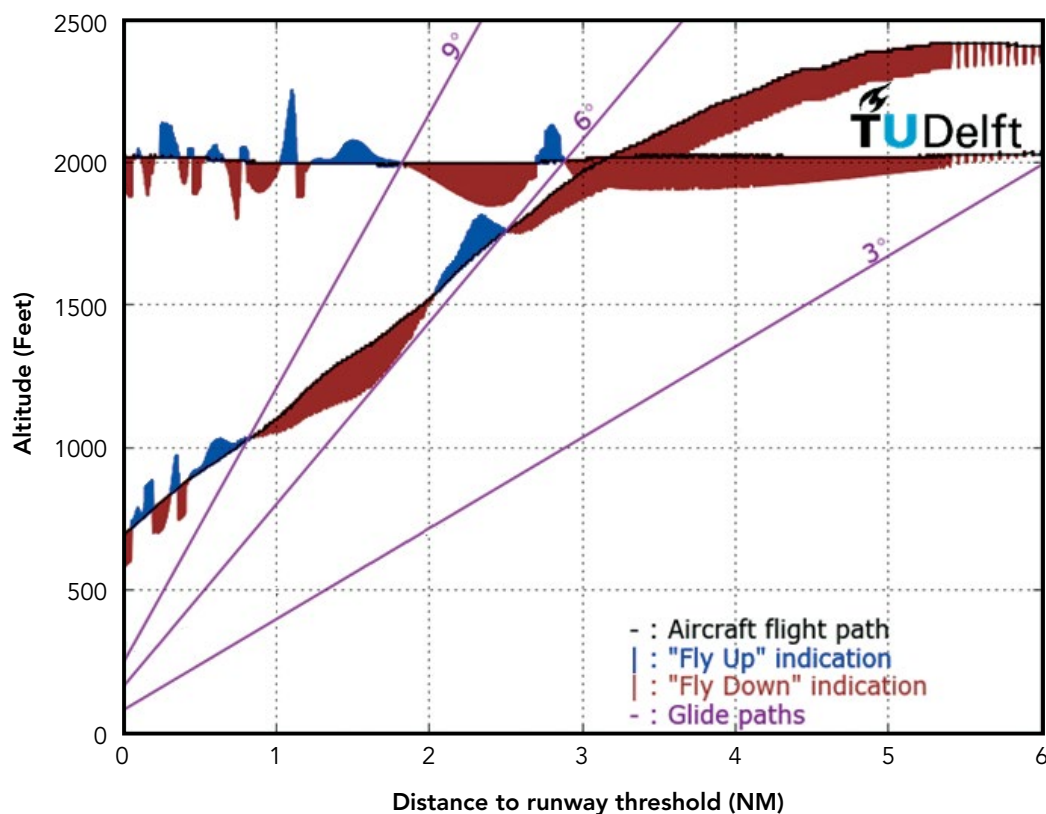
Figure 17: 2,000 feet level and diagonal run measurement flight at Eindhoven Airport Runway 03.

A measurement was performed at 2,000 feet in level flight and a descending run was performed with the autopilot not engaged. The measurement at Eindhoven Airport Runway 03 showed that a 'Fly Down' indication was measured between a 3 and 6 degree Glide Path. Around the 6 degree Glide Path a small 'Fly Up' indication area was present. Between approximately the 6 and 9 degree Glide Path a 'Fly Down' indication was measured. Hereafter a 'Fly Up' indication was measured between 9 and 15 degrees with a small area of 'Fly Down around 12 degrees. See Figure 17 for the results.

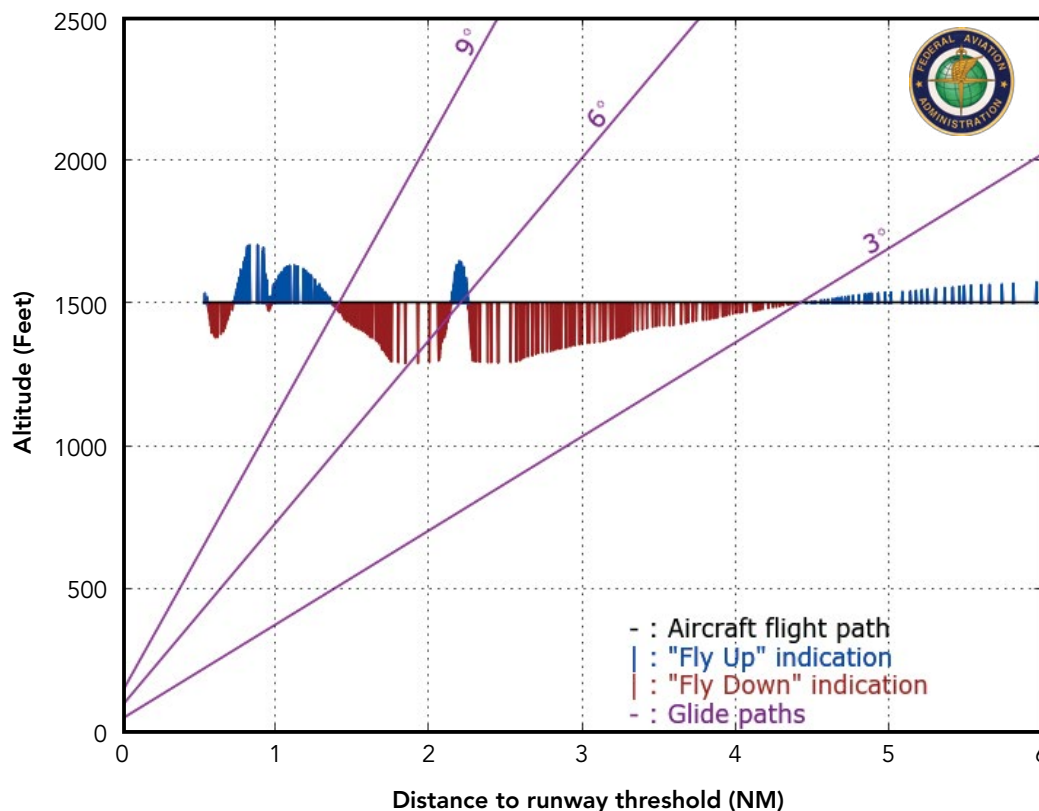
Figure 18: 1,500 feet level flight measurement of the Null Reference Glide Slope antenna system [source data FAA – adapted by the DSB].

The measurement of the Null Reference Glide Slope antenna systems showed that below the 3 degree Glide Path a 'Fly Up' indication is present. Above the 3 and until the 6 degree Glide Path a 'Fly Down' indication is present. Hereafter signal reversal occurs around 6 degrees and a 'Fly Down' indication is present until approximately the 9 degree Glide Path. Above 9 degree Glide Path a 'Fly Up' indication is present.

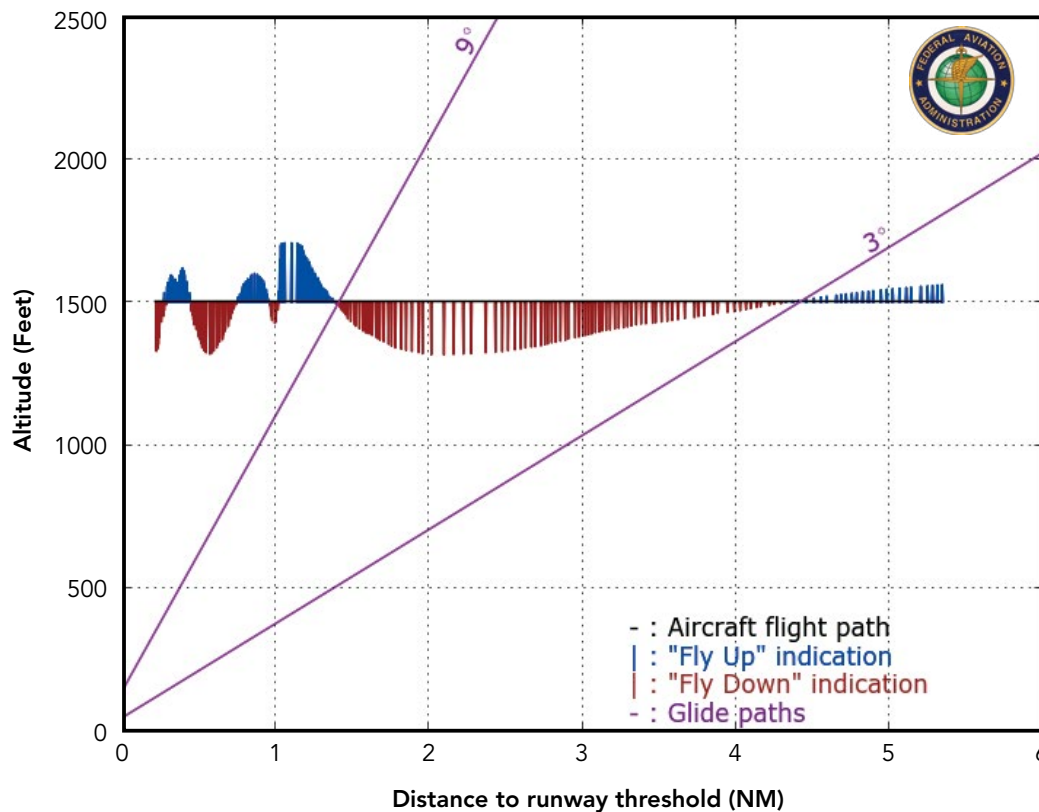
Figure 19: 1,500 feet level flight measurement of Sideband Glide Slope antenna system [source data FAA – adapted by the DSB].

Measurement of the Sideband Glide Slope antenna systems showed that below the 3 degree Glide Path a 'Fly Up' indication is present. Above the 3 and until the 9 degree Glide Path a 'Fly Down' indication is present. Hereafter signal reversal occurs at approximately 12 degrees with a 'Fly Down' and then a 'Fly Up' indication.

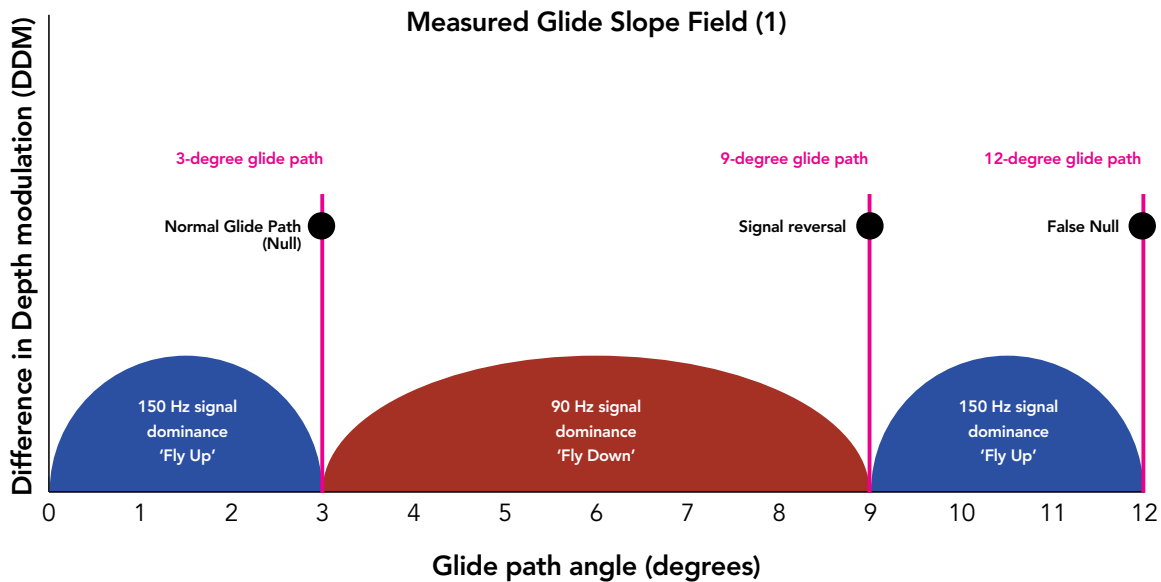
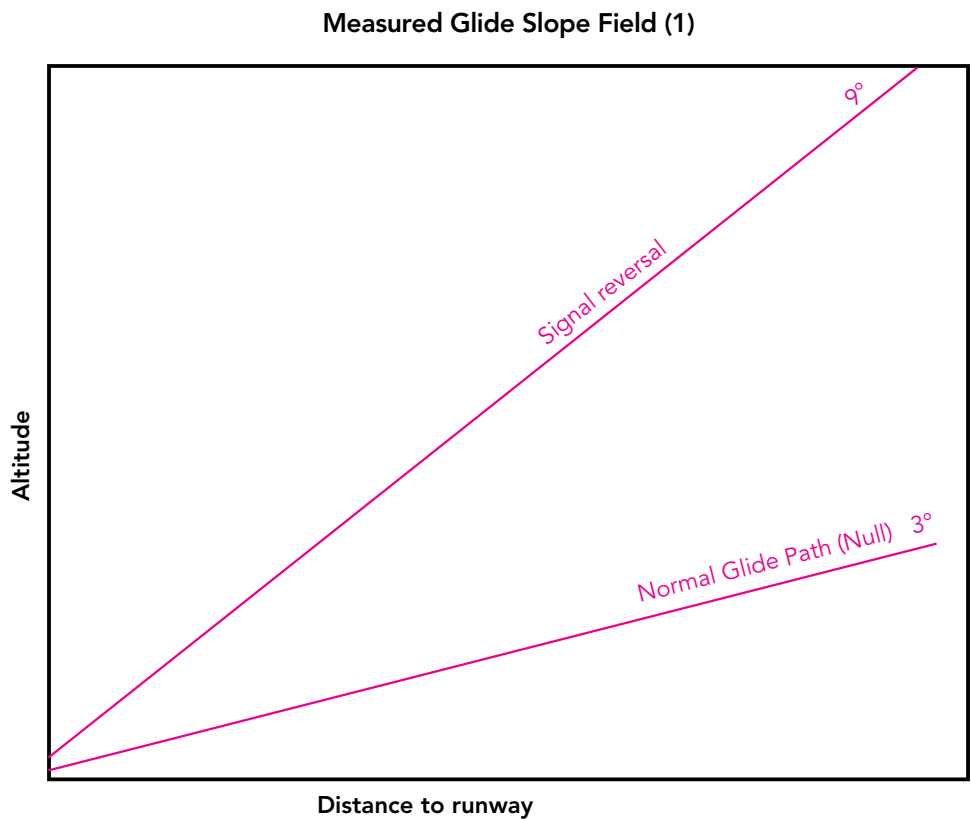
The first type of field is depicted schematically in Figure 20. Below the 3 degree Glide Path a 150 Hz signal dominance ('Fly Up') is present. Following a 90 Hz signal dominance ('Fly Down') between the 3 degree and 9 degree Glide Path angle. Between 9 and 12 degree Glide Path angle a 150 Hz signal dominance is presents (Fly Up').

Figure 20: DDM versus Glide Path angle first Glide Slope field characteristic; signal reversal at 9 degree Glide Path (Sideband and M-array).

Figure 21: Cross section first Glide Slope field characteristic; signal reversal at 9 degree Glide Path (Sideband and M-array).

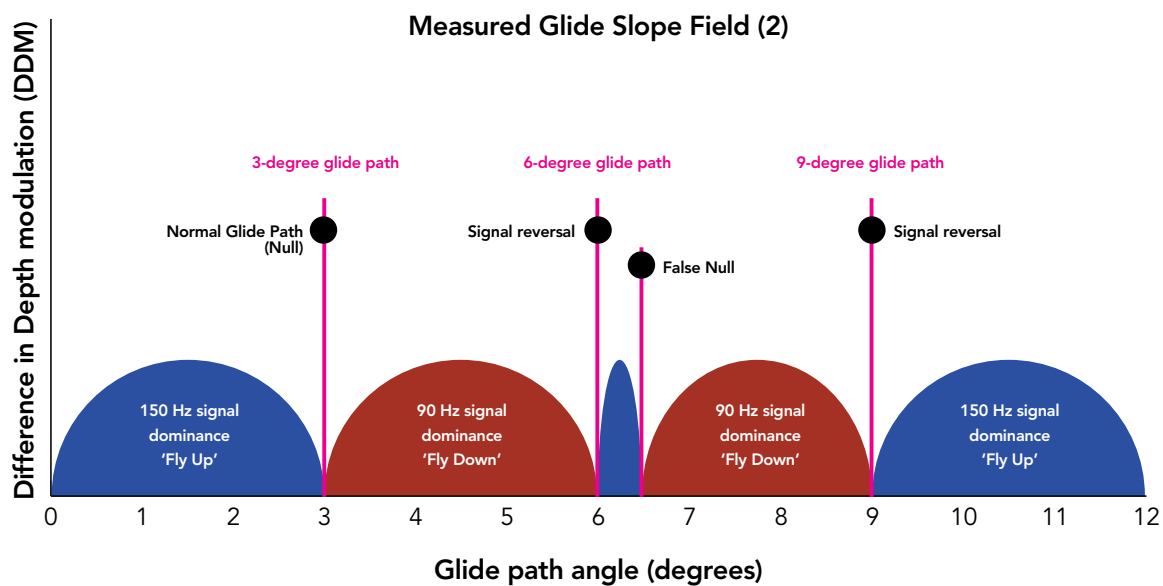
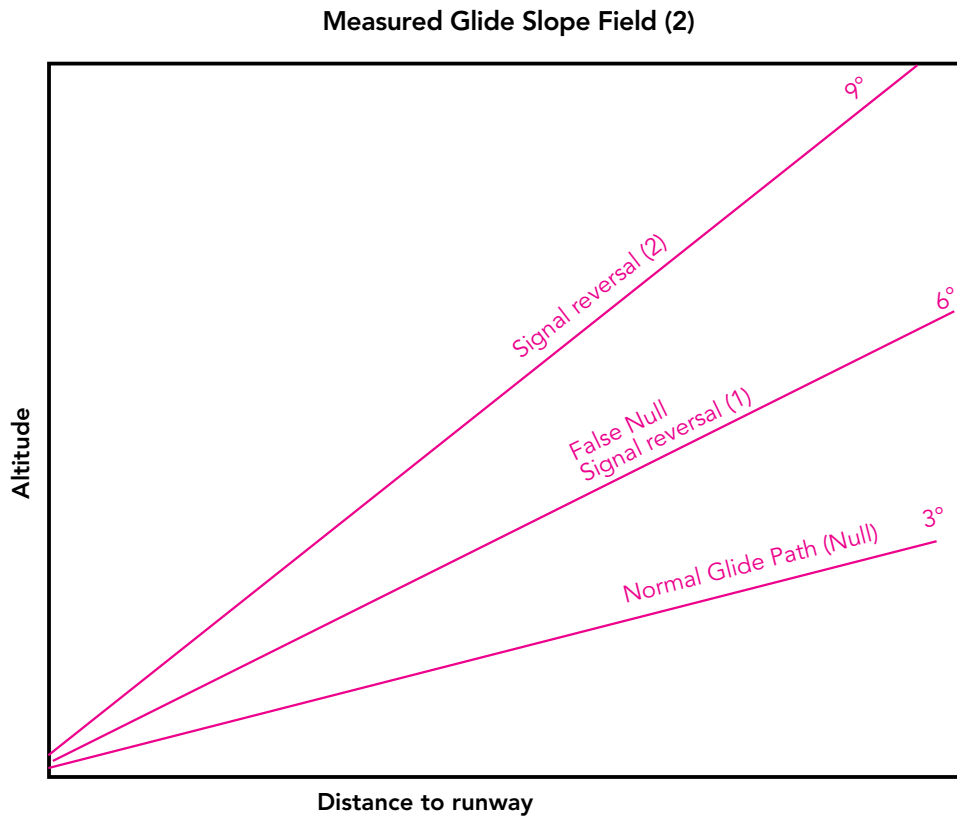
The second type of field is presented schematically in Figure 22. Below the 3 degree Glide Path a 150 Hz signal dominance ('Fly Up') is present. Following a 90 Hz signal dominance ('Fly Down') between the 3 degree and 6 degree Glide Path angle. Around the 6 degree angle a small area with 150 Hz signal dominance ('Fly Up') is present. Thereafter, until the 9 degree Glide Path angle a 90 Hz signal dominance is present ('Fly Down'). Finally, between the 9 and 12 degree Glide Path angle a 150 Hz signal dominance is presents ('Fly Up').

Figure 22: DDM versus Glide Path angle second Glide Slope field characteristic; first signal reversal at 6 degree Glide Path (Null reference and M-array).

Figure 23: Cross section second Glide Slope field characteristic; first signal reversal at 6 degree Glide Path (Null reference and M-array).

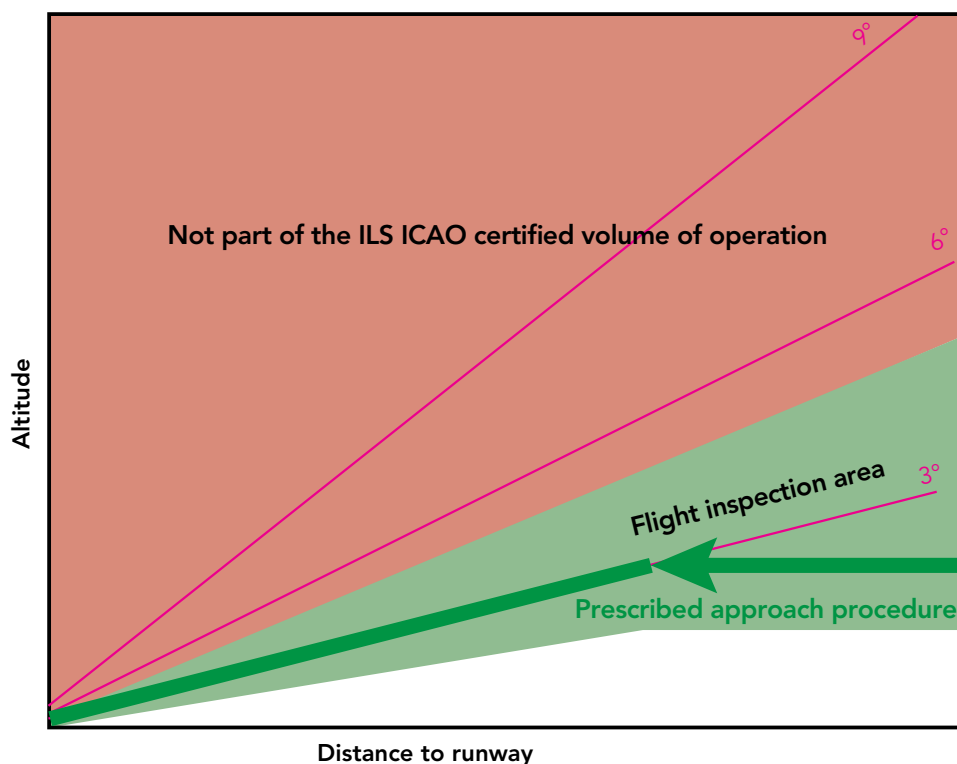
The measurements at Eindhoven Airport, where identical M-array antennas are used for both runways (03 and 21), showed that each runway had a different Glide Slope signal characteristic. According to the manufacturer, local deviation in ground plane and/or system configuration could explain this difference. The presence of other Glide Slope field characteristics with M-array or other types of Image array antenna systems cannot be discounted, but that was beyond the Dutch Safety Board's scope in this investigation.

Figure 24: Cross section of ILS Glide Slope signal that is inspected and certified for operational use.

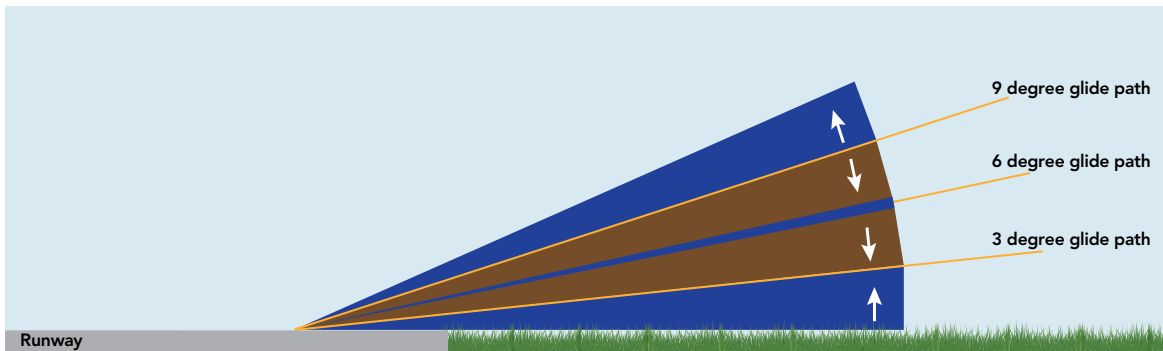
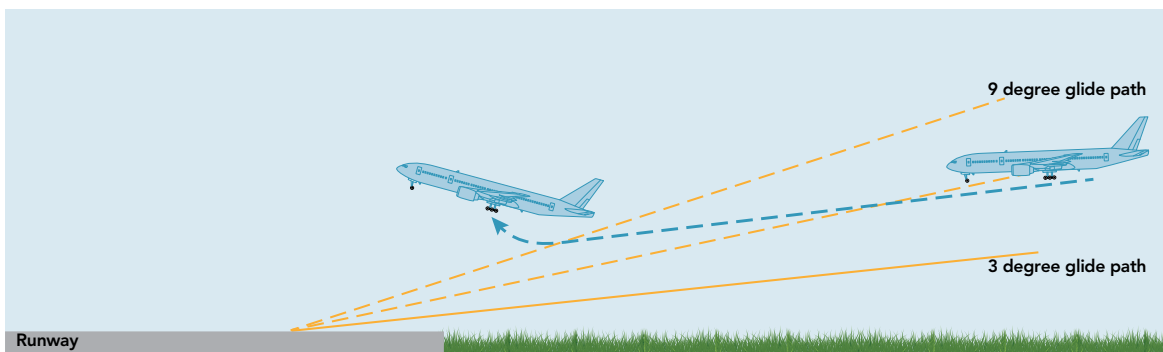
1. A signal reversal was always present at approximately 9 degree glide path.
2. A signal reversal was sometimes present at approximately 6 degree glide path.³⁹

Figure 1: Cross section view of the M-array ILS antenna system. Schematic overview of the "Fly up"(blue) and "Fly down"(brown) indication.

Figure 2: Example of glide slope capture with a pitch upset above 3 degree glide path.

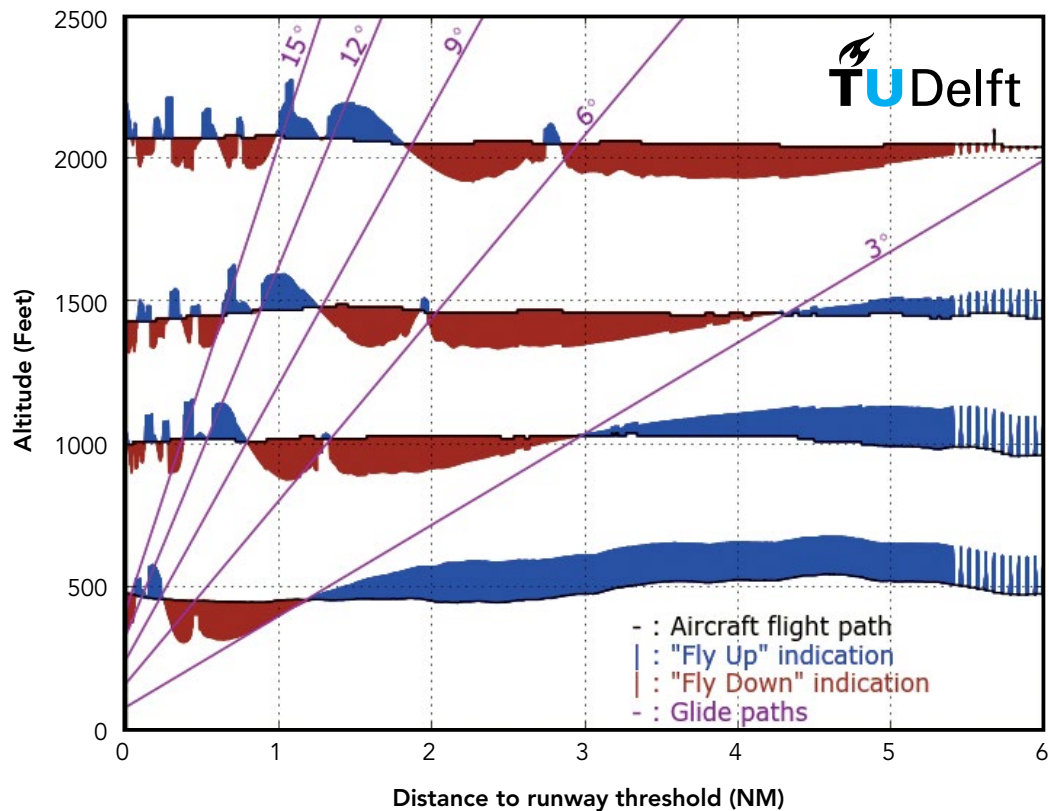
Figure 4: horizontal Glide Slope signal measurements Woensdrecht Air Base

Following these flight tests it was shown that while flying the scenarios at Woensdrecht Air Base the Auto Pilot Glide Slope logic activated when the 6 degree Glide Path was crossed. The autopilot subsequently followed the 'Fly Up' command and a pitch-up occurred, flight crew intervention was essential.'

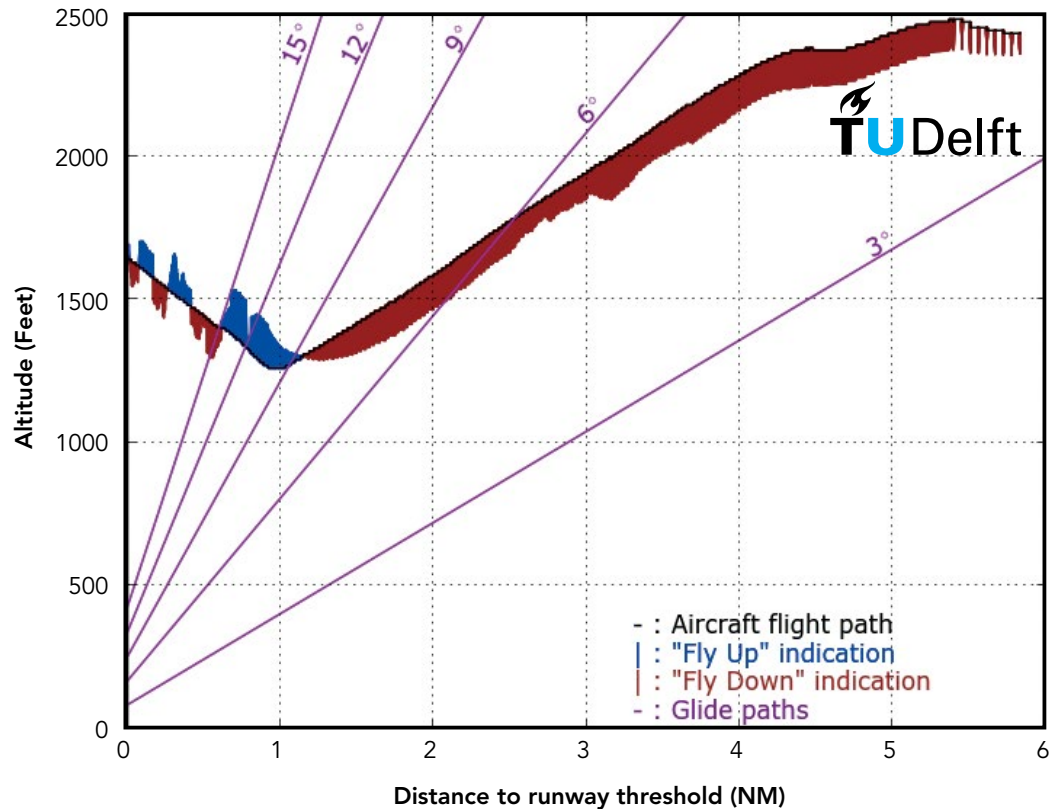
Figure 5: scenario 3 measurement flight Eindhoven Airport runway 21

'To follow the profile of the incident flight, we programmed a vertical profile in the FMS, providing vertical guidance on the PFD from 2,500 feet at 5 NM from the threshold, to 1,000 feet at 1 NM. This profile was tracked using the vertical speed mode of the flight director coupled to the autopilot with the Glide Slope armed, the same setup the incident flight had used.'

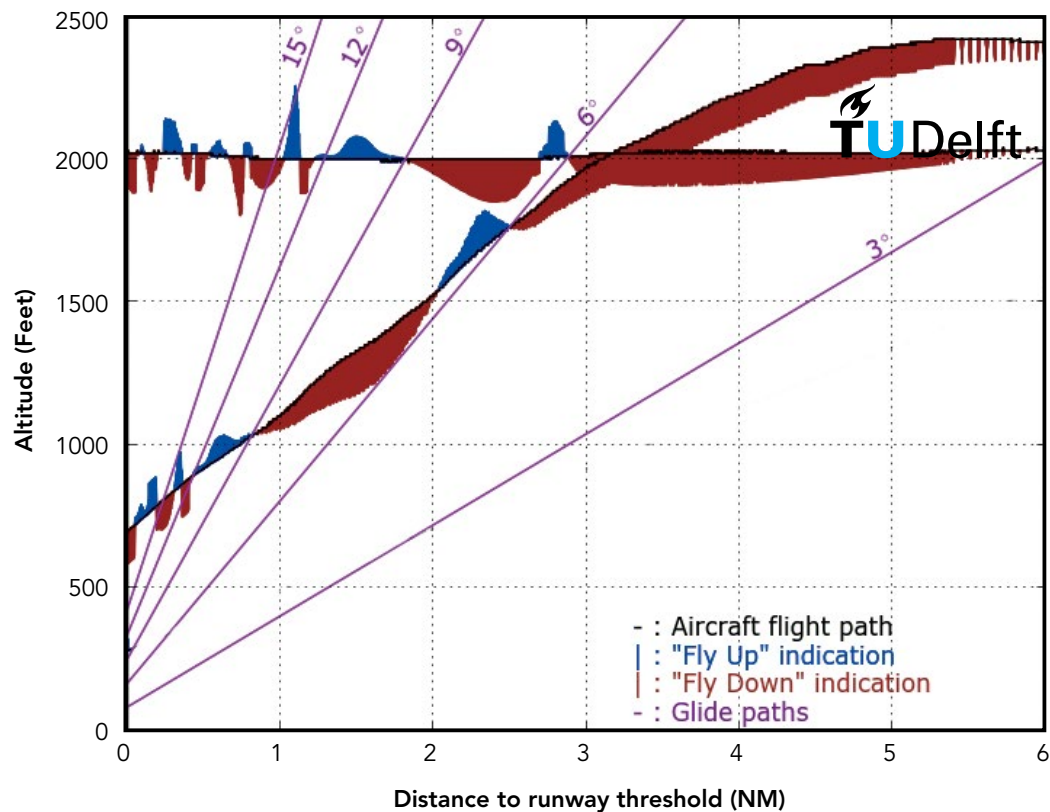
Figure 6: scenario 3 measurement flight Eindhoven Airport runway 03

A second flight campaign was done with a second aircraft, PH-NLZ operated by NLR, to measure the Glide Slope field at Eindhoven Airport runway 03. A horizontal measurement was done at 2,000 feet and a diagonal run down (scenario #3) was done with the autopilot not engaged. The focus of the measurement was to record additional data, therefore the autopilot in Glide Slope capture was disengaged as not to get pitch-up which would disturb the measurement run.
