DUTCH
SAFETY BOARD

Shipping Occurrences Report

May - October 2015

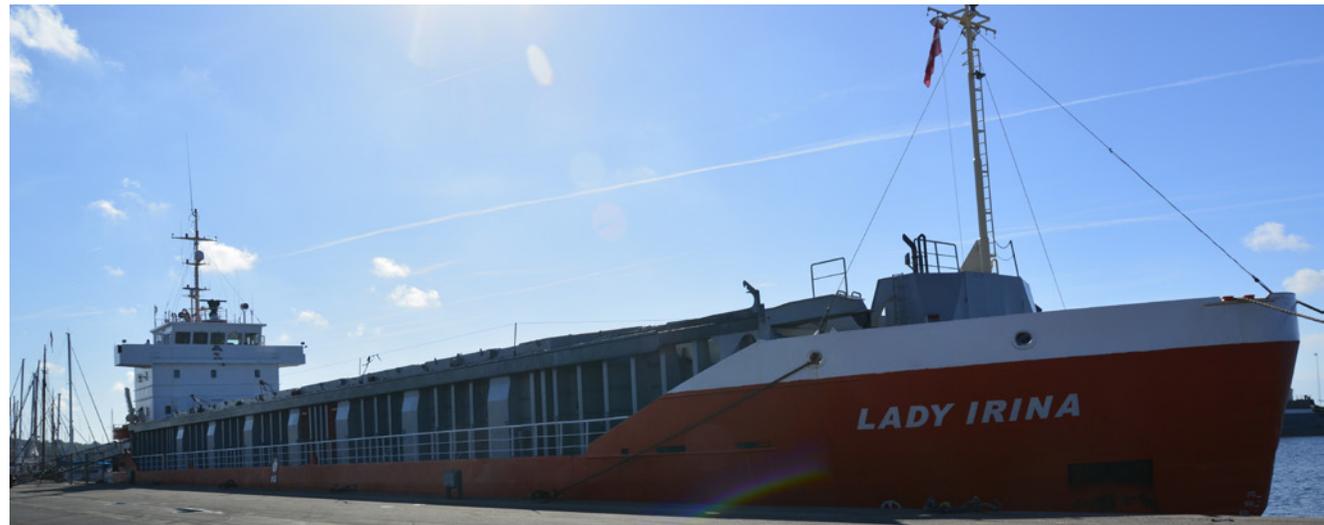
Lady Irina. (Source: *Wijnne Barends B.V.*)

needed to enter the bow thruster room for this. As the Chief Engineer had not been seen for some time, the first mate went looking for him and found him lying in the bow thruster room. The crew members then started a rescue operation to remove the Chief Engineer from the bow thruster room, but they were unsuccessful. A coroner ascertained that the Chief Engineer had died from carbon monoxide. During the rescue operation two other crew members also became unwell as a result of carbon monoxide poisoning.

The 'wood pellets' cargo on board Lady Irina produced carbon monoxide that could have leaked into the fore-castle via various routes from the cargo hold. As the bow thruster room and tank had not been ventilated for more than 24 hours, carbon monoxide levels had increased. It was common practice to ventilate the tank and bow thruster room at the start of the working day by leaving the door open for fifteen to twenty minutes. The doors also remained open during any activities.

The risk of hazardous atmosphere in the tank and bow thruster room was estimated as being low and practice was adjusted accordingly; the areas were not treated as confined spaces. The daily practice on board on entering the tank and bow thruster room was adapted in accordance with the nature and daily use of the areas and was not

based on a well-founded estimate of the risks. Also from the actions during the rescue operation it appears that no connection was made between the (potentially) hazardous atmosphere in the bow thruster room and tank and the incident. This accident could have easily resulted in more victims of carbon monoxide poisoning.

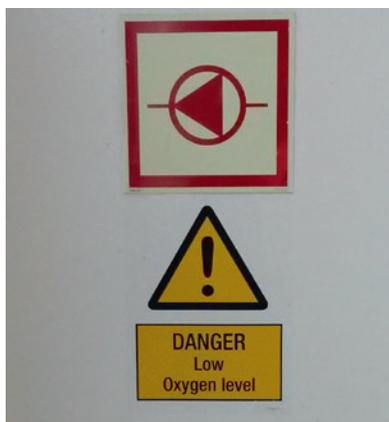
Entrance bow thruster room before the accident. (Source: Wijnne Barends B.V.)

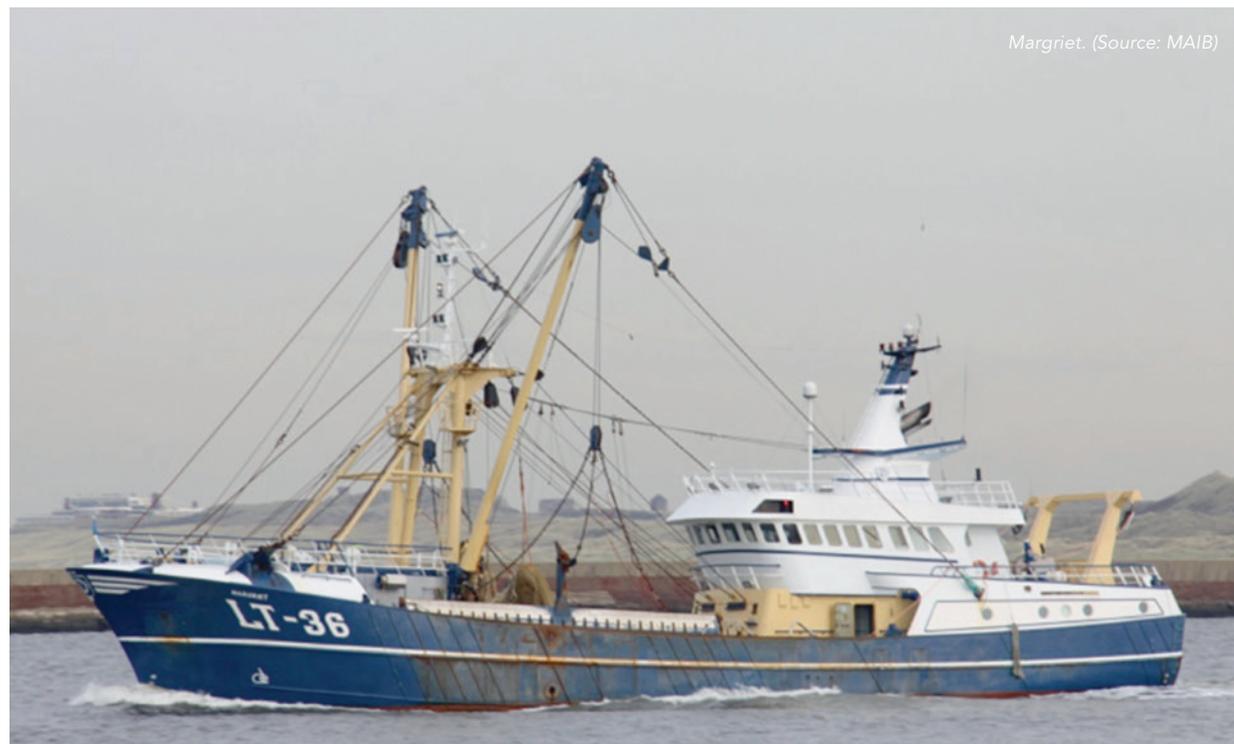
Margriet. (Source: MAIB)

The MAIB investigation found, amongst other things, that the Margriet officer of the watch did not maintain effective lookout. He had not seen the tanker, which was just 1 nautical mile away, when he changed course in the direction of the tanker. The implemented course change just prior to the collision showed that the mate was awake.

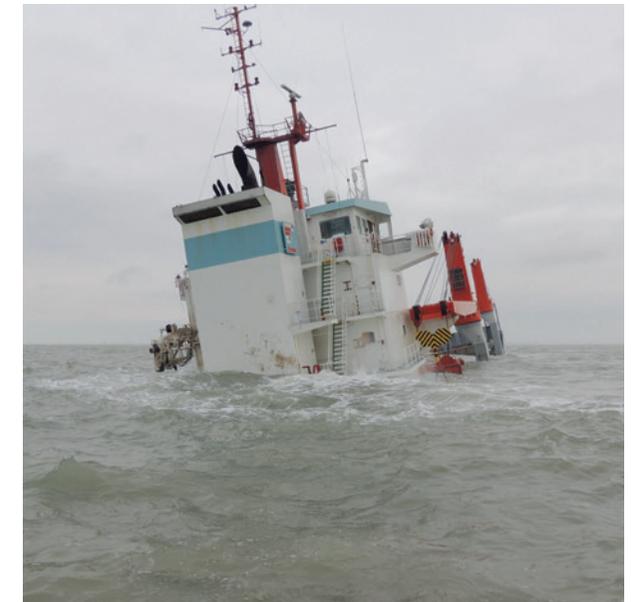
A freighter sailing under the Dutch flag collided with a Marshall Islands-flagged LNG tanker by the coast of Zeebrugge on 6 October. This caused the freighter to sink. All 12 crew members were saved, but the ship was considered lost. In addition, the wrecking of the freighter caused oil pollution on the Belgian and Dutch coasts. The LNG tanker sustained damage to the bulbous bow with some leakage as a consequence of this. After unloading the cargo in Zeebrugge the vessel was taken to Belfast for repair. Both vessels had pilots on board at the time of the accident.

Sunken freighter.

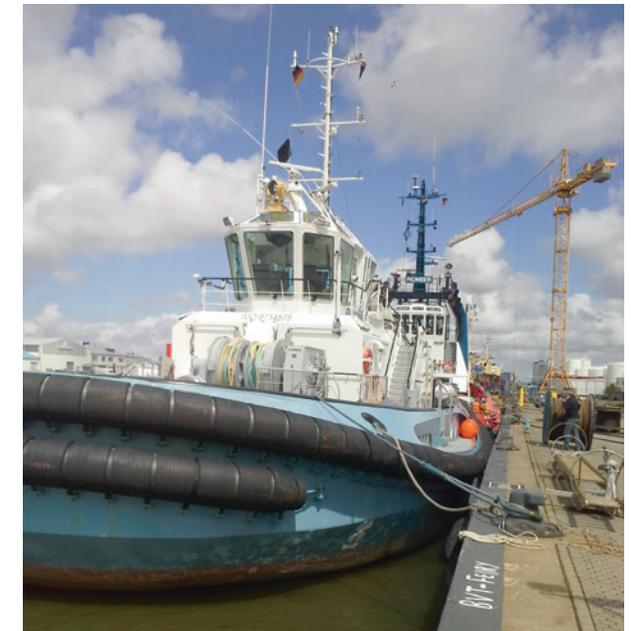
Left: Damage on Eddy1. Right: Eddy1 in the dock. (Source: Holland Shipyards)

The Eddy1 sustained serious damage through this, but was able to reach a nearby berth under its own steam. The Seahorse had some paint damage and continued its journey further up river.

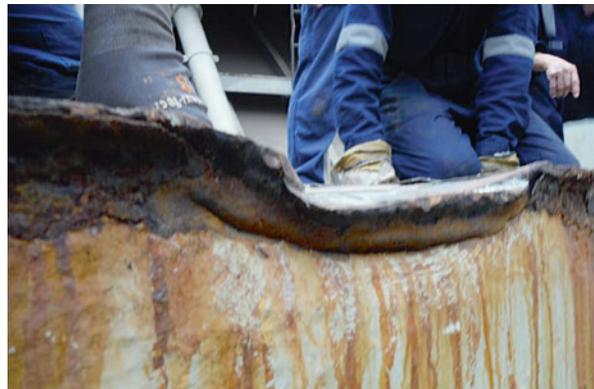
During inspection, after the container had fallen, it appeared that the spreader was in a poor technical condition: the handles of the spreader's locking mechanism were broken off. The spreader was in a half-open position, which meant that the container could fall. The damage to the ship comprised a dent and some paint damage. The damage was repaired and the shipping activities continued.

Dent in deck (Nedlloyd De Liefde). (Source: Maersk)

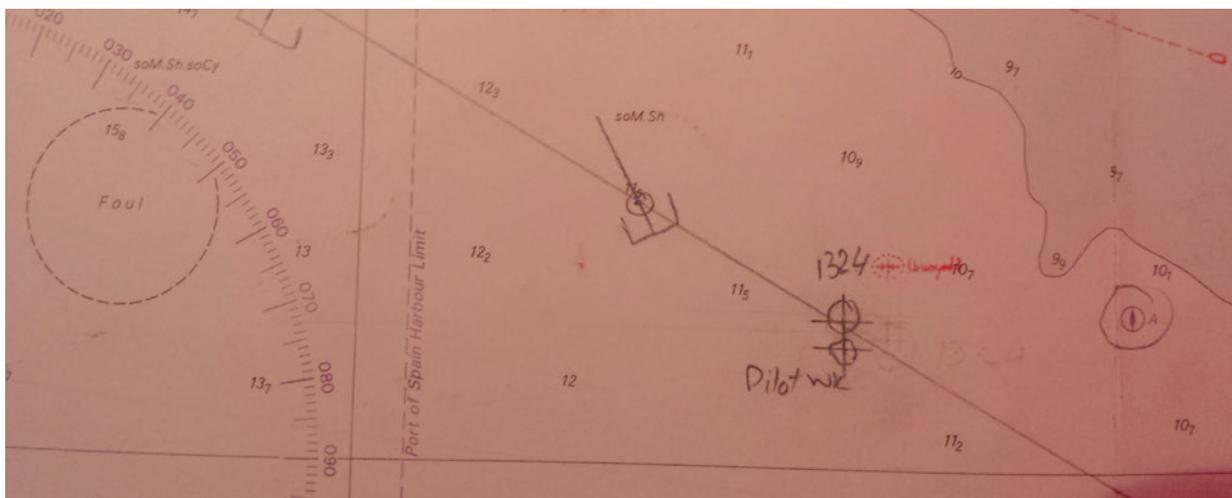
The APL Guard crew had observed no buoy at the wreck's indicated position. Neither was a buoy visible at the site of the collision. Shortly after this a pilot came on board. He explained that the new position of the wreck was 2.5 cables to the south of the position stated in the NtM. The new position concurred exactly with the site of the collision.

The ALP Guard sustained damage to the starboard side bow below the waterline, resulting in several leaks. The ship needed to go to a dry dock for repair.

Chart with position of wreck and track of ALP Guard. (Source: ALP Guard)

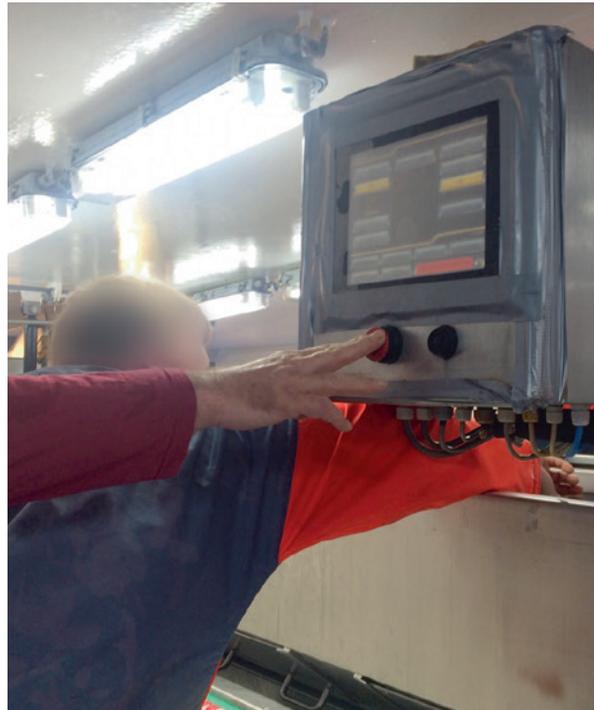
Reconstruction of the arm position during the incident on the TX36. (Source: owner Jan van Toon)

A crew member saw there were fish still lying on the table, while another crew member was controlling the table, moving it downwards. The victim removed the fish from the table, but became trapped in doing so. He fractured his elbow and needed to be taken to hospital by helicopter.
