DUTCH  
SAFETY BOARD

# Collision between a passenger train and a man lift at Dalfsen

*The Hague, December 2016*

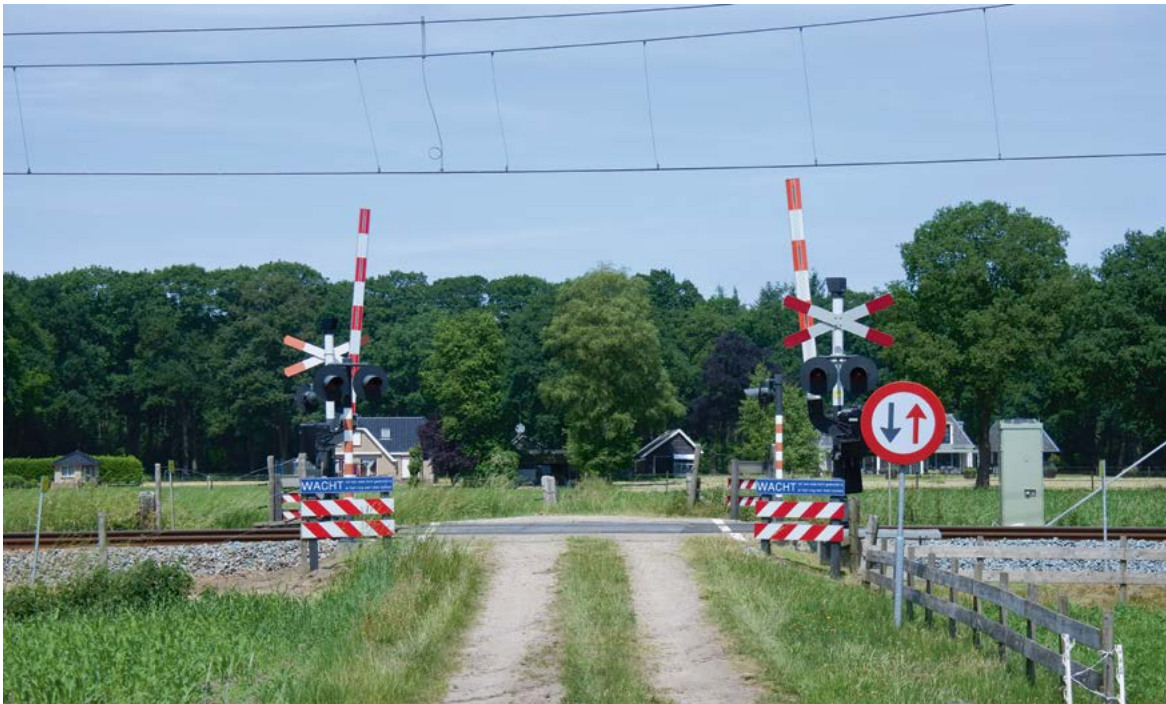
The level crossing where the accident occurred is the crossing between the Dalfsen - Ommen railway line and Het Lage Veld road. The level crossing is located in a rural area and is equipped with automatic half barriers (mini-AHOB, see figure 1).

Figure 1: The level crossing where the accident occurred. Photo: Dutch Safety Board

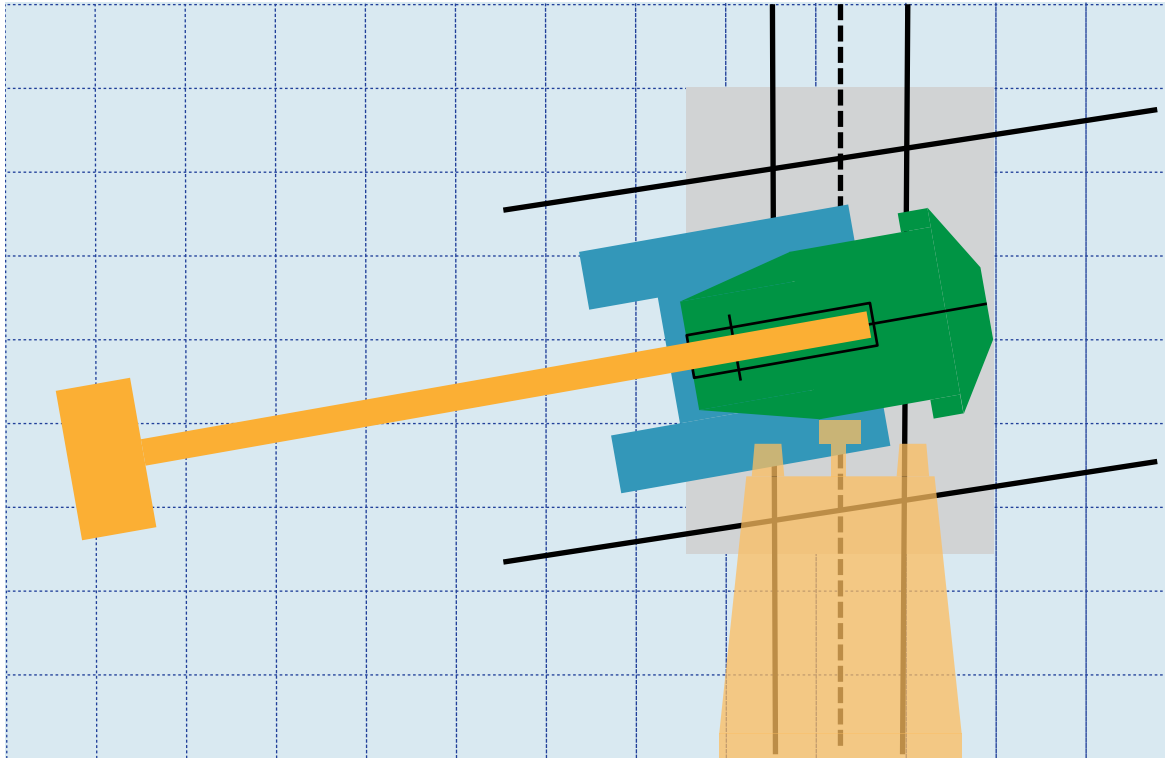
Figure 7 shows the positions of the train and the man lift at the start of the collision. The front of the train collided with the rear part of the left side of the man lift. During the collision, the train speed decreased to approximately 107 km/hour while the man lift was accelerated to approximately the same speed. In addition, the man lift and the front of the train were severely damaged.

Figure 7: The positions of the train and the man lift at the start of the collision.

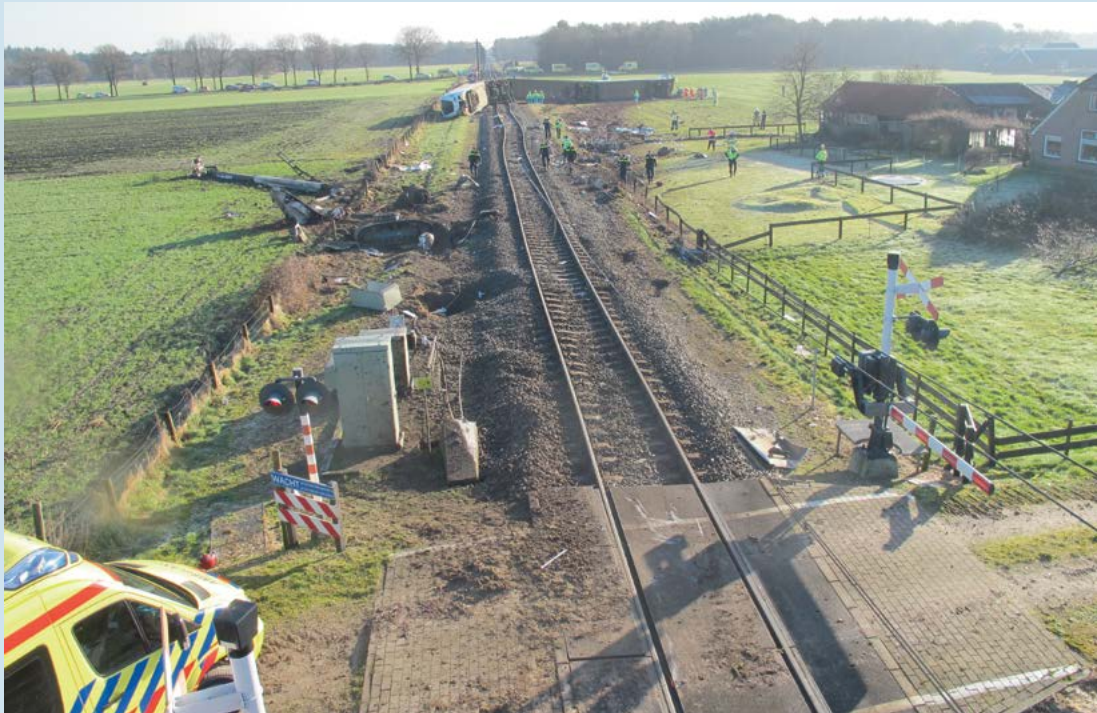
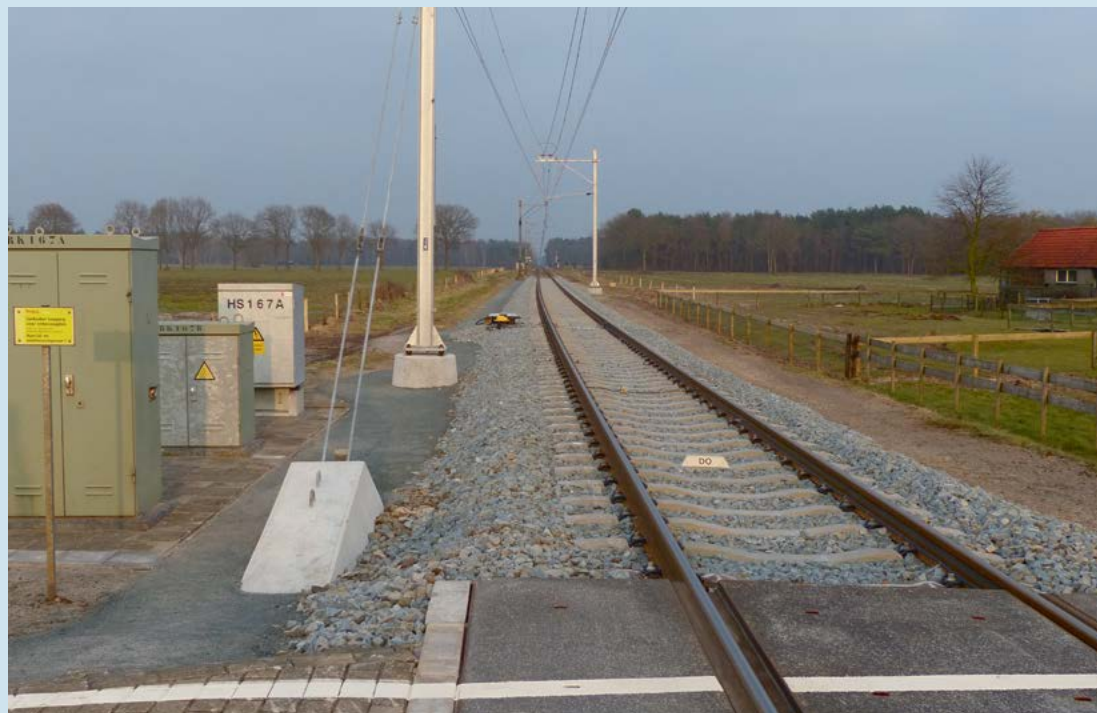
There was a secondary crash shortly after the train collided with the man lift. In this crash the man lift, which had accelerated to a speed of approximately 107 km/hour as result of the train colliding with it, crashed into an overhead lines pole which was standing approximately 15 metres to the east of the level crossing on the north side of the track. As a result of this secondary crash, the overhead lines pole - including the concrete foundations - was ripped from the ground and bent. The wreckage of the man lift and the overhead lines pole ended up a distance of 30 to 60 metres from the level crossing on the north side of the track (also see figure 8).

Figure 8: The upper photo shows the end situation, viewed from the train's direction of travel. In the foreground is the level crossing where the collision occurred; the man lift was crossing from right to left. The wreckage of the man lift and the overhead lines pole can be seen to the left of the track. The train was about 120-150 metres beyond the level crossing, approximately at right angles to the track, on the left-hand side. The lower photo was taken after the damage to the railway infrastructure had been repaired. The (replaced overhead lines pole can be seen in the middle of the photo. Photos: Police (upper), Dutch Safety Board (lower)

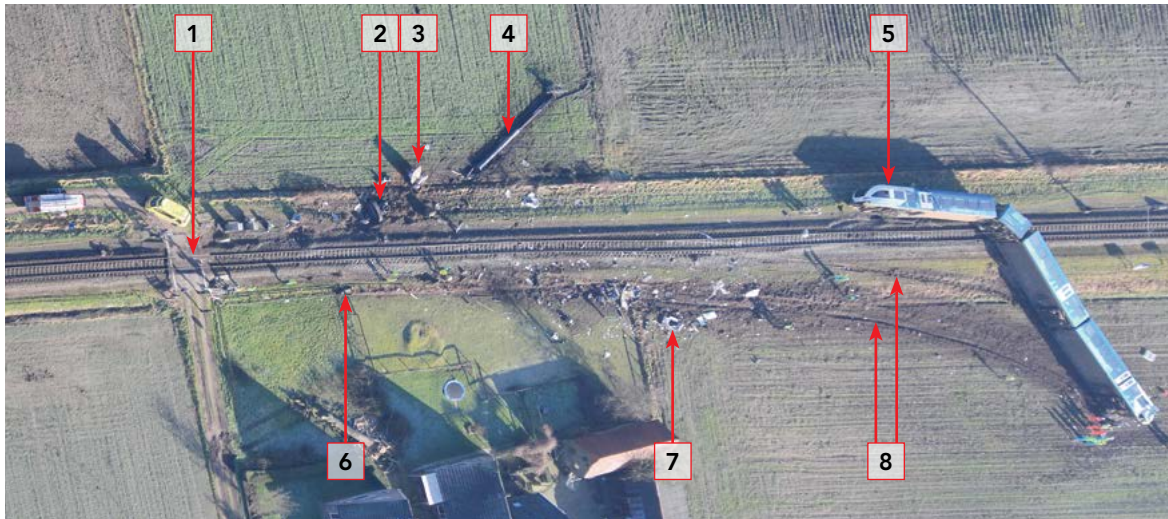
Figure 9: Final positions of the train and man lift wreckage. Photo: Police

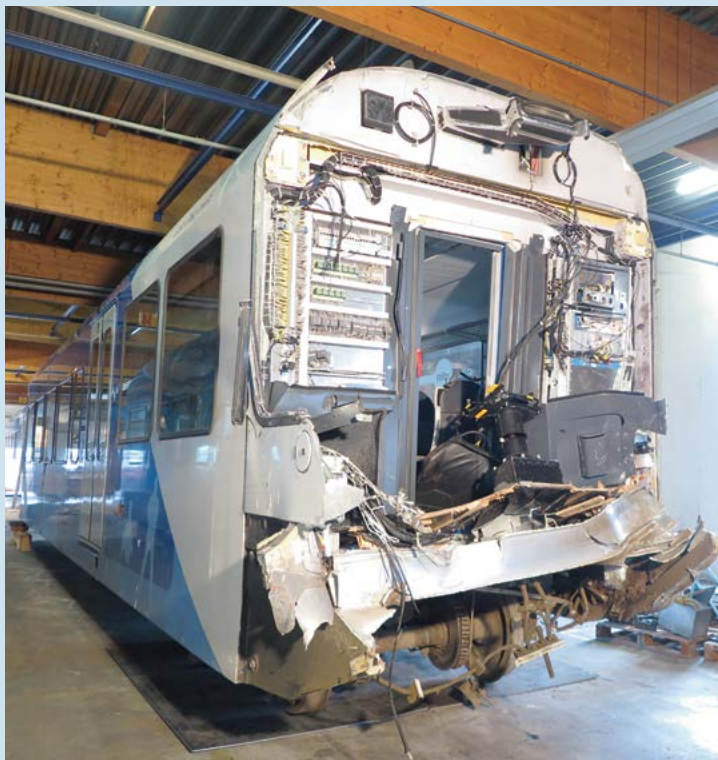
Figure 10: The driver's cab was totally destroyed in the accident. Photo: Dutch Safety Board

The consequences of the accident in Dalfsen were very serious in the sense that the train driver lost his life and the train was derailed and toppled over. The train driver died because the train cab was completely destroyed by the forces that were exerted on it during the accident. This was a relatively new type of train and the crashworthiness of the cab complied with the latest acceptance requirements. This means that trains have a specifically designed crash structure to withstand impacts of a specific magnitude. The train concerned was part of a series of trains which display defects in the welds in the crash structure. Train drivers were, therefore, once again reminded to flee the cab if a severe impact was imminent and seek refuge in the adjacent passenger compartment. The above begs the question why did the cab collapse in the accident in Dalfsen and to what extent did the weld defects play a role in this. The extent to which the train driver had an opportunity to leave the cab in good time is also relevant.

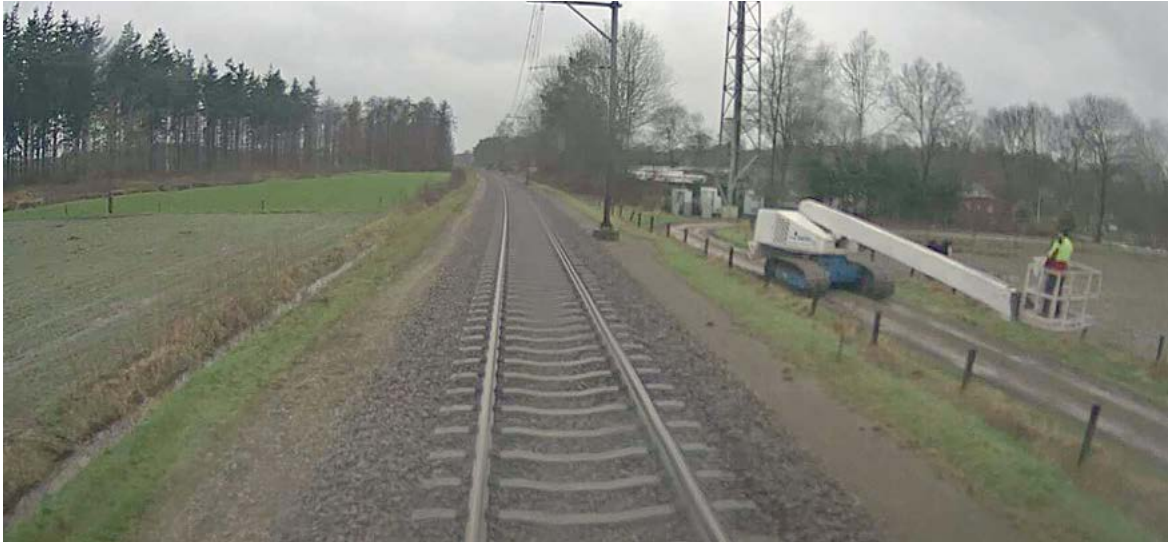
Figure 11: This photo shows the man lift during its journey the previous day to the location where it was used. The operator is in the man basket at the end of the boom, which is approximately ten metres long. The boom normally points backwards while driving. On its approach to the level crossing the boom was temporarily pointing forwards (see photo); prior to the crossing the boom was turned back to the rear. Photo: Arriva front camera, 22 February 2016

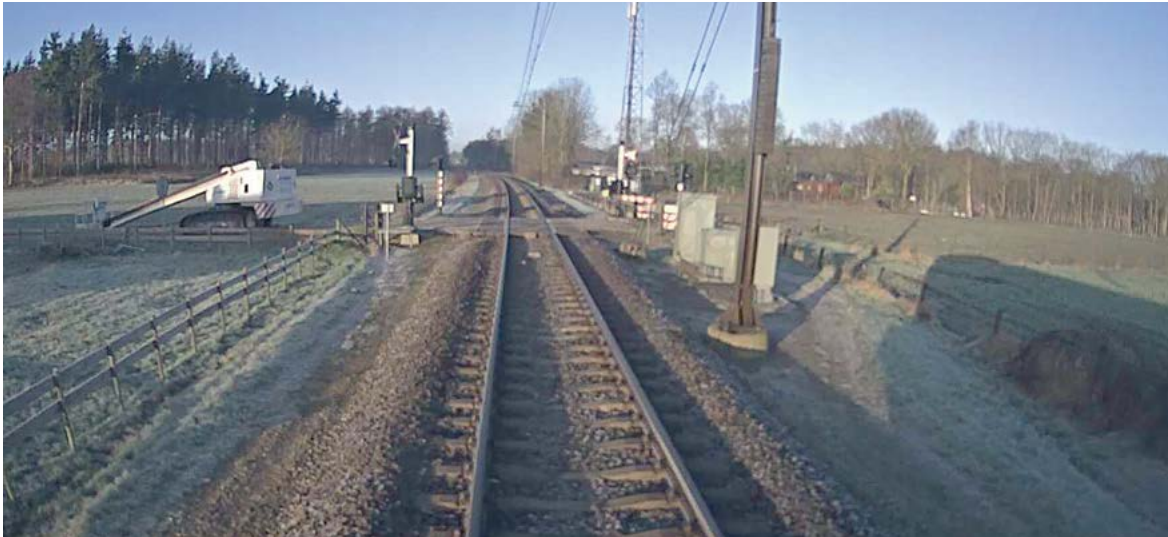
The crossing was completed successfully in this manner on the way there, which reinforced their belief that they could also cross in this manner on the way back. On the morning of the accident, once the man lift was no longer needed for the uprooting work, it was prepared for the return journey. The man lift was parked at a distance of approximately five metres in front of the level crossing (figure 12). The boom was initially pointing backwards (in relation to the intended direction of travel).

Figure 12: This photo (taken from the last train to pass prior to the accident) shows the position at which the man lift was parked prior to the return journey (close to the level crossing, with the boom still in a southerly direction). Photo: Arriva front camera

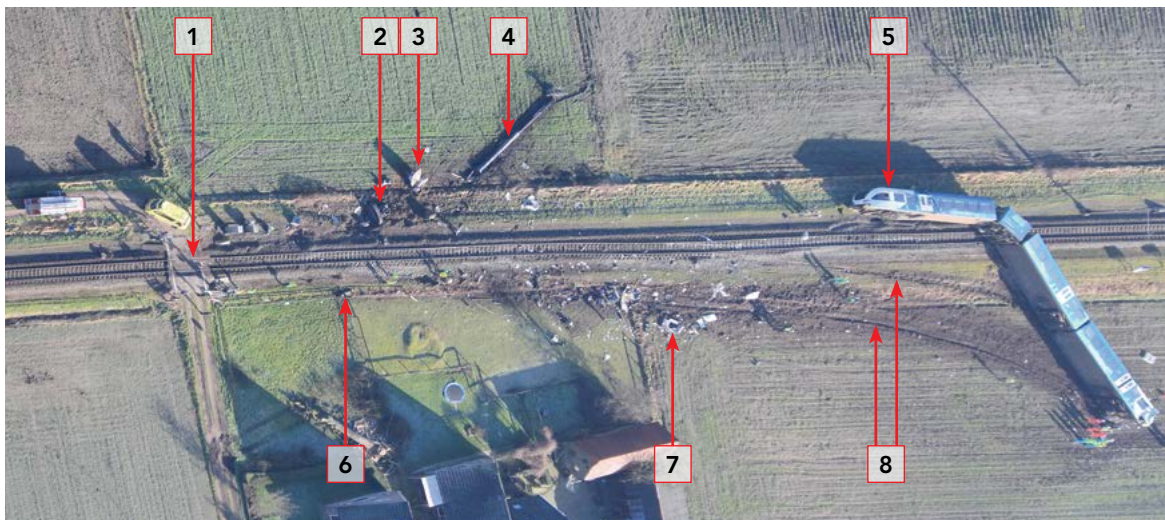
- At this location, the track runs in an approximately east to west direction. The train was travelling in an easterly direction and the man lift was crossing the level crossing in a northerly direction.
- The collision broke the man lift into three pieces (chassis, superstructure and boom) and they ended up 30 to 60 metres to the northeast of the level crossing.
- After the collision, the train covered a further distance of approximately 150 metres in an easterly direction and then toppled onto its left-hand side (shortly before coming to a standstill).

Figure 20: Final positions of the train and man lift wreckage. Photo: Police

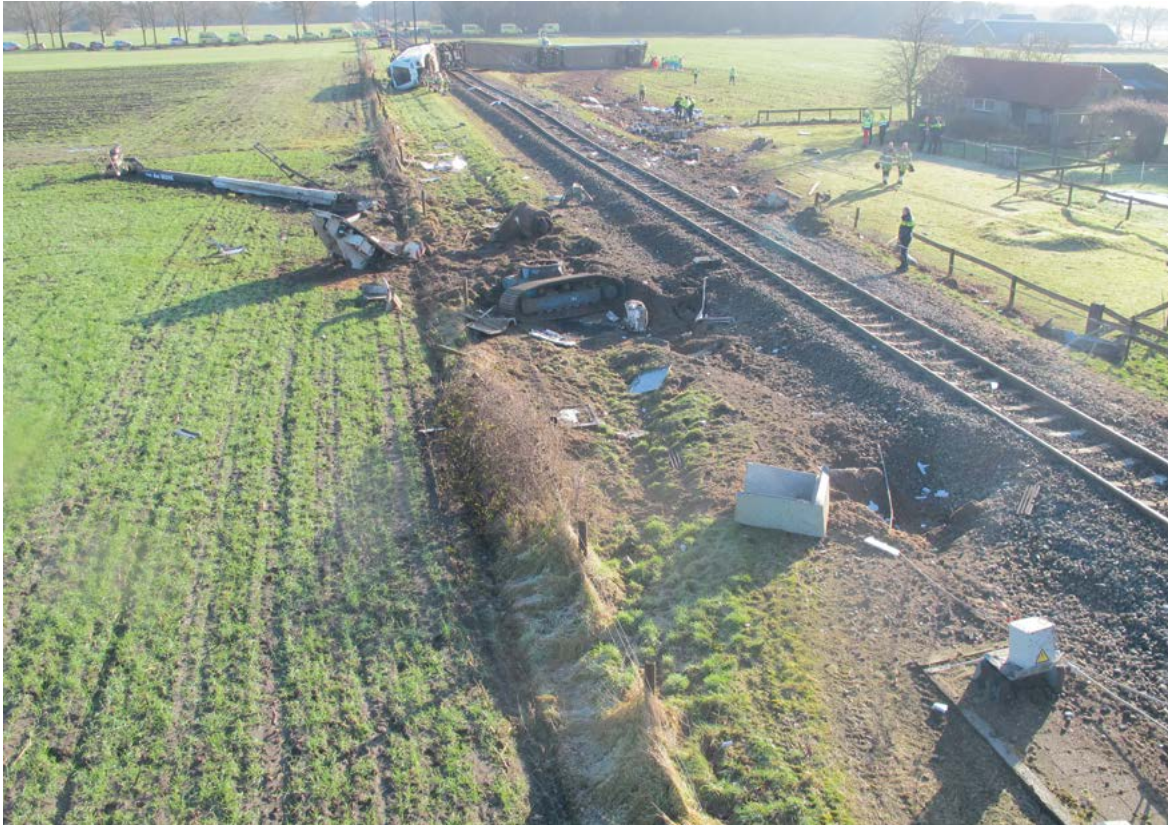
Figure 21: The final positions of the wreckage of the man lift and the overhead lines pole (on the north side of the track). The overhead lines pole was standing in the location where a hollow can be seen in the photo (at the bottom of the picture). Photo: Police

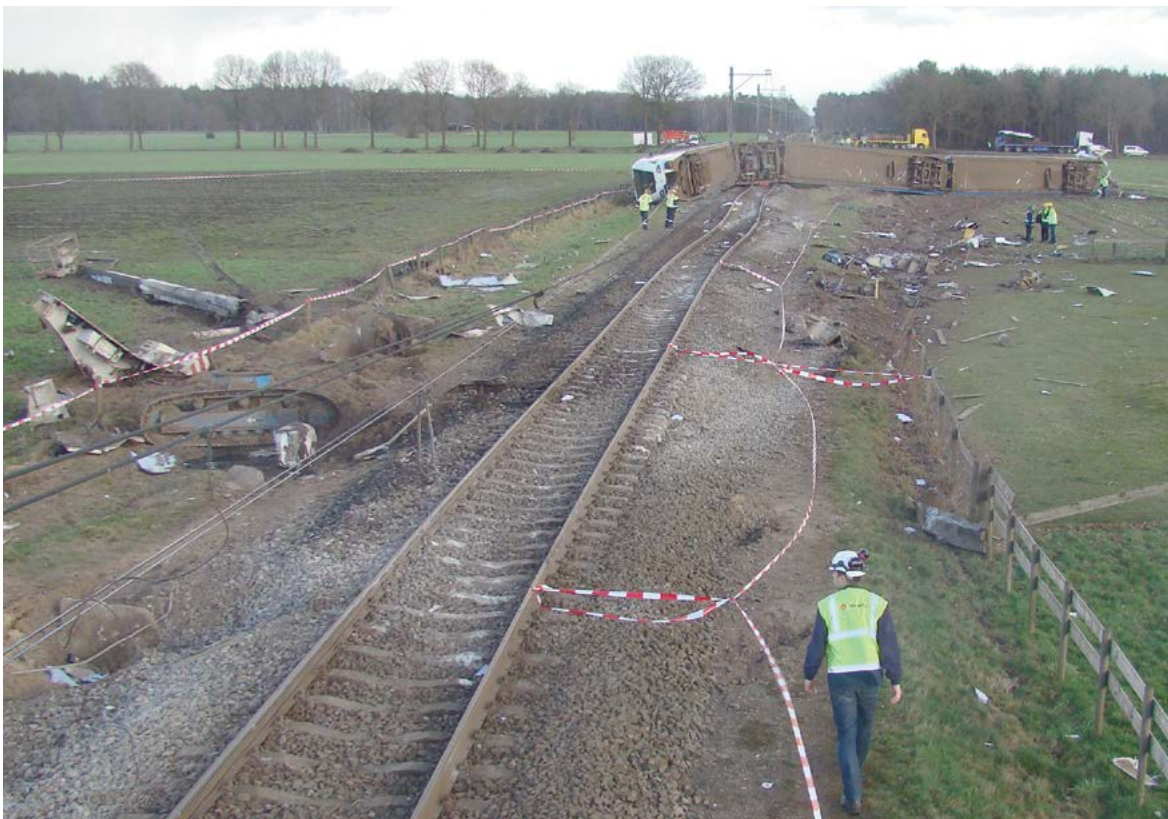
Figure 22: The final positions of the wreckage of the front of the train (on the south side of the track) and the damage to the railway infrastructure. Photo: Police

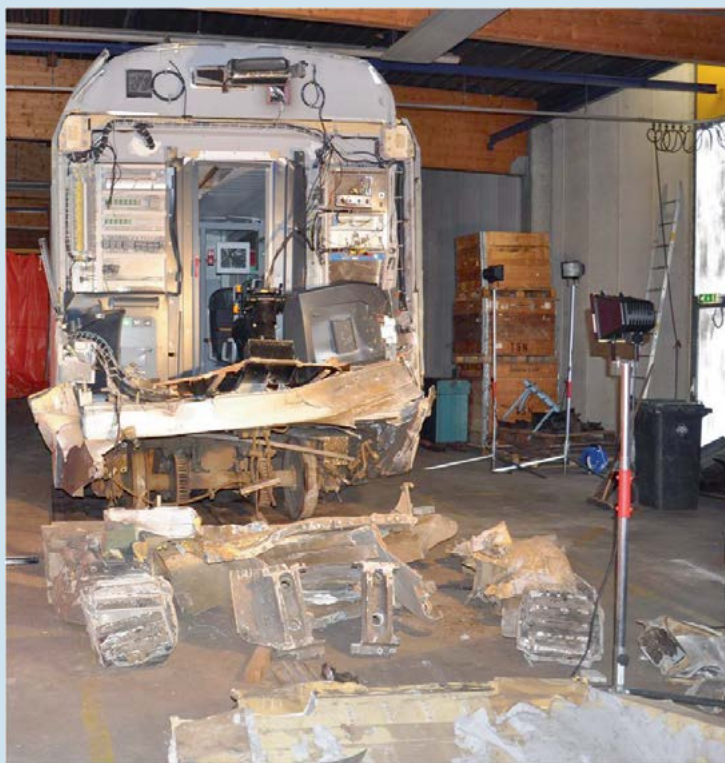
Figure 23: The damage to the front of the train. Photo: Dutch Safety Board

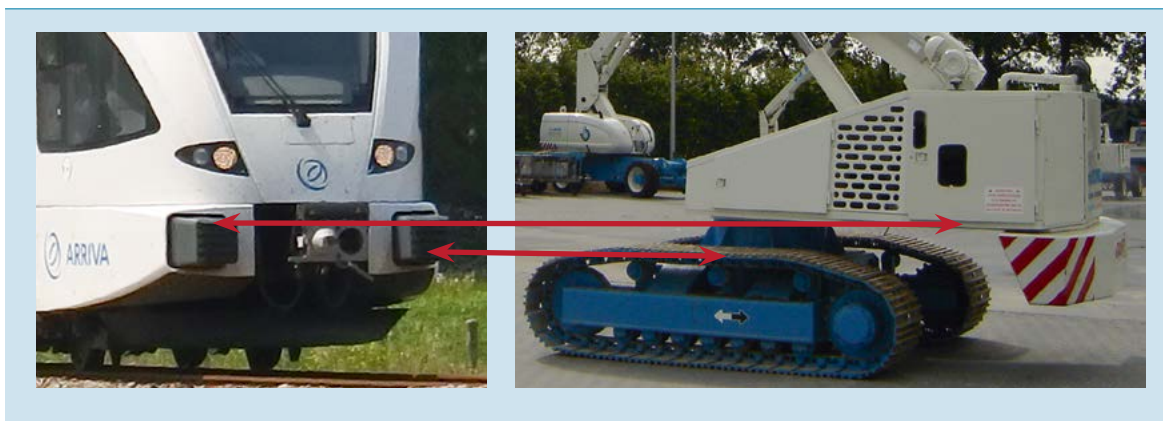
- The bottom part of the left crash buffer (approximately in the centre) came into contact with the side of the left caterpillar track.
- The top part of the right crash buffer came into contact with the side of the superstructure.
- At the start of the primary impact, the front of the coupler was in the open space between the caterpillar track and the contraweight.

Figure 24: These photos show which parts of the train and the man lift came into contact with each other in the primary impact. Photos: Dutch Safety Board (left), Man lift rental company (right)

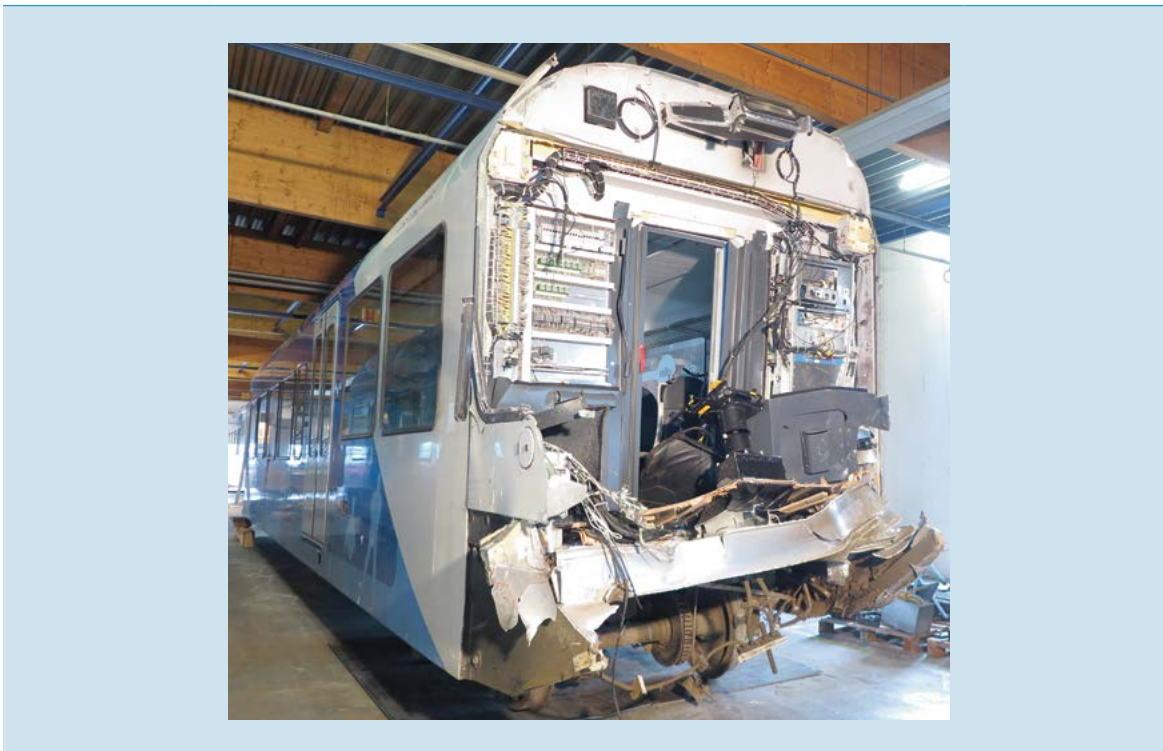
As a result of the collision, the cab was totally destroyed and separated from the front wall of the first carriage (see figure 26).

Figure 26: The driver's cab was totally destroyed by the collision. Photo: Dutch Safety Board

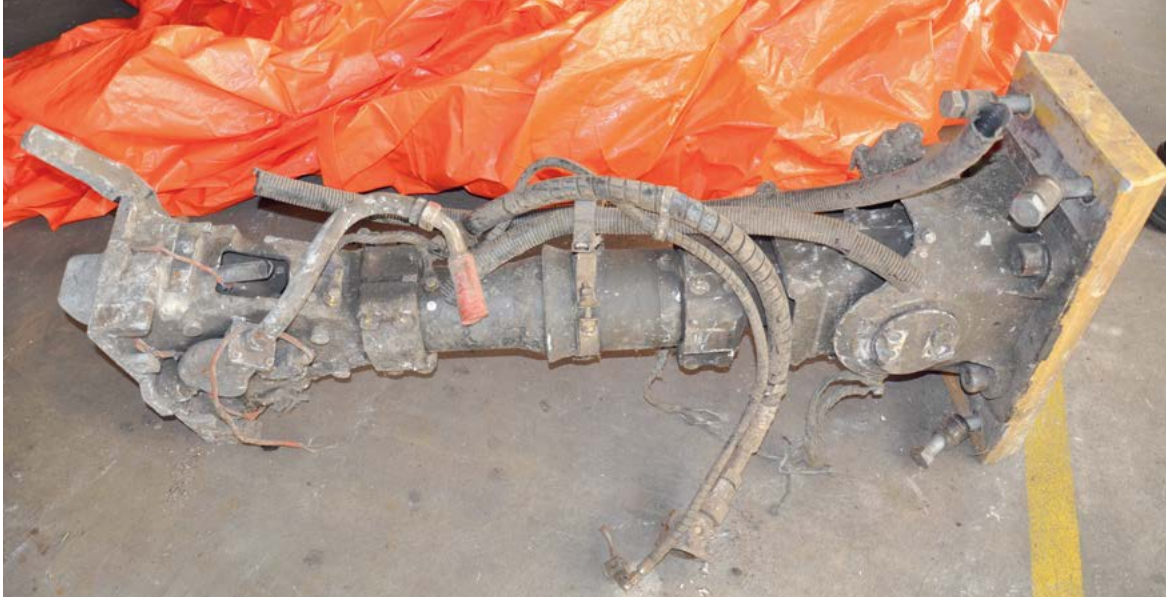
The coupler, which is normally the first thing involved in a collision, is designed to absorb some of the impact energy when it is compressed; it has not become significantly shorter, see figure 27.

Figure 27: The automatic coupler was not significantly deformed. Photo: Dutch Safety Board

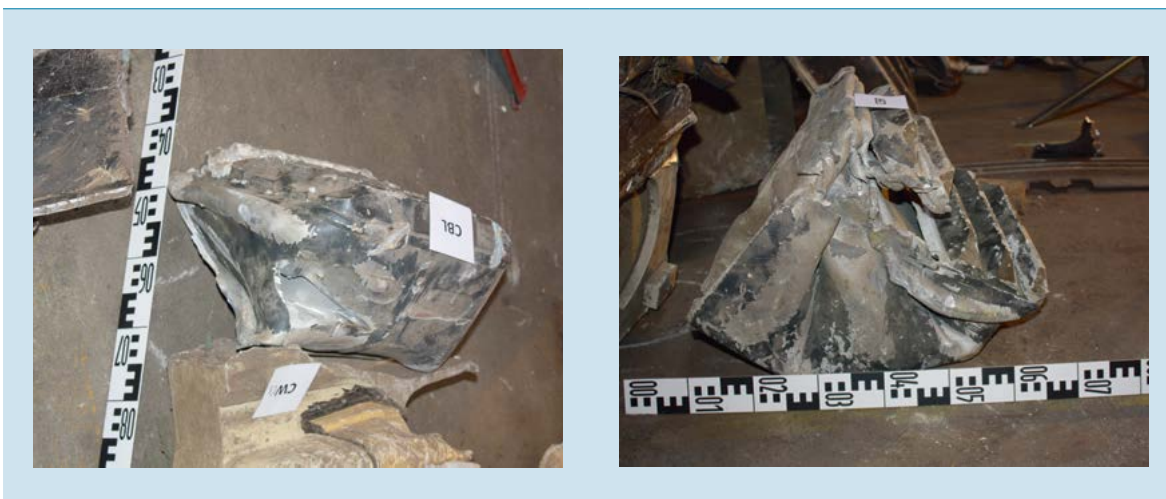
The photos in figure 28 show the two severely deformed crash buffers. The bottom part of the left crash buffer is more compressed than the top part. The reverse applies for the right buffer.

Figure 28: The severely deformed crash buffers. Photos: Dekra Rail/The Dutch Safety Board

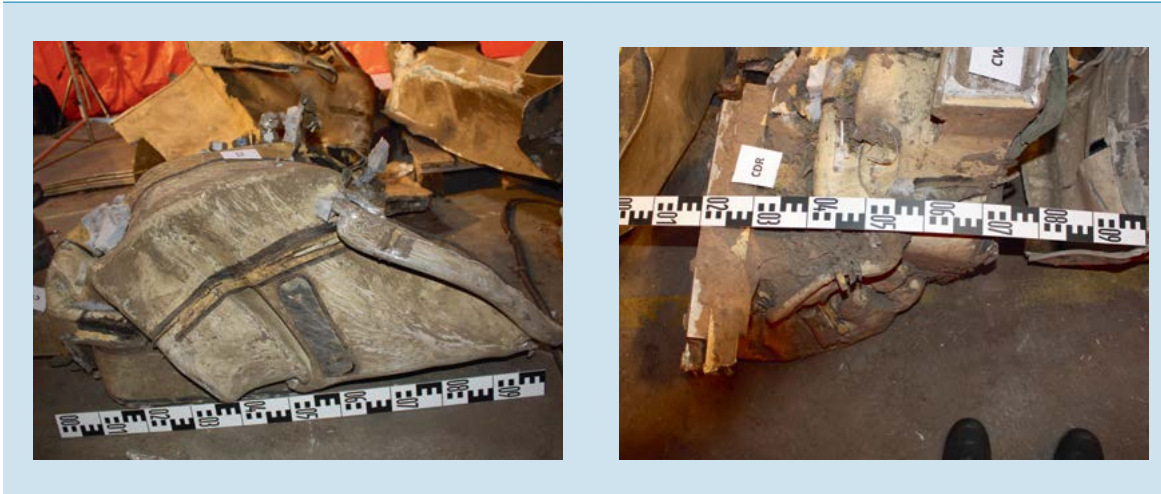
Figure 29: The severely deformed crash boxes. Photos: Dekra Rail/Dutch Safety Board

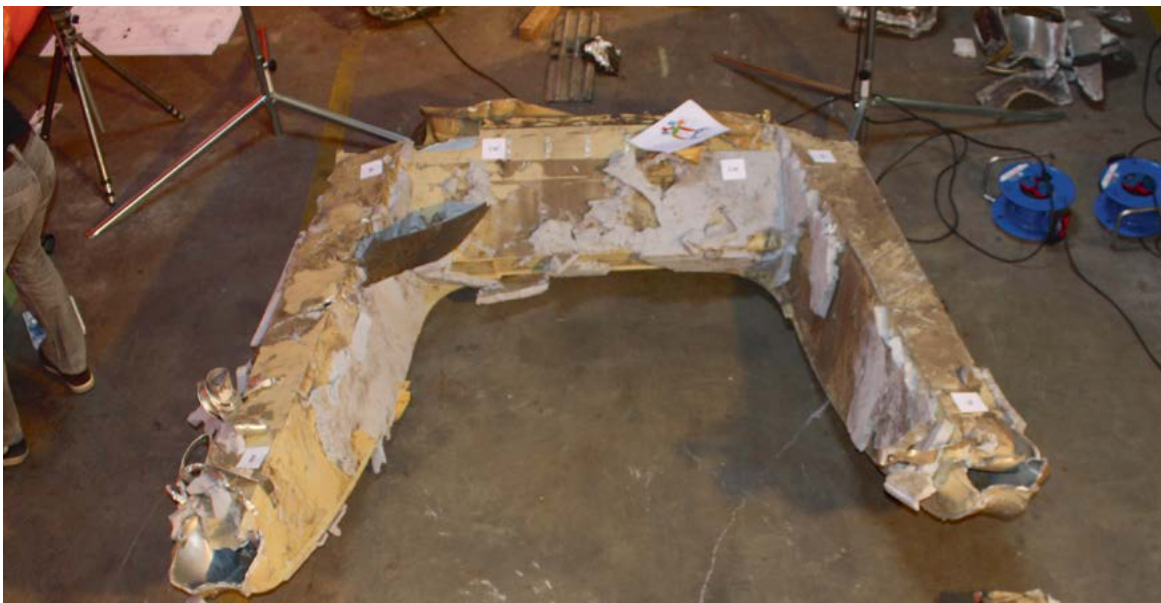
Figure 30: A-pillars and crash wall. Photo: Dekra Rail/Dutch Safety Board

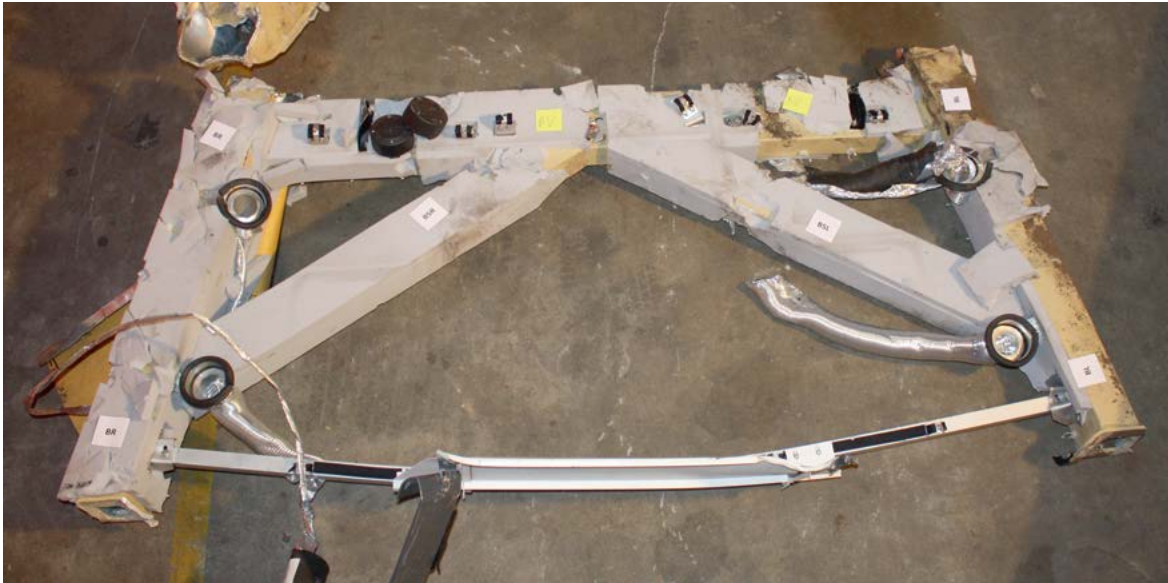
Figure 31: Top frame. Photo: Dekra Rail/Dutch Safety Board

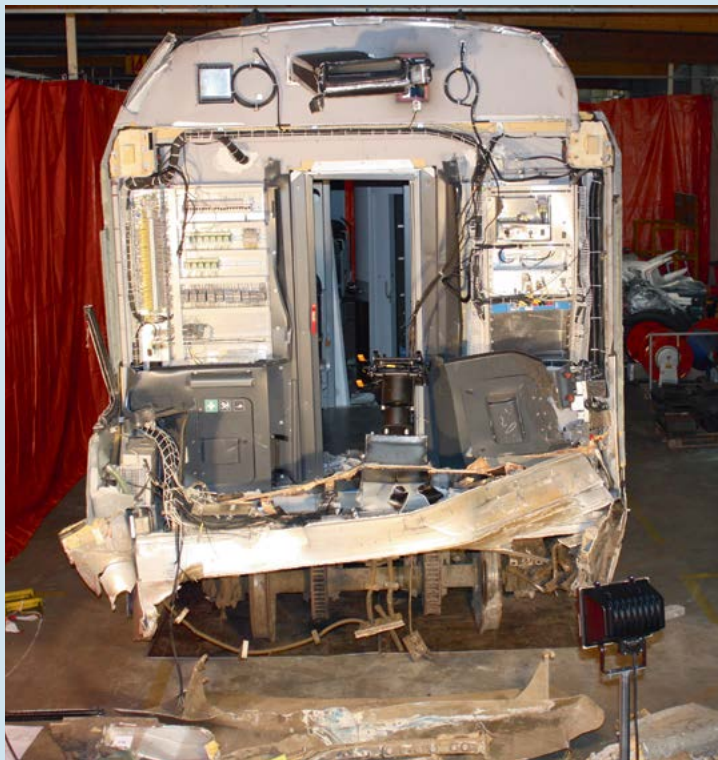
Figure 32: The front carriage is slightly twisted on the longitudinal axis in an anti-clockwise direction. Photo: Dutch Safety Board

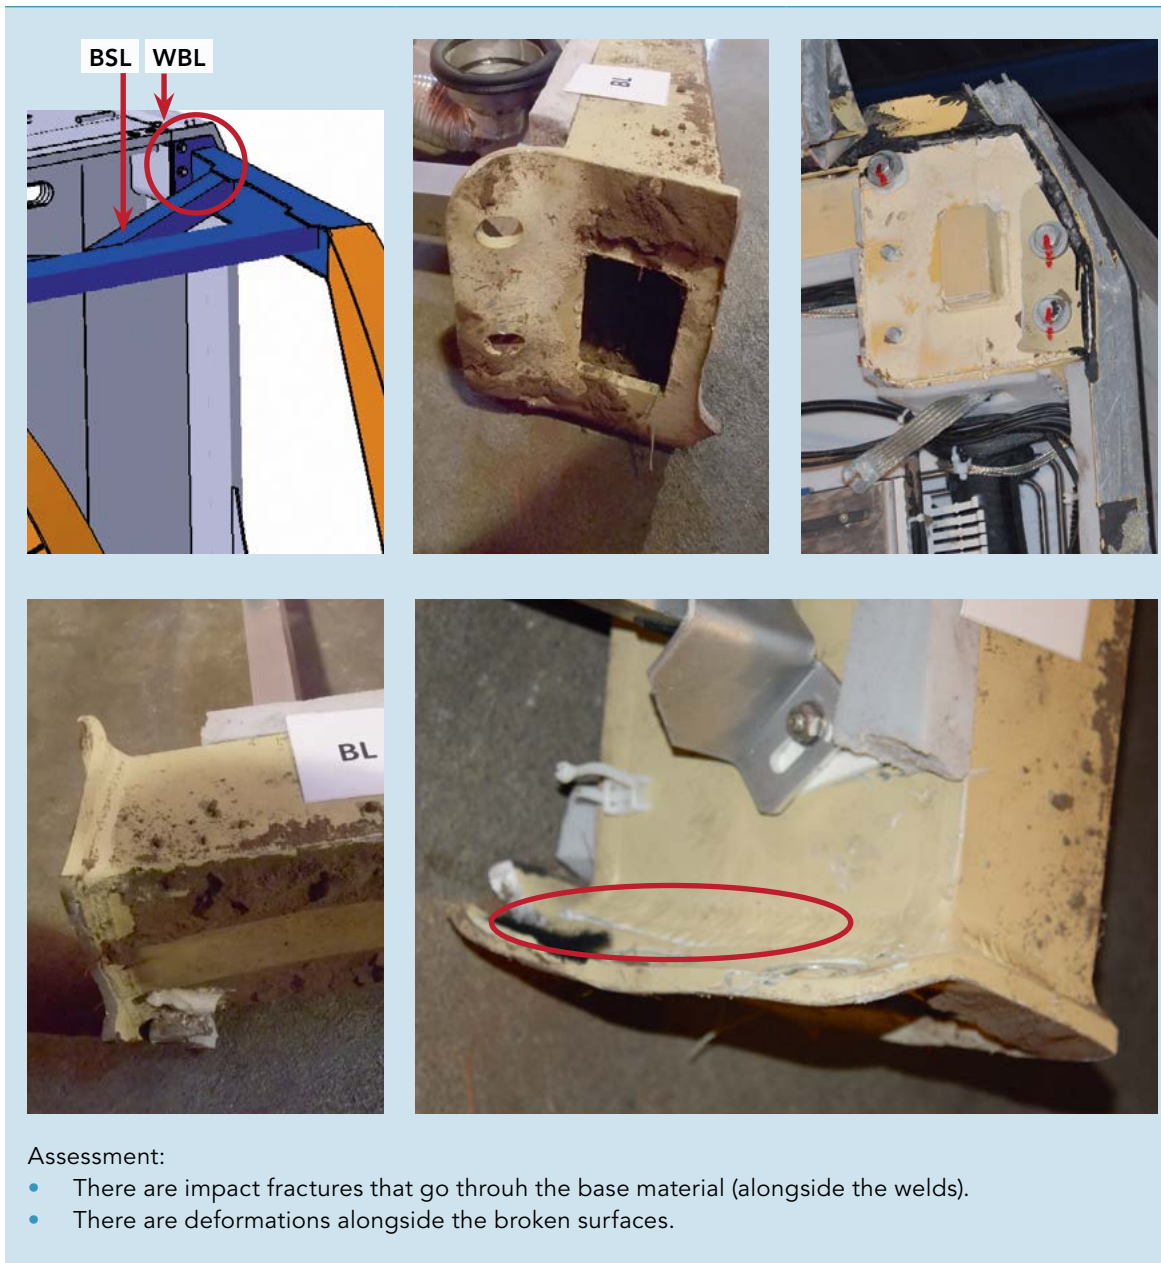
Figure 35: Assessment of the collapse of the left-hand carriage wall/top frame joint. Photos: Dekra Rail/Dutch Safety Board

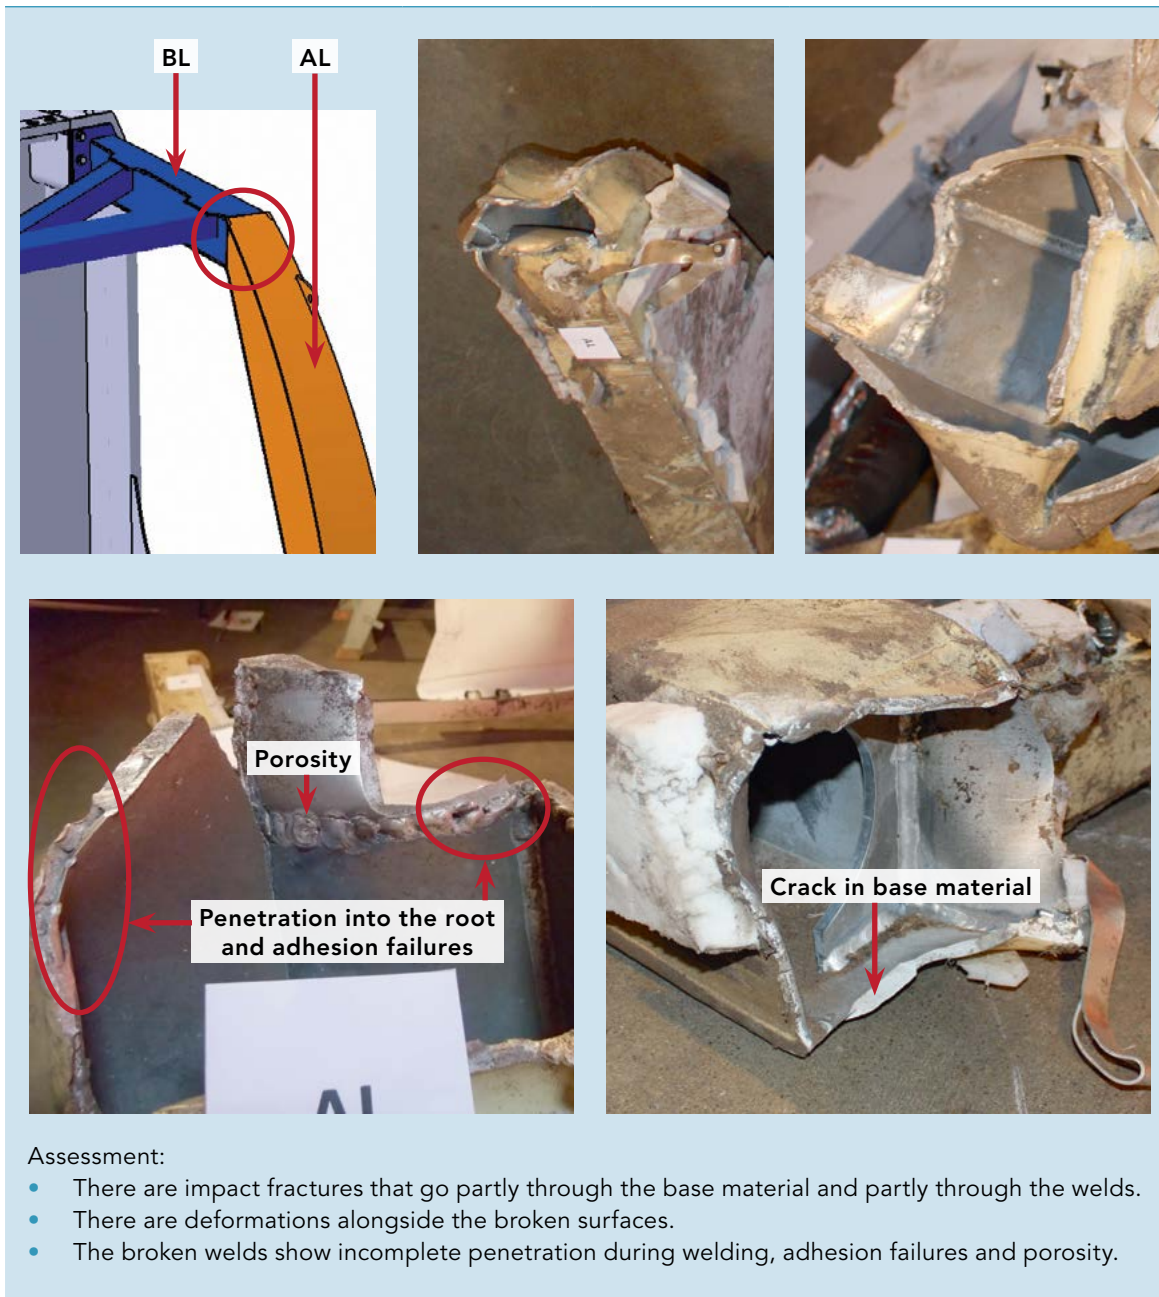
Figure 37: Assessment of the collapse of the left-hand top frame/frame pillar joint. Photos: Dekra Rail/Dutch Safety Board

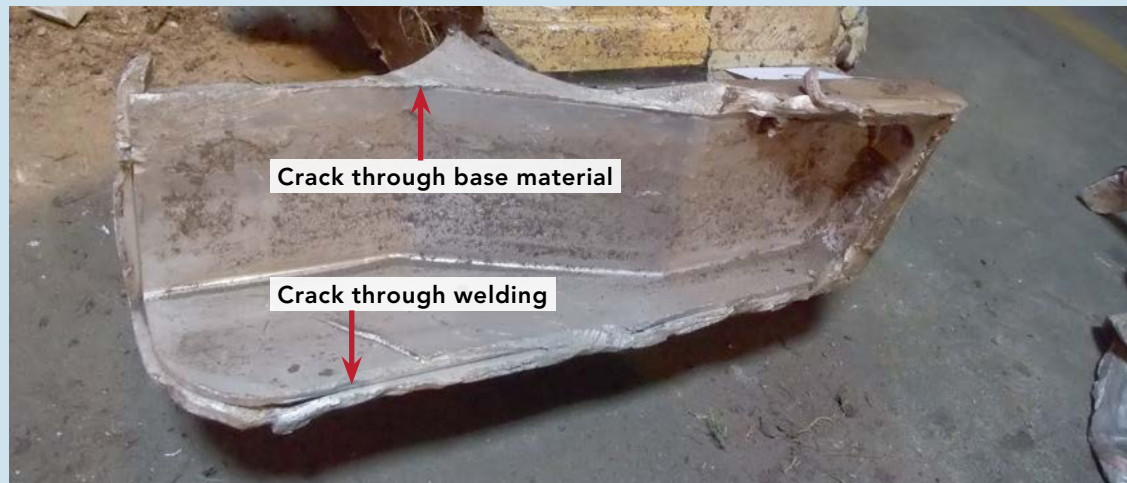
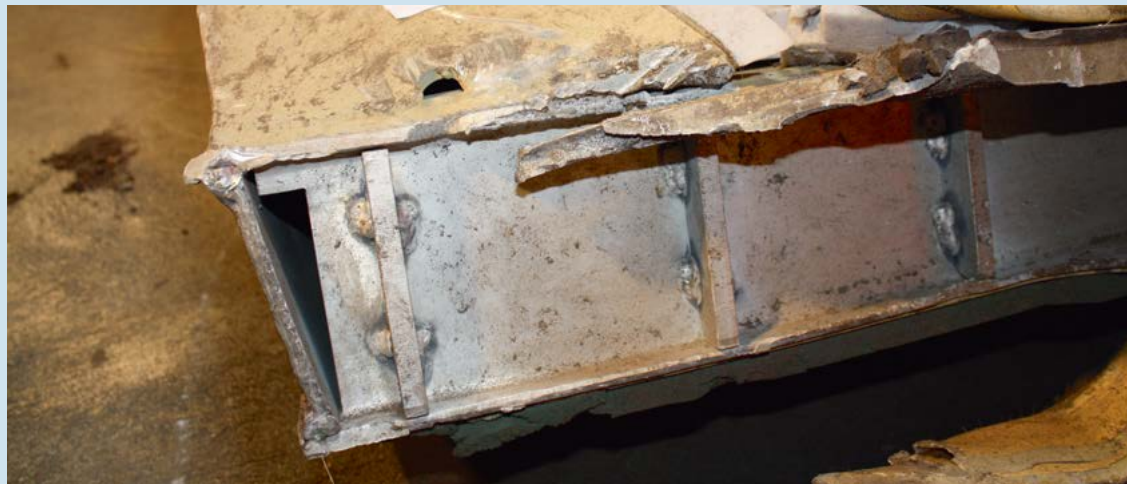
Figure 39: Assessment of the collapse of the left-hand crash wall/connector joint. Photos: Dekra Rail/Dutch Safety Board

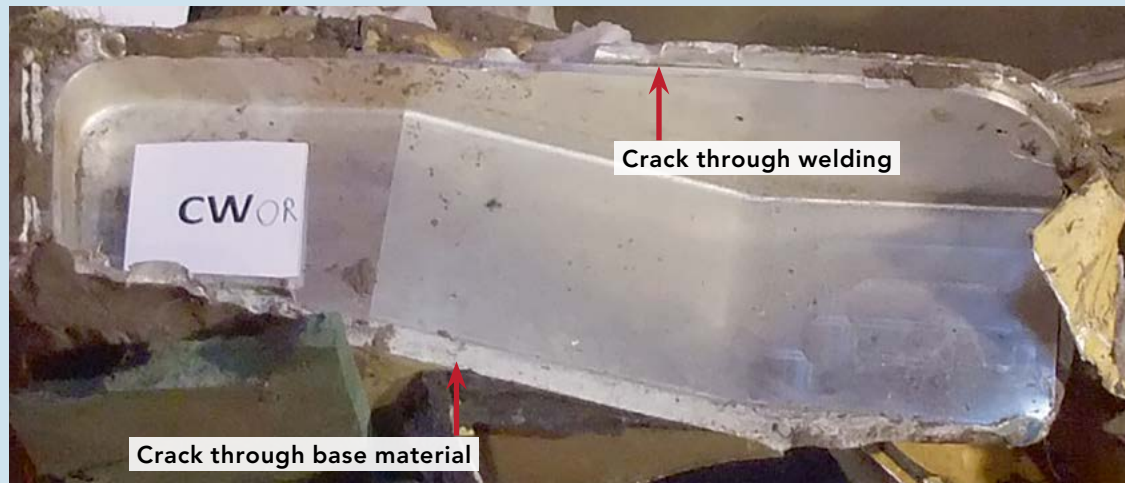
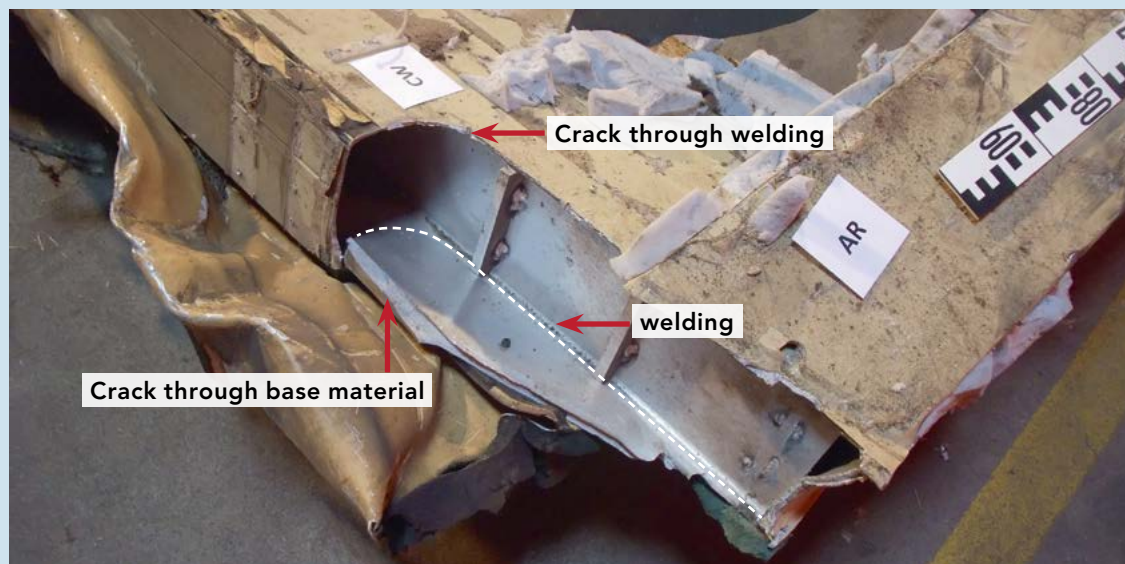
Figure 40: Assessment of the collapse of the right-hand crash wall/connector joint. Photos: Dekra Rail/Dutch Safety Board
