DUTCH  
SAFETY BOARD

# Quarterly Aviation Report

January - March 2017

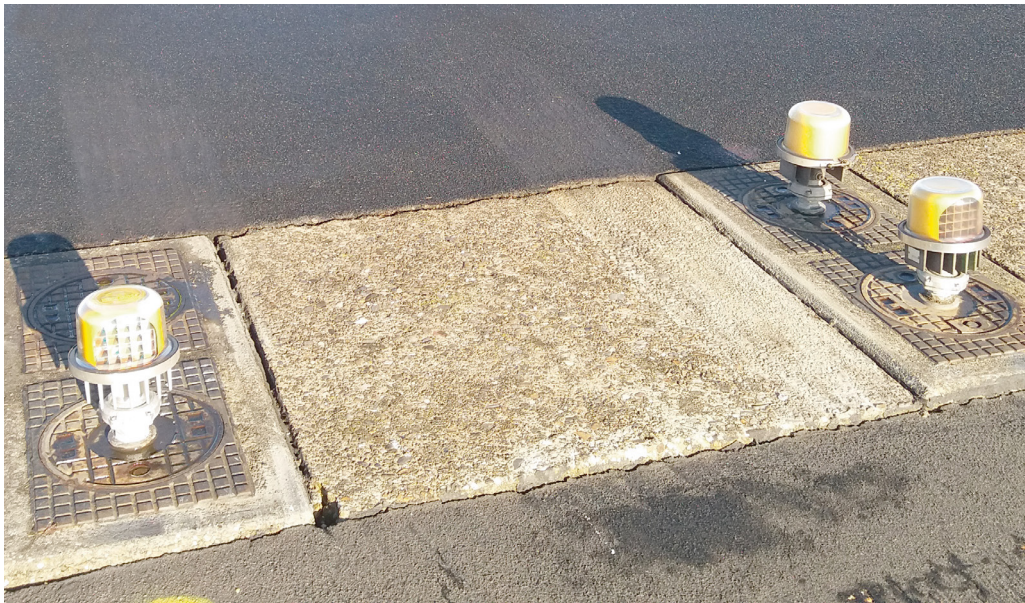
The cargo aeroplane struck some of the threshold lighting lamps on the runway threshold shortly before landing on runway 36R. The aeroplane sustained damage as a result.

The three threshold lamps (after replacement) struck by VQ-BLR. (Photo: AAS)

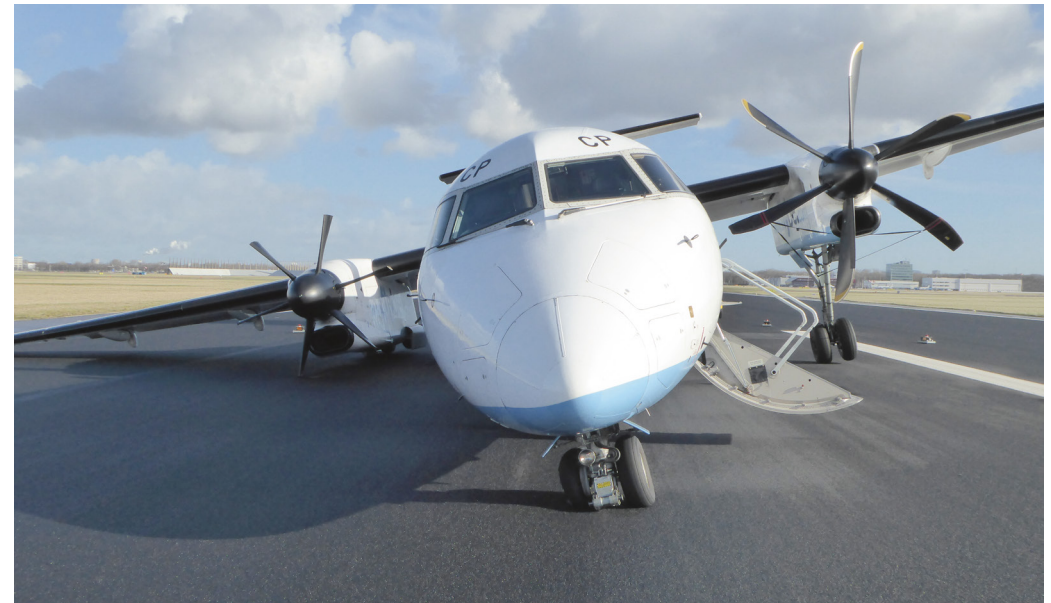
The right main landing gear of the Bombardier Q400 collapsed during landing on runway 22. The aeroplane came to a stop on the runway on its right wing and in the process sustained damage to the right wing, the right propeller, the landing gear and the fuselage. Nobody on the aeroplane was injured.

G-JECP with the collapsed landing gear

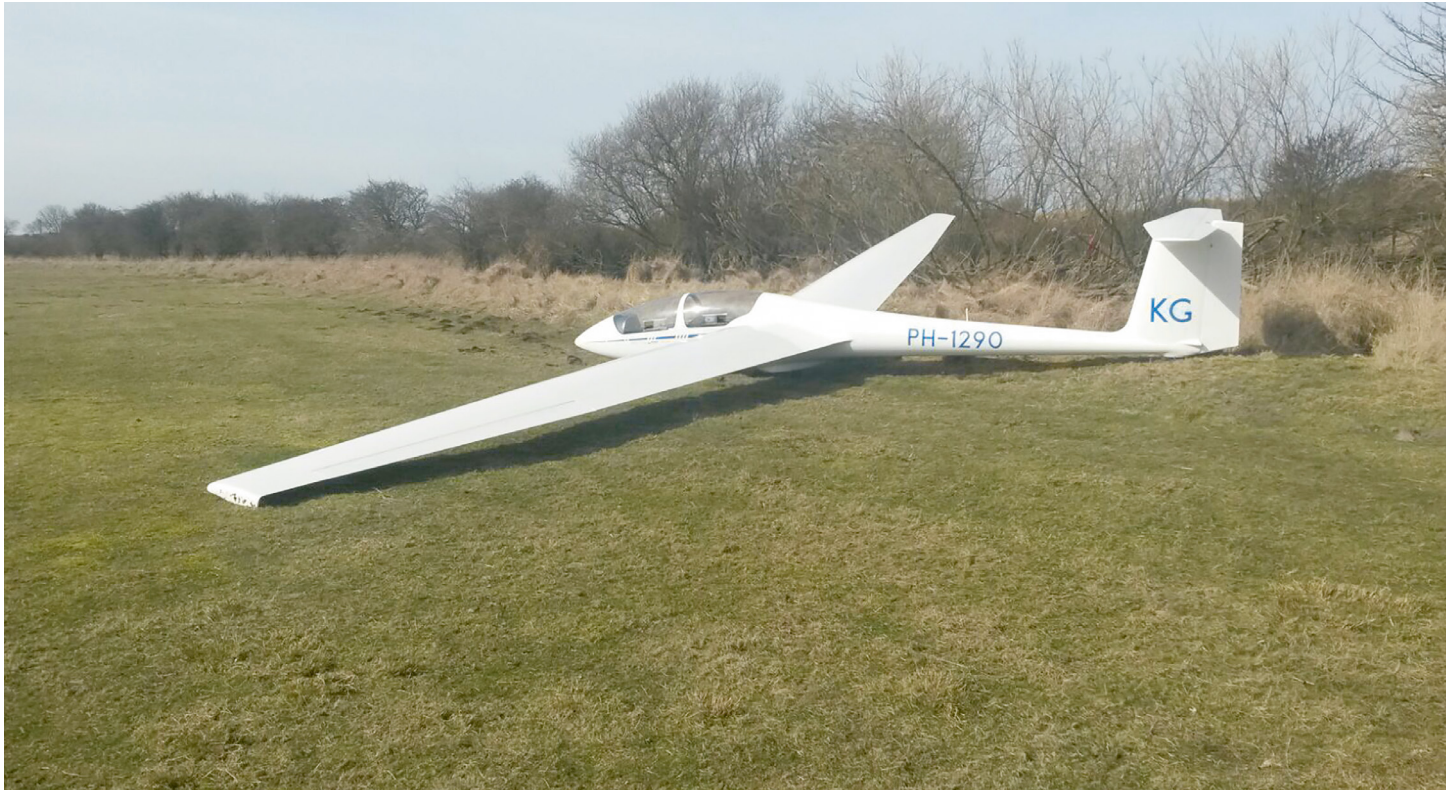
The glider, with an instructor and a student on board, made a crosswind landing during a check flight at the start of the gliding season. On final approach the left wing struck a bush at low altitude, as a result of which the glider rotated approximately 270 degrees about its top axis in the air and then came to a stop on the ground. Neither occupant was harmed. The glider sustained, among other things, damage to its left wing tip.

PH-1290 after the occurrence. (Photo: KZC)

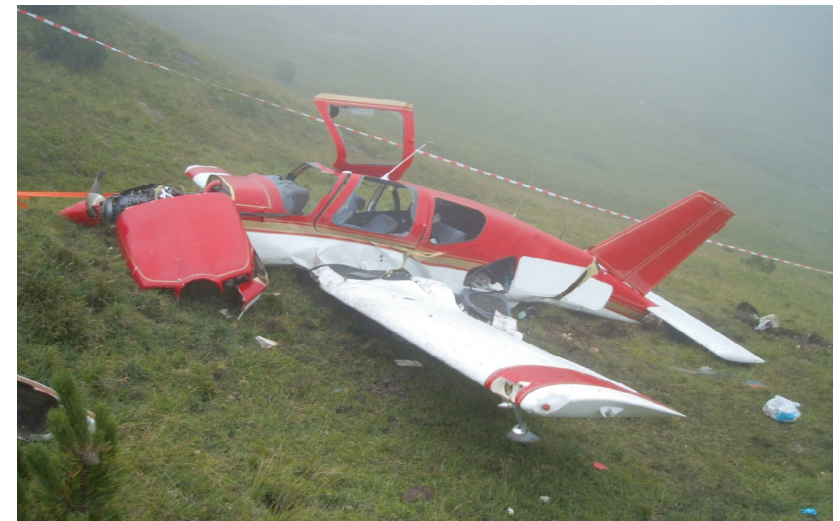
*The Socata TB10 after the accident. (Photo: VERSA)*

In this collision the passenger died and the captain was seriously injured. The aeroplane was severely damaged.

Based on the radar data and radio traffic that was examined it was concluded that the captain had misjudged his position. In the radio traffic with Munich Info he had said that he was 8,000 feet above Kufstein, while he was actually just north of Wörgl, approximately seven to ten kilometres southwest of Kufstein. Because of the deteriorating weather conditions, the captain no longer had any ground visibility and it was impossible to navigate visually.

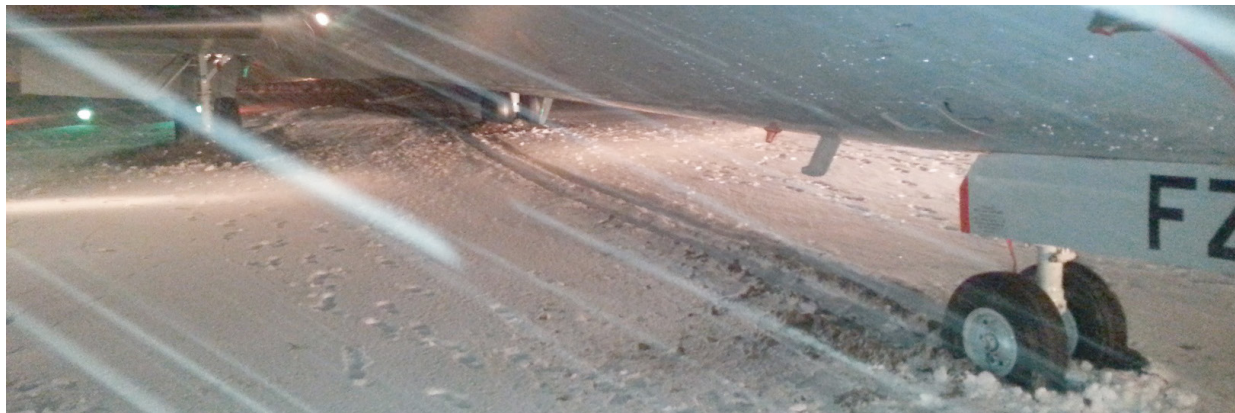
YR-FZA after the runway excursion. (Photo: SHK)

The Fokker 100 was making a scheduled domestic flight from Arvidsjaur Airport to Gällivare Airport in Sweden. On board were four crew members and 51 passengers. The aeroplane made an instrument approach to Gällivare Airport in the dark in winter conditions and passed the threshold of runway 30 at a height of around 50 feet at a speed of 134 knots. The Fokker made a hard landing at a constant speed in the touchdown zone, bounced once and made a yaw movement. After the landing, which was made with full flaps and extended speed brakes, the lift dumpers on the top side of the wings came up. The pilots stated that they had selected maximum reverse and had activated the brakes immediately after the yaw movement. The aeroplane came to a stop past the end of the runway and sustained minor damage in the process. Nobody on the aeroplane was harmed.

The incident was caused by the gradual decrease of the conditions for a safe landing that was not perceived by the pilots in due time. Factors contributing to this were:

- The airspeed did not drop from a height of 50 feet to the landing.
- The reported frictional coefficients of the runway were probably unreliable.
- The braking capacity of the wheel brakes was probably not fully used because of the initial yaw movement.
- The RPM of the engines, following the selection of reverse, did not increase until 20 seconds after the landing.

The report contains three recommendations, directed to ICAO, EASA and the Swedish Transport Agency. These recommendations relate to the introduction of a safe landing concept, which includes the flight phase from overflying the runway threshold to the aeroplane coming to a complete stop. This concept must at least give attention to the following points:

- Overflying the runway threshold at suitable speed.
- Monitoring of suitable speed reduction between overflying the runway threshold and landing.
- Landing on the suitable and agreed upon part of the landing runway.
- Performing a go-around if the suitable speed, speed reduction or landing on the suitable part of the landing runway are not achieved.

- The applicable use of braking systems, such as the speed brake, lift dumpers, reverse thrust and wheel brakes.

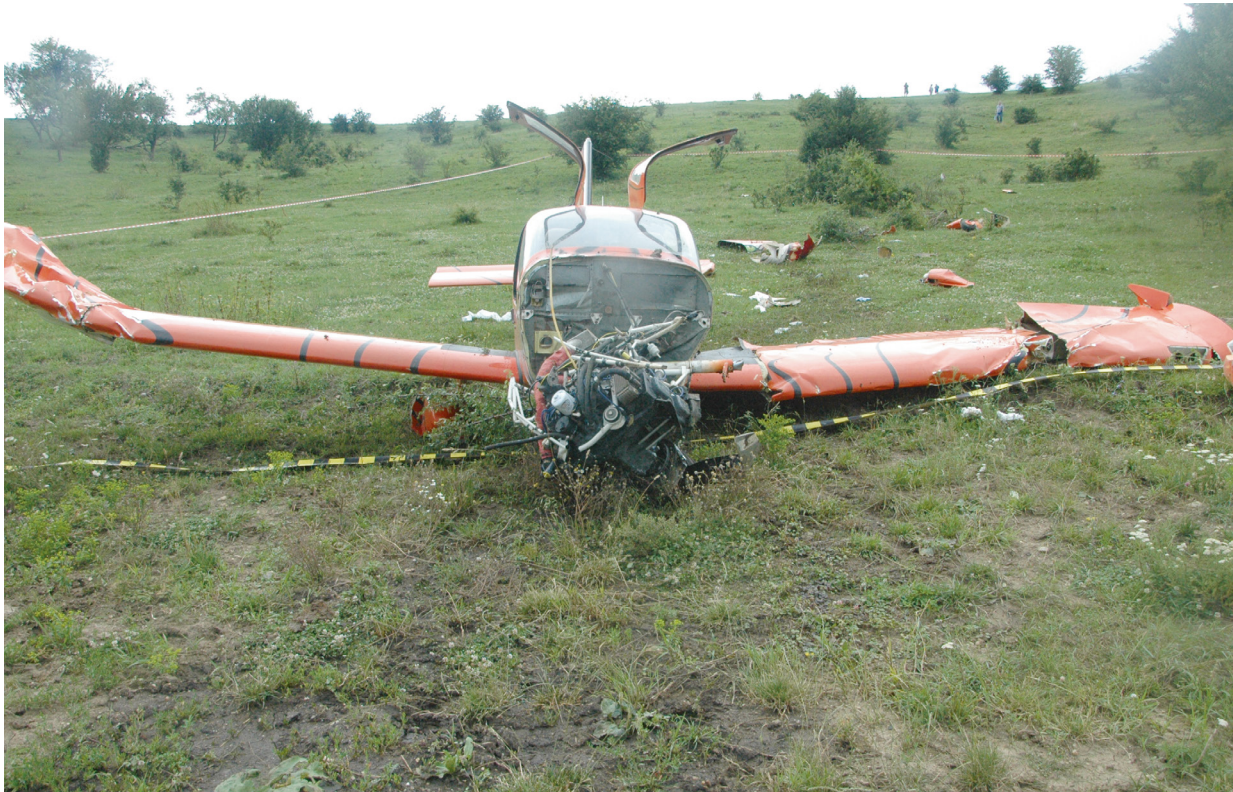
The pilot of the Socata TB9, with three passengers on board, was attempting to take off from runway 15, a grass runway, for a flight during a show at Măgura-Cisnădie Airport in Romania. During its take-off run the Socata TB9 passed through a number of pools of mud, causing the aeroplane to accelerate less quickly. The pilot nonetheless decided to go on with the take-off because he felt able to build up sufficient speed to lift off in time. As the pilot approached the end of the take-off runway and the adjacent safety zone, he tried to rotate at a speed of 55 knots. According to the aeroplane's manual, the rotation speed of the Socata TB9 is 65 knots. The aeroplane stalled and ended up in a valley behind the take-off runway. One of the four passengers suffered serious injury in the process. The aeroplane was severely damaged.

PH-BRT after the accident. (Photo: CIAS)

The pilot had calculated that the required runway length for take-off with the PH-BRT was 528 metres. He made this calculation using data from the aeroplane's manual and applied a correction for taking off from a grass runway. The available runway length was 600 metres. The aeroplane's manual did not however provide for a calculation with a wet grass runway with pools of mud. Because of the decelerating effect of the pools of mud the aeroplane reached a speed of 55 knots at the end of the take-off runway. The pilot, who had just flown a Cessna 172N (with a rotation speed of 55 knots) attempted to rotate at this speed. According to the aircraft manual for the Socata TB9, the stalling speed in the take-off configuration is 54 knots. The early rotation therefore led to a stall, which meant that the aeroplane was unable to gain any height and ended up in a valley behind the take-off runway.

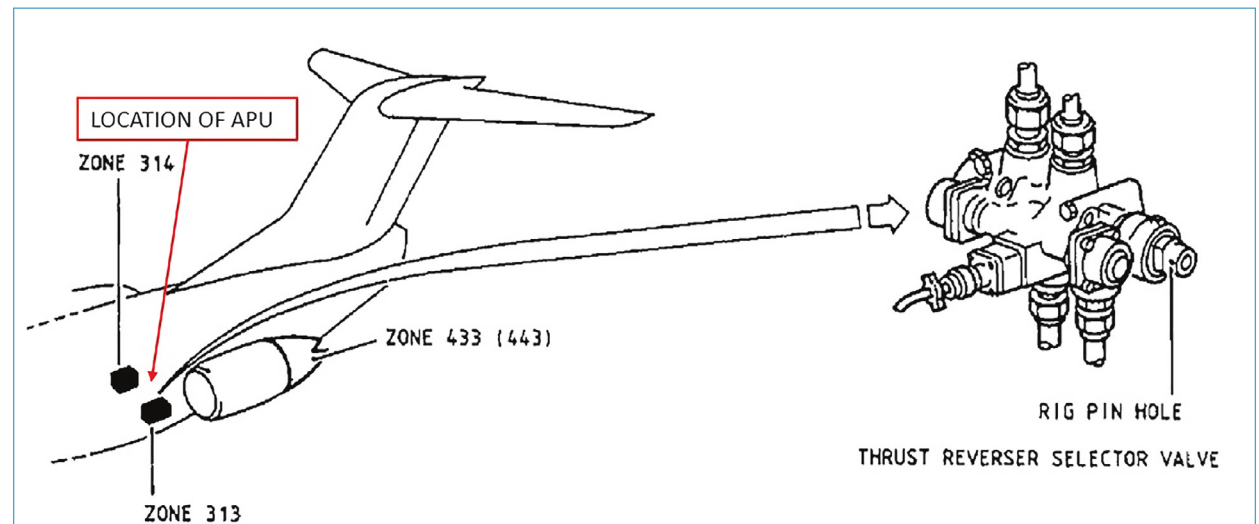
In the course of repair work a maintenance organisation found that hydraulic oil had leaked from hydraulic system #1 because of a damaged O-ring in the thrust reverser selector valve of the port engine. An inspection also revealed hydraulic fluid in the APU and the air conditioning system. The hydraulic oil leaking past the damaged O-ring, which was located close to the APU inlet, could be drawn into the APU by the air suction resulting from the APU at the time that the aeroplane was stationary on the ground. Once the aeroplane had landed and weight was bearing on the wheels, the air supply for the air

conditioning automatically switched over from the engines to the APU. As a result, hydraulic oil that had penetrated the APU was spread to other elements of the air conditioning system. Switching the air supply for the air conditioning system back from the APU to the engines manually by the captain was therefore not effective because the hydraulic oil had already spread through the air conditioning system.

The location of the thrust reverse selector valve in relation to the APU. (Photo: ATSB)

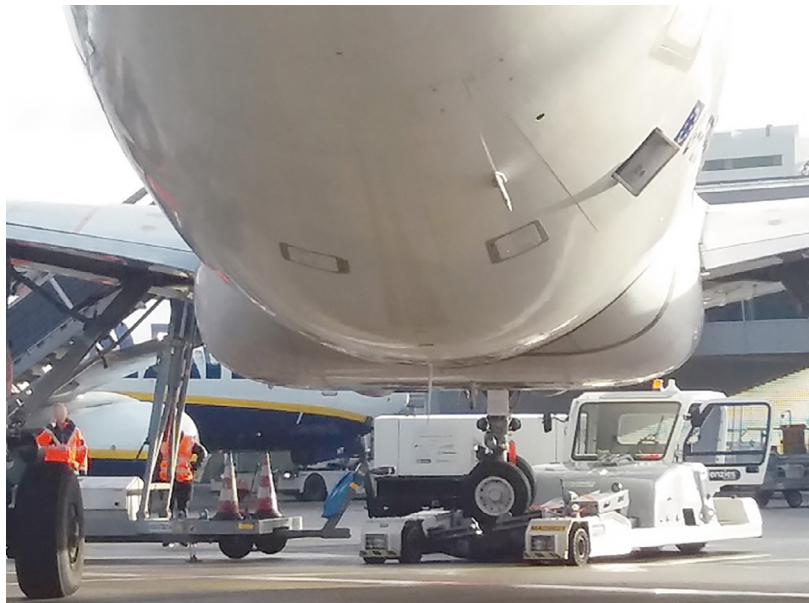
Various inspections recommended by the aeroplane manufacturer were carried out on the nose landing gear on site following the incident to determine whether it had sustained any damage. No defects were found, after which the nose landing gear was released for use for a restricted duration of 200 flights or 30 days. The nose landing gear was replaced during this period of time. The manufacturer of the nose landing gear then carried out a detailed inspection of the nose landing gear involved in the incident. No abnormalities were found and the nose landing gear was overhauled and taken back into service.

The Airbus A319 following the mistaken activation of the parking brake. (Photo: Amsterdam Airport Schiphol)

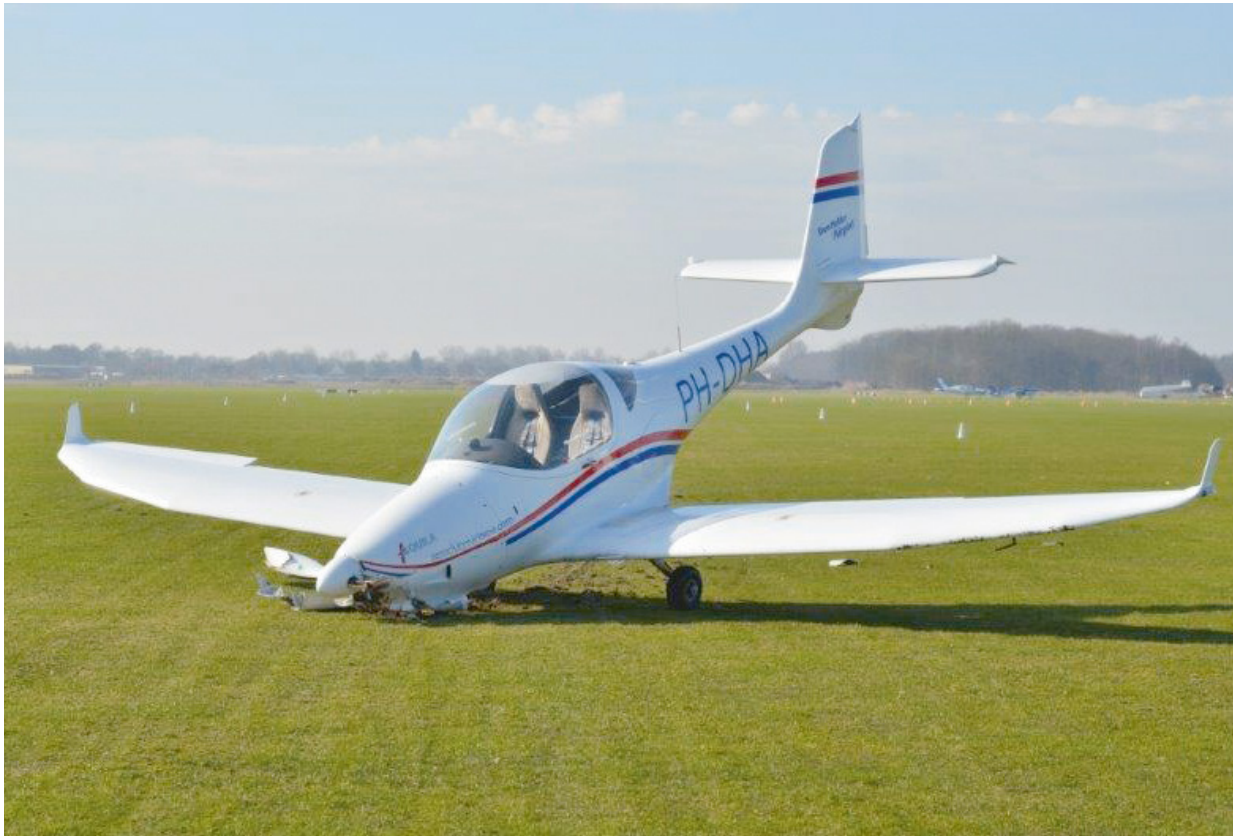
PH-DHA after the occurrence. (Photo: Aviation Police)

The Aquila AT-01, with a pilot and a passenger on board, was carrying out a cross country flight from Den Helder Airport to Midden-Zeeland Airport. During the crosswind landing on runway 09 at Midden-Zeeland Airport (the wind was blowing from the south with a strength of roughly three knots) the aeroplane bounced several times and the nose wheel broke off. The aeroplane ended up on its nose and threatened to tip over. When the aeroplane came to a stop, it tipped back onto its main landing gear. Neither occupant was harmed. The aeroplane sustained damage to its nose wheel, propeller, engine, left side main wheel cover and the Pitot tube under the left wing.

Eye witnesses stated that the aeroplane had bounced twice during landing. After the second bounce they observed the nose of the aeroplane come down and the aeroplane made contact with the ground on the nose landing gear. The nose wheel then broke off.
