DUTCH
SAFETY BOARD

Shipping Occurrences Report

May - November 2017

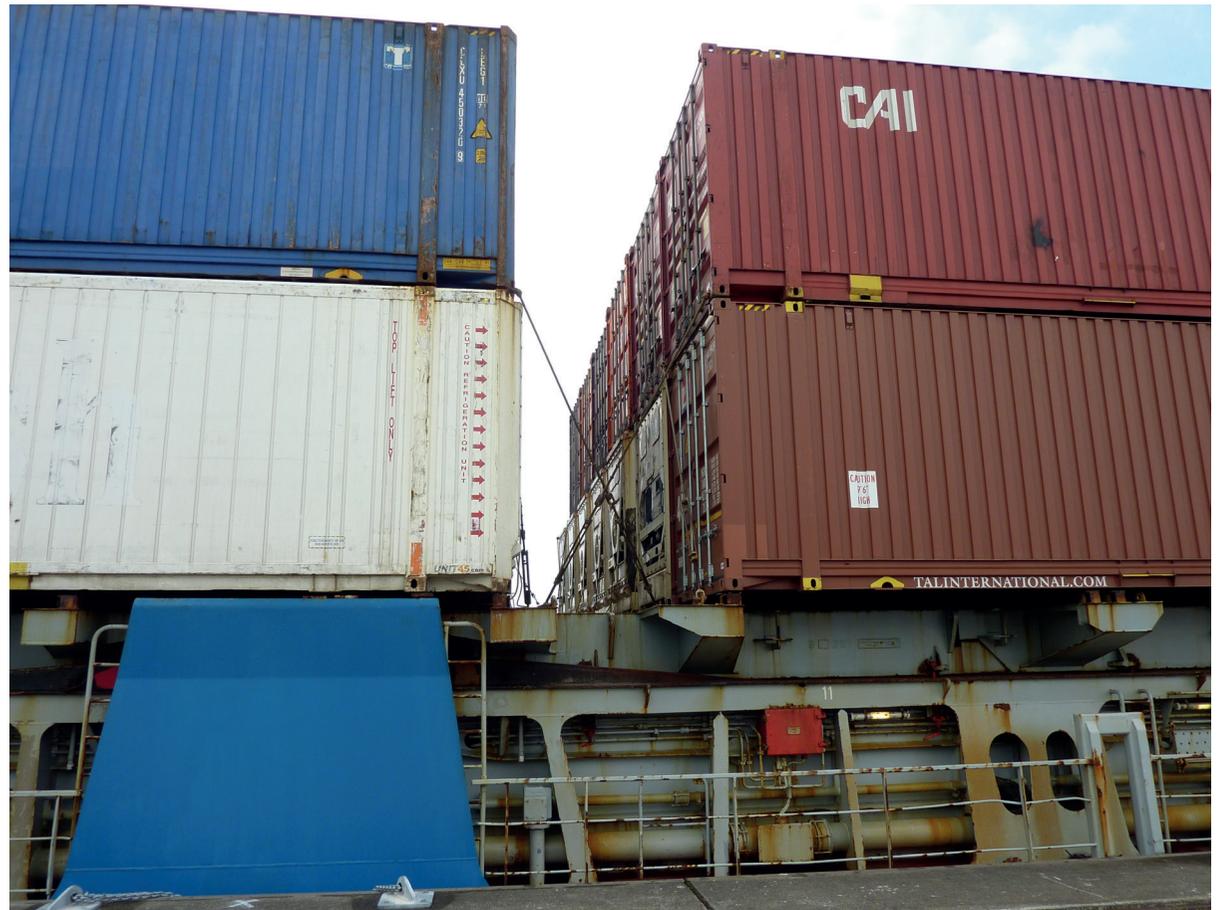
- The victim died because a container was put back while he was still under it.
- There were no clear and consistent agreements about the teamwork between the team on-board and the one onshore about loading and unloading activities at the port. This also meant that there was no coordinating and unique supervision and responsibility role. The investigation led to doubts about safety awareness on a management level. Due to a lack of supervision with regard to the implementation on the work floor, it was effectively left to the work floor to remove observed safety risks. The investigation showed that this could result in the activities being performed based on a personal viewpoint without aiming for a joint safety perspective.

Position in-between the containers.

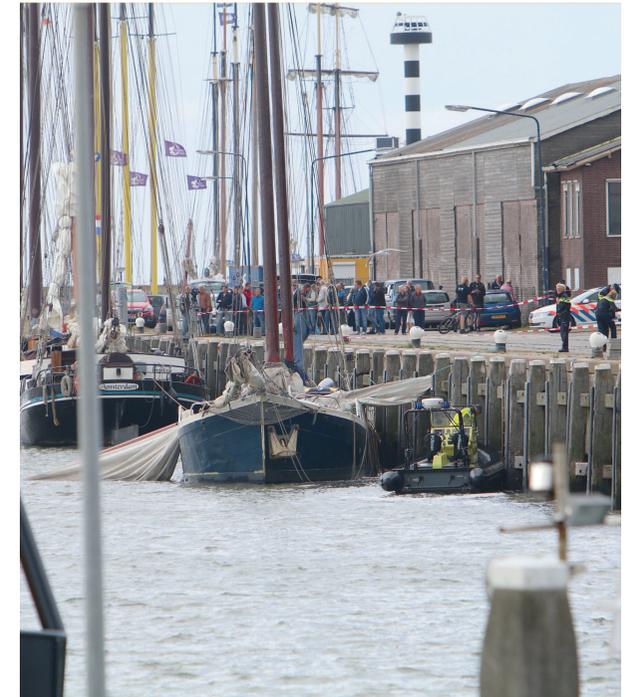
Although the mast breaking came as a complete surprise to those involved, the investigation showed that a process of at least four years preceded this. Water penetrated deeply into the mast during this period after which it could not leave the mast any more. This water started a rotting process in due course in the inside of the mast. The wood rot continued to such an extent during the last two years that the mast lost nearly all its strength.

Amicitia after the accident. (Photo: CAMJO media/Jaring Rispens)

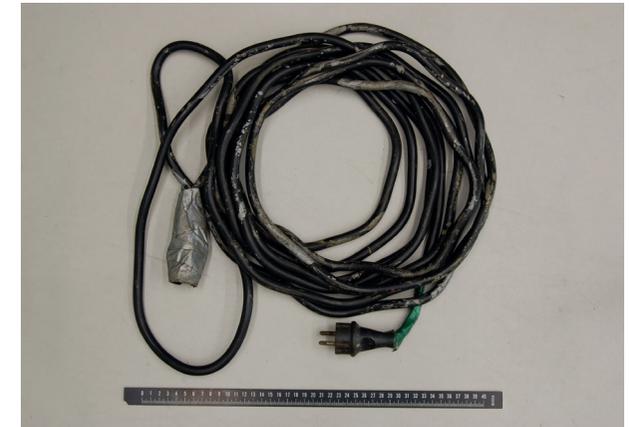
- The victim probably died because he was electrocuted. He had a cable with him on which a fitting and plug had been added in a messy manner; it was a faulty assembly. The victim probably grabbed hold of the phase through an opening where the fitting was. A safe voltage was not being used.
- It is possible that the victim underestimated the risk of working with electricity on-board. The risks of electricity are more significant when working in a confined space. In addition to the shown risk of electrocution, this also entailed a fire and explosion risk.
- If we keep all the risks of paintwork in a confined space in our minds, it is doubtful that this work in the tank should have been performed by the ship's crew at that time.

Involved cable in tank. (Photo: Netherlands Forensic Institute)

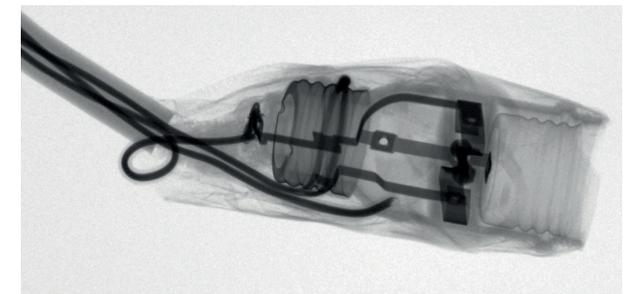
Figure Fitting as connected on the cable. (Photo: Netherlands Forensic Institute)

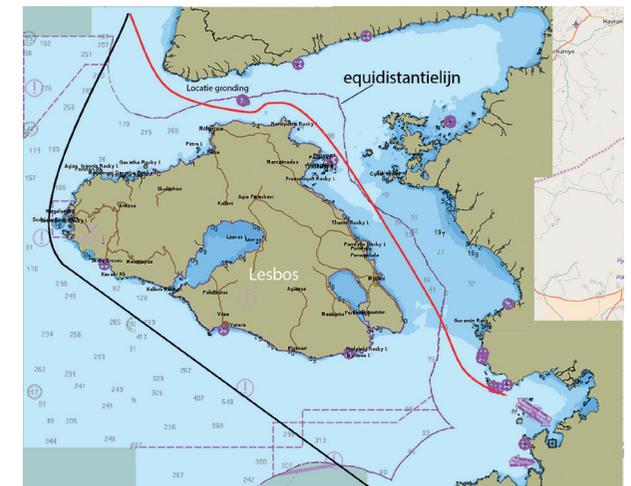
The investigation showed that the voyage preparations on-board the Nova Cura were made for the route to Izmir that runs to the west of Lesbos. When the destination become Aliaga, the route was changed. The new route run to the north of Lesbos and new voyage preparations were not made for this. Although new waypoints were set, no other information was used in changing the route. The Pilots for the area were not consulted for potential hazards, the sector lights were either not identified and the available ENC (Electronic Navigational Chart) was not checked for reliability.

Route to Aliaga to the north of Lesbos (red) and route to Izmir to the west of Lesbos (black). (Source: GR4APP01)

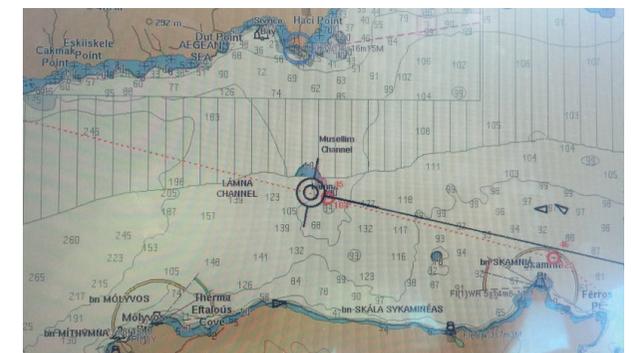
Position of the Nova Cura on the Greek sea chart.

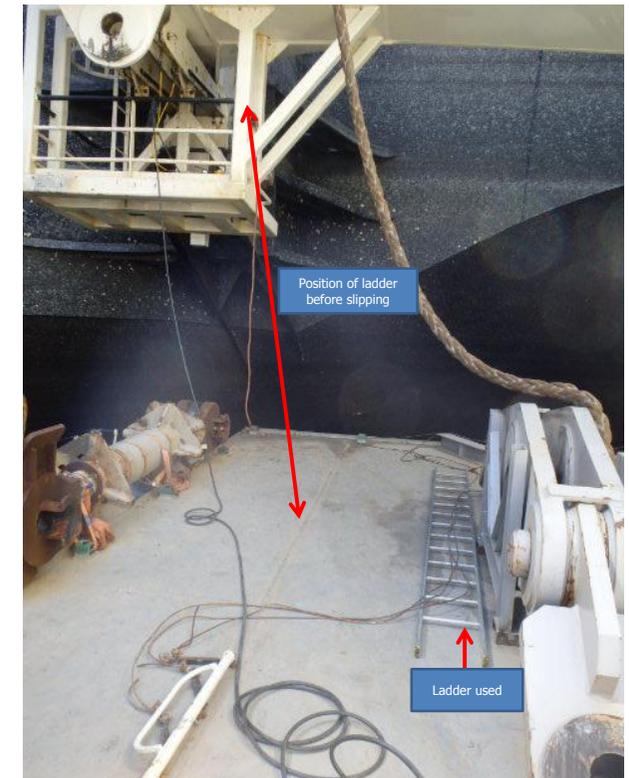
A crew member of the Maltese crane ship Pioneering Spirit broke his arm and elbow on 9 May 2017 at around noon when he fell because a ladder slid away while he was climbing it. The ship was moored at the Alexia haven in Rotterdam.

Ladder working position on the Pioneering Spirit. (Photo: Allseas)

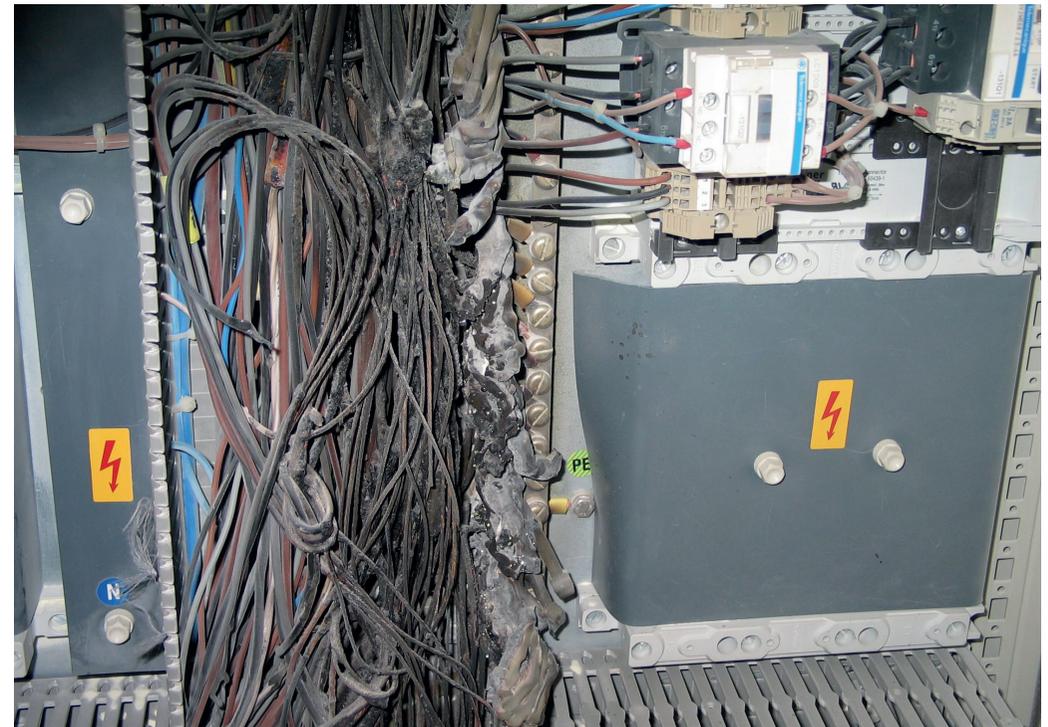
On 27 May 2017 fire broke out in the engine room on-board the Hydra cargo ship sailing under the Dutch flag. The fire was quickly discovered and could be put out with a powder fire extinguisher. The possible cause was a short-circuit. Despite the fact that the fire was quickly discovered and put out, there was considerable damage to the main switchboard. The main engine was no longer operational, after which the ship was sent against the quay of the Kiel Canal at a slow speed. Two tugs later on picked up the ship and took it to Brunsbüttel. The cause of the fire is unknown.

Main switchboard with burnt-out parts on the Hydra. (Photo: Bundesstelle für Seeunfalluntersuchung)

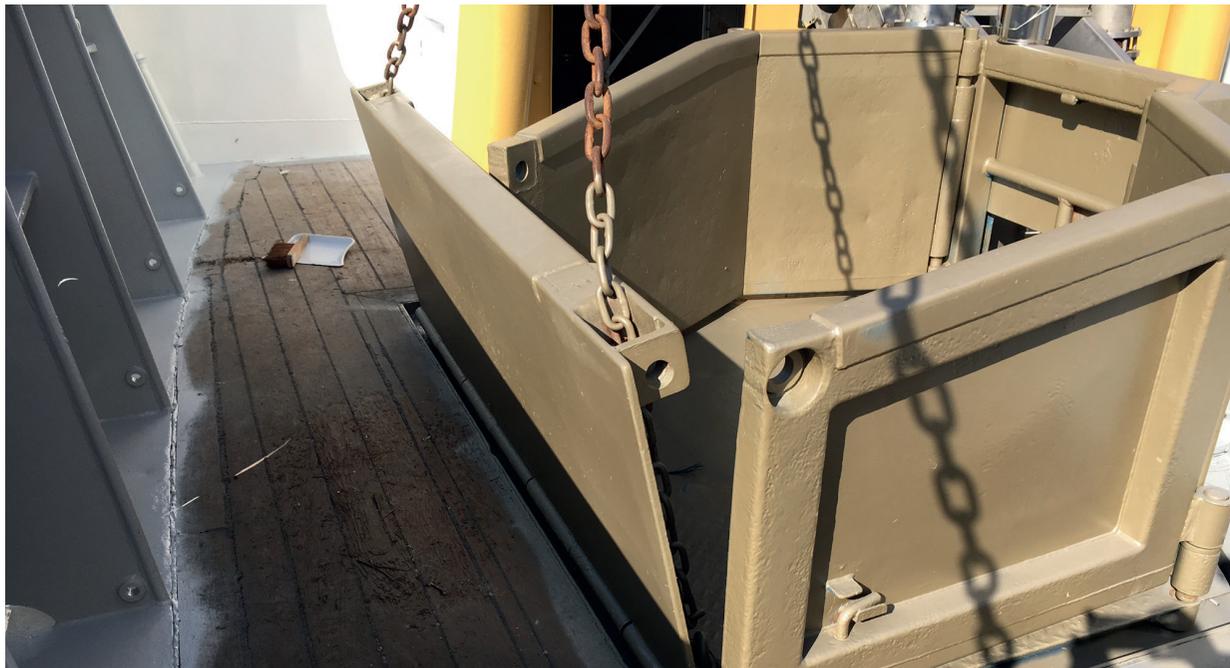
On 19 June 2017 a crew member broke his shin bone and fibula on-board the Dutch fishing vessel Jacob Cornelis (SCH145). The crew was preparing the vessel for docking that was about to happen. The tanks had been provisionally folded away for paintwork. The crew was busy taking the jumper blocks to shore to have them overhauled. The block was lifted using the jumper wire and pulled to shore by the crew. When lifting one of the jumper blocks from on-board, it hit the side door of the tank. The side door folded down and this meant that the lower leg of the victim became trapped between the side door and the bulwark. Next, the crew quickly lifted the side door again and freed the victim.

Jacob Cornelis side door and bulwark. (Photo: Jacob Cornelis owner)

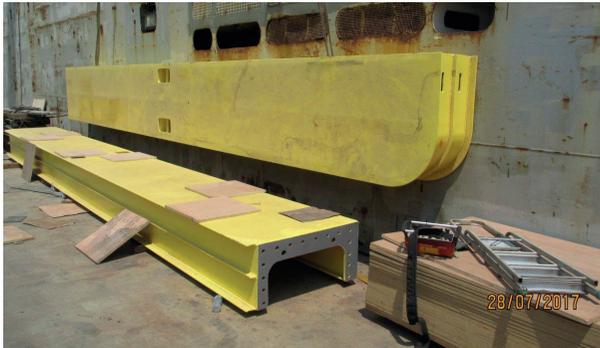
A section of the temporary dock bulkhead had to be lifted with a crane. The temporary dock bulkhead moved in the direction of the dock wall during lifting. The first officer tried to stop the movement with his hand and a few of his fingers became trapped.

Temporary dock bulkhead in the crane against the dock wall. (Photo: RollDock Shipping)

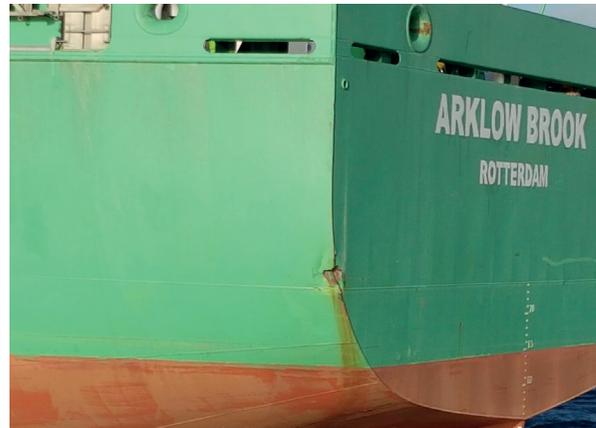
Two barges (Imperial I and Imperial IV) became adrift because of high winds in the evening of 4 August 2017 and drifted towards the Dutch cargo ship Arklow Brook. On-board of the Arklow Brook they had been busy unloading that day. When the barges hit the ship, the crew was resting. The Arklow Brook suffered such damage that they were not allowed to continue sailing straight away.

Damage to the Arklow Brook. (Photo: ILT)

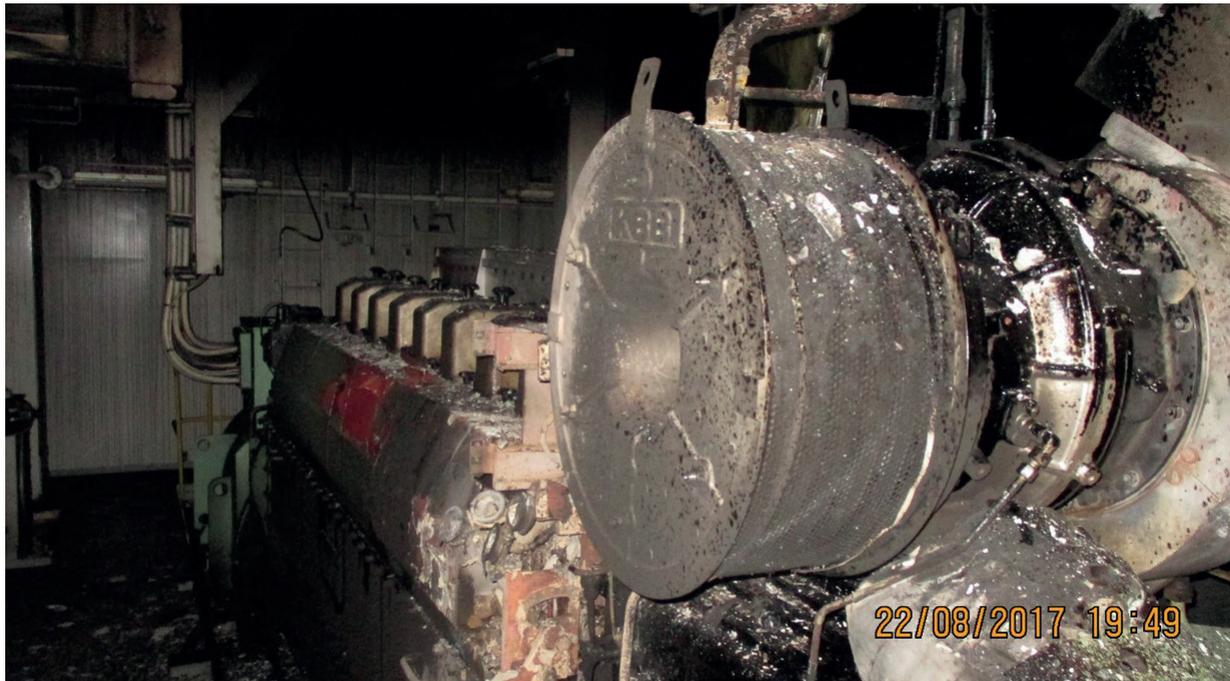
The automatic fire alarm system was triggered by a fire indication in the engine room. The engineers investigated the cause of the fire alarm system being triggered. They saw smoke and flames when they entered the engine room. They closed the engine room access point and immediately activated the quick-closing valves.

The generator of the Maersk Pembroke after the fire. (Photo: Maersk Pembroke crew)

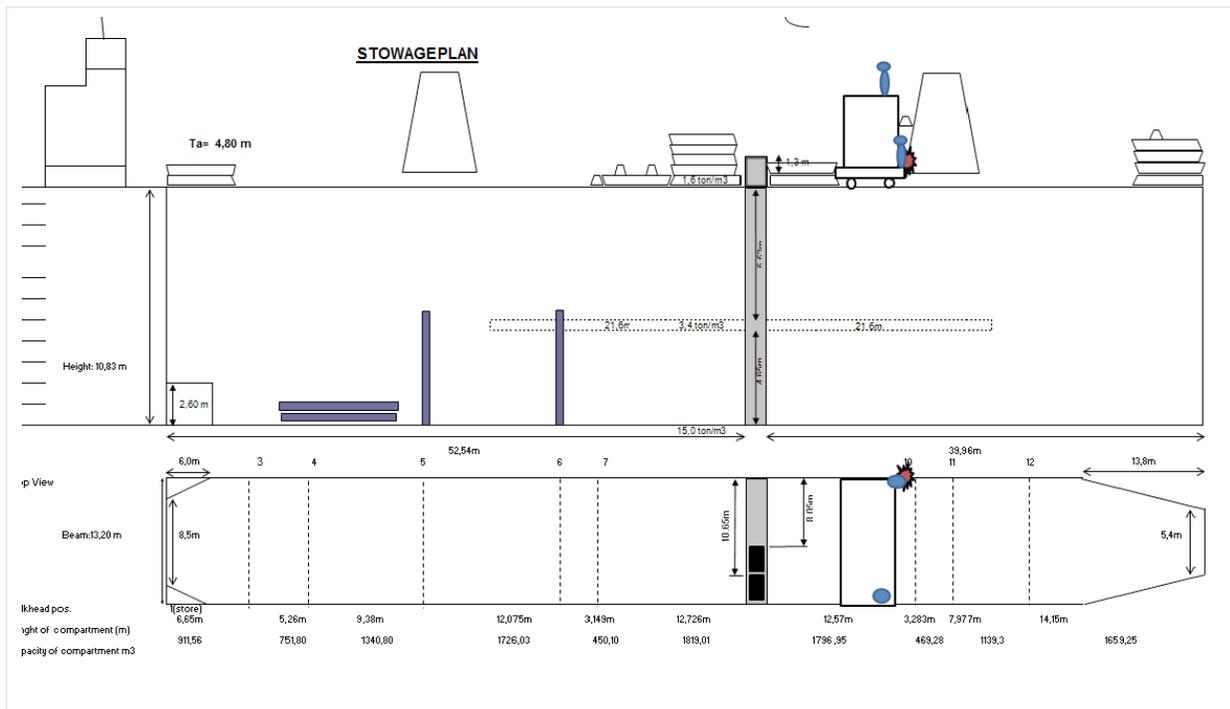
A crew member on-board of the cargo ship Onego Trader sailing under the Dutch flag suffered serious injuries to his lower leg on 29 September 2017 when closing the cargo hatches using a hatch cover crane. The crew member was helping his colleague who was operating the hatch cover crane grabbing and moving the hatch covers when he became trapped between the hatch cover crane and the crane base. The ship was anchored at the Port of Gothenburg when the accident happened.

Situation sketch of becoming trapped Onego Trader. (Source: Kustvaart Harlingen)

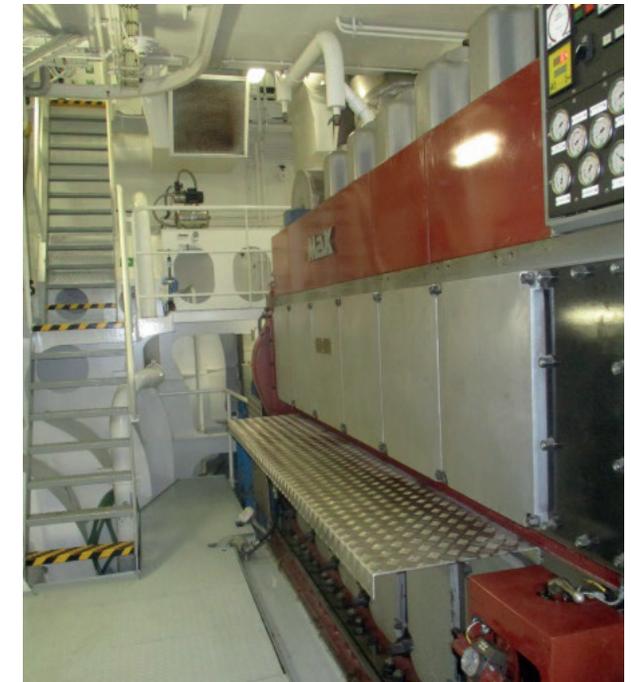
On 30 September 2017 the chief engineer who was on-board of the Dutch cargo ship Symphony Star fell from a higher situated engine platform and suffered a serious leg injury. The ship was sailing in the Bay of Biscay and had just switched from MGO to HFO when one of the fuel pumps on the main engine falteral. The chief engineer climbed on to the engine platform to resolve the problem when he lost his balance and fell backwards on to the deck that was below.

Symphony Star engine platform. (Photo: Symphony Shipping)
