Collision with tug due to loss of brake pressure, BAe Avro RJ85

The Hague, January 2019

Identification number:	2015109
Classification:	Serious incident
Date, time of occurrence:	15 December 2015, 19.45 ¹
Location of occurrence:	Amsterdam Airport Schiphol, A8 taxiway
Registration:	EI-RJT
Aircraft type:	BAe Avro RJ85
Aircraft category:	Four engine turbofan
Type of flight:	Commercial air transport – passenger
Phase of operation:	Pushback
Damage to aircraft:	Substantial
Crew:	Four (two flight crew, two cabin crew)
Passengers:	52
Injuries:	None
Other damage:	Slight damage to towbarless tug
Light conditions:	Night

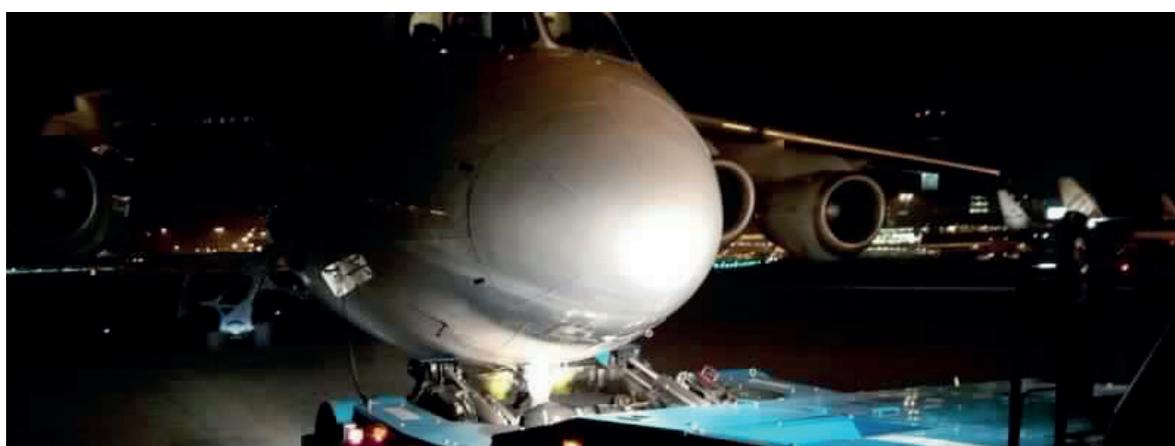
Figure 1: EI-RJT and towbarless tug after collision. (Source: Amsterdam Airport Schiphol)

Figure 1, Figure 2 and Figure 3 show photographs taken after the collision. The aircraft moved along the pushback line after the brake pressure loss, as seen in the QAR heading data. The collision took place several metres in front of the pushback limit line with the tug's docking mechanism raised. The damage to the aircraft's front fuselage partially shows paint from the tug, which likely sustained slight damage from the collision.

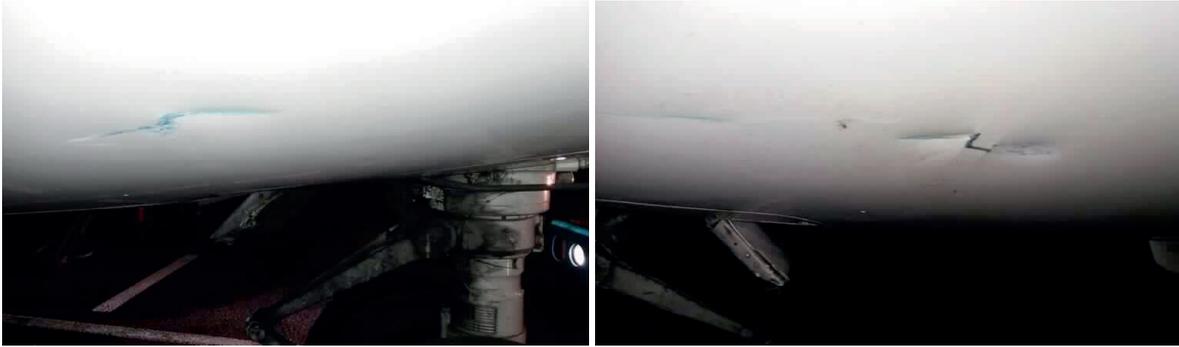
The aircraft sustained substantial damage to the front fuselage skin, as can be seen in Figure 2. It was grounded for approximately one week to repair the damage. During this period, one of the parking brake valves was found to be operating intermittently. Following the fuselage repairs and replacement of the valve the aircraft returned to service.

Figure 2: Damage to the right and left sides of the front fuselage. Note the location of the nose gear position for reference. (Source: Amsterdam Airport Schiphol)

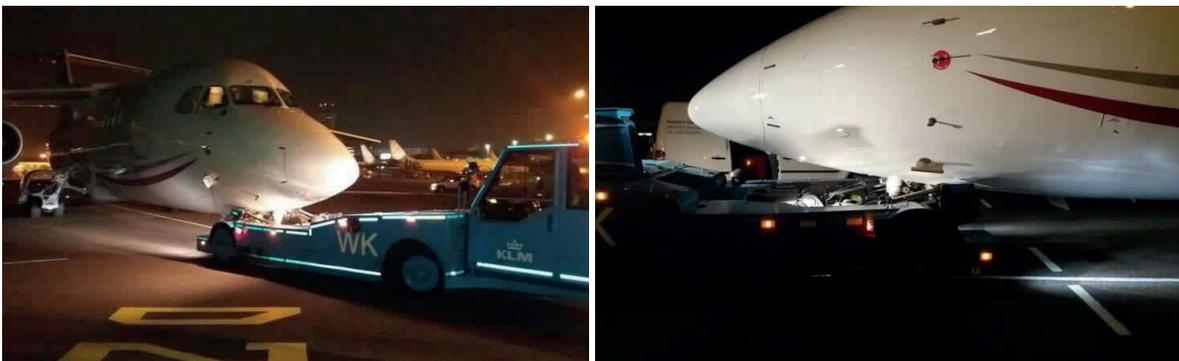
Figure 3: Aircraft and tug after collision. (Source: Amsterdam Airport Schiphol)

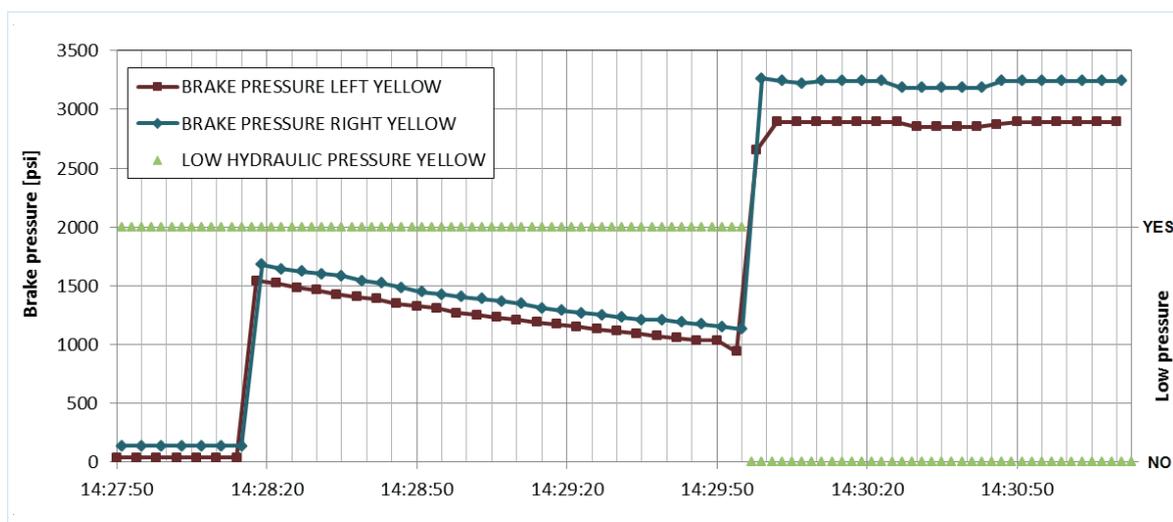
The operator provided flight data monitoring (FDM) data for the previous pushback on the day of the event, four hours earlier. Relevant parameters are shown in Figure 4.

Figure 4: FDM brake pressures and hydraulic pressure warning for the previous pushback on 15 December 2015. Time on the x-axis is in UTC.

From the FDM data provided by the operator, the element(s) of an initial brake pressure of 1,500 psi and a pressure decay rate of 6 psi/s appear(s) to be present during at least one flight prior to the incident (see Figure 4). In the previous flight, further decay and/or a sudden drop in brake pressure appear to have been stopped by pressurisation through the AC pump or EDP.

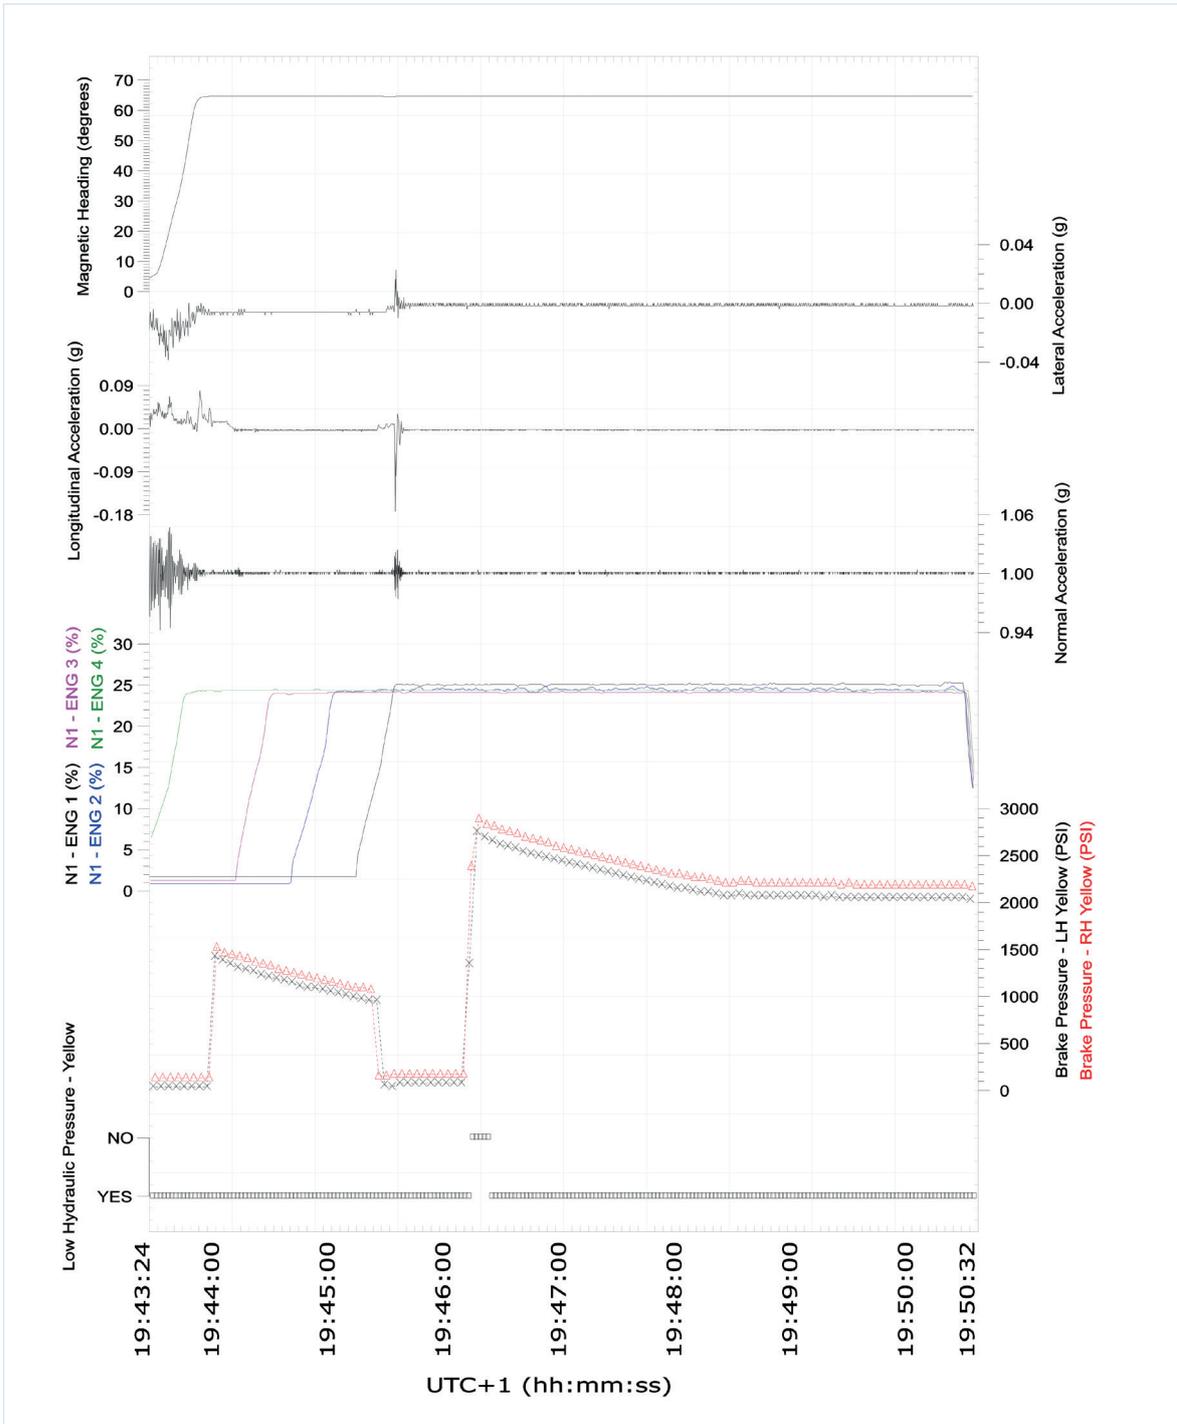
Figure 5: QAR data print-out: left and right yellow brake pressures, engine N1 speeds, heading and airframe accelerations. Data with discrete markers are recorded less than once per second.

The data shows brake pressure being applied before engine number 3 was started at 19.43:58 hours. The yellow brake pressure upon application was around 1,500 psi left and right. The yellow brake pressures decayed at almost 6 psi/s for around 85 seconds (up to 19.45:23 hours) and then suddenly dropped to around 100 psi. The accuracy of the pressure sensor data in this range is unknown. During this time engines numbers 3, 2 and 1 were started to idle as well.

Following this peak at almost 3,000 psi, the brake pressure directly decayed again at a similar rate to before the impact up to about 19.48:30 hours and then stabilised just above 2,000 psi for the remainder of the recording. The last seconds of the recording show all engine rotation speeds dropping simultaneously, indicating deliberate engine shutdown by the crew.
