DUTCH
SAFETY BOARD

Shipping Occurrences Report

November 2020 - May 2021

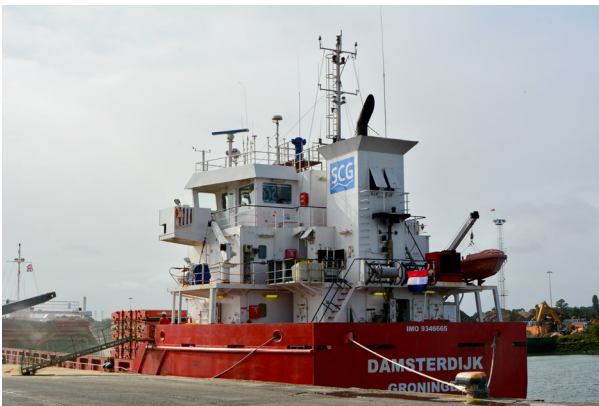
The stern line became entangled in the ship's propeller due to lack of clear communication. The victim was not equipped with a walkie-talkie, and the orders of the mooring team leader had not been passed on. The mooring team leader was beyond the hearing range, and out of view of the victim and the cadet. As a result, the mooring team leader was unaware of what was happening on the afterdeck, and was unable to warn the victim in time.

Damsterdijk, moored in the port of Ipswich (UK).

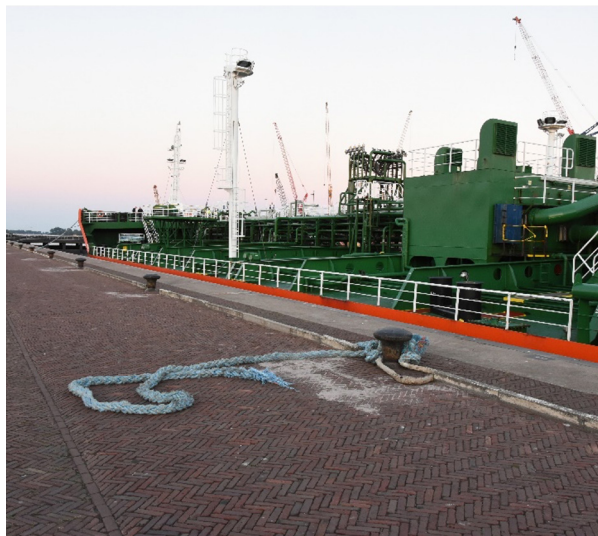
On the bridge of the *RN Privodino*, there had been miscommunication about the eventual position of the vessel in the lock, and unclear agreements had been reached on the individual responsibilities of the various parties, during the lock passage.

On the foredeck, the mooring team consisted of five people: the third mate, the boatswain, the motorman and two deckhands. The boatswain, who was operating the winches, was able to see that the forward spring was paid out and fastened around the bollard on the quayside. Because he had passed the lock at IJmuiden on more than 50 occasions, he assumed that this meant that the vessel was almost in position. Of his own volition, the boatswain then decided to place the forward spring under tension, without having received an order to do so. The forward spring broke and hit the motorman, with a fatal outcome.

RN Privodino in the lock at IJmuiden.. (Source: National Police)

Working outside the snap-back zones
During mooring and unmooring, large parts of the foredeck of the RN Privodino were considered unsafe working areas and marked accordingly. Because the areas that were actually dangerous changed depending on which mooring line was used and how it was guided over the deck, in the sudden occurrence of a dangerous situation, it was no longer possible to rapidly determine where a safe position could be sought. In addition, it was not possible to determine from which safe position the work could be carried out. During the accident, the motorman was located in the so-called snap-back zone of the breaking mooring line.

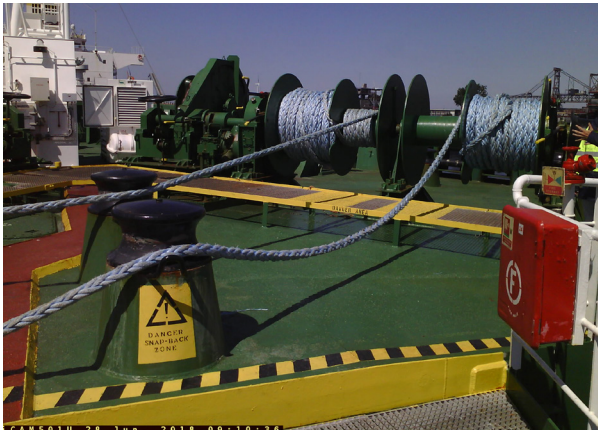
Spring winch with split drums on board the RN Privodino. (Source: RN Privodino)

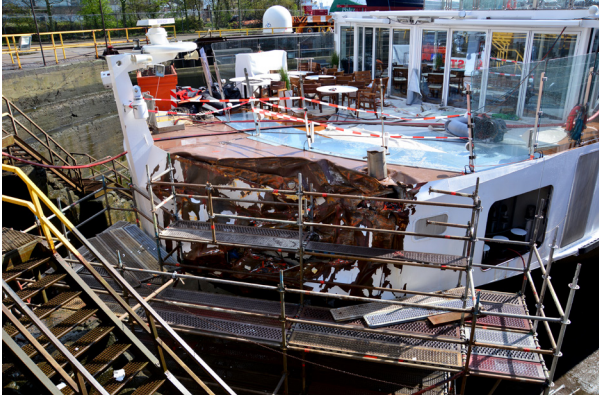
On 1 April 2019, shortly after midnight, a collision took place on the Westerschelde between the Swiss river cruise ship Viking Idun and a Maltese chemical tanker. Both ships suffered considerable damage. There were 171 mainly elderly passengers and 49 crew members on board the cruise ship. At the moment of the collision, the majority of passengers were sleeping in closed cabins, and a number suffered minor injuries as a result of the impact. The chemical tanker was transporting a cargo of benzene, heptane and methanol. The collision tore a large hole in the outer skin of the tanker. The use of double-walled tanks for the storage of chemicals prevented the spillage of very toxic substances.

Damage to river cruise ship Viking Idun.

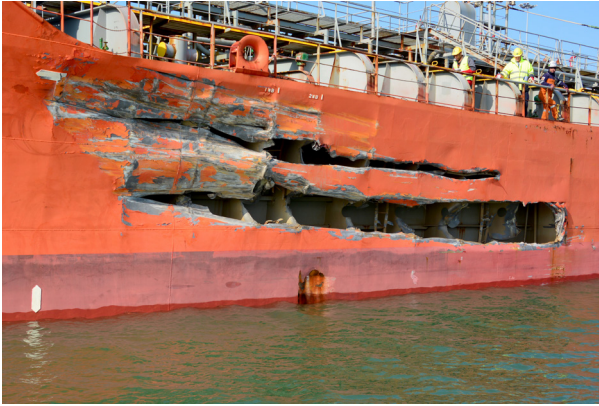
Damage to the Chemical Marketer.

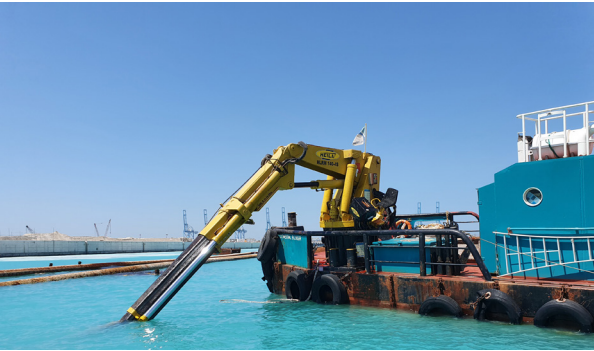
Because the pontoon was no longer supporting the pipeline, while the pipeline was still suspended from the crane of the Coastal Boxer, the vessel started to heel to port. The angle of heel was such that everyone was immediately required to evacuate the Coastal Boxer. Following the incident, it emerged that the pontoon that had broken free had not been connected to the pipeline.

Coastal Boxer during the accident (Source: Acta Marine)

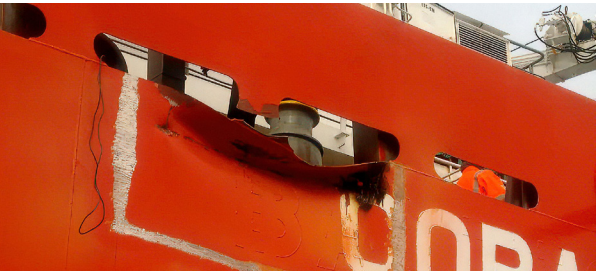
In the port of Köping in Sweden, the Dutch LPG tanker Coral Ivory collided with the moored Dutch cargo vessel Isis. The collision was caused by problems with the adjustable propellor on the Coral Ivory. The damage to the Coral Ivory consisted of a dent measuring two metres by half a metre, that had to be repaired before the ship could continue its journey. The damage to the Isis was limited to paint marks from the Coral Ivory.

Damage to the Coral Ivory. (Source: Anthony Veder)

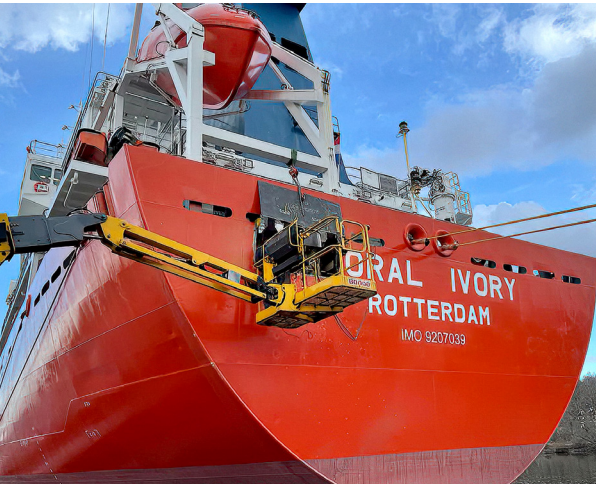
On site repair to the Coral Ivory. (Source: Anthony Veder)

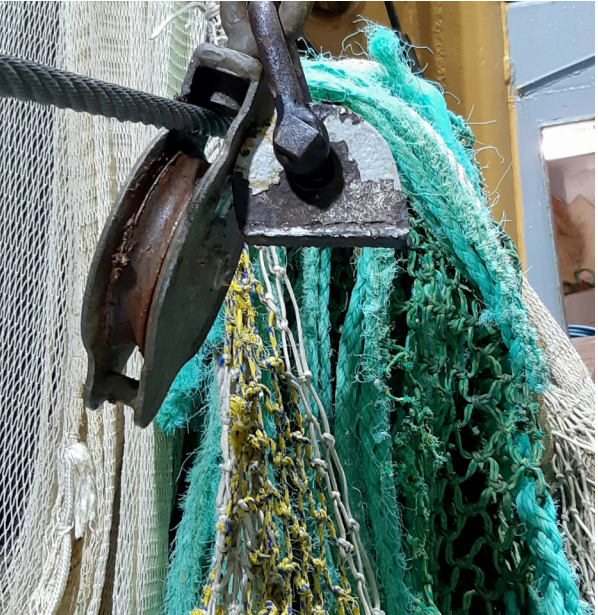
While setting the fishing gear, the port gear initially became caught behind the bulwark. After the skipper slightly raised the boom, the gear jerked free. As a result, a steel eye attached to the wheelhouse broke off. A steel tackle (block) through which a steel cable was passed under tension was attached to the eye. As a result of the eye breaking loose, the cable pulled taut between the next block and the winch. The block hit the victim hard on the back of the head, as it broke free.

The block on board the WR-23 that hit the victim.

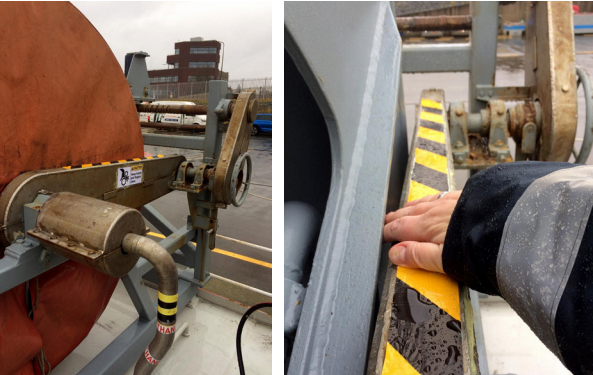
Left: Hose reel on board the Kroonborg. Right: Position where the crew member injured his hand on board the Kroonborg. (Source pictures: Wagenborg)

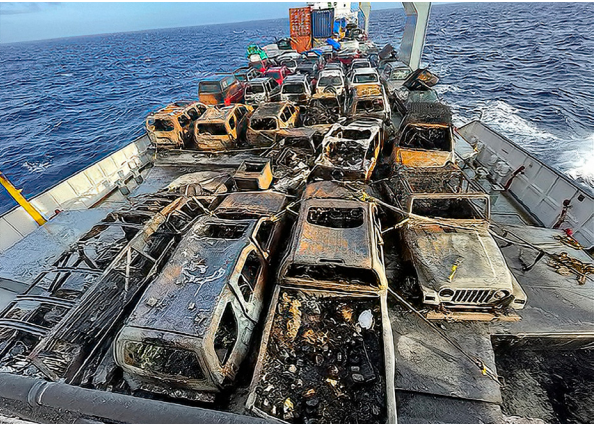
Burned-out cars on board the Beauforte. (Source: Vertom Bereedungs gmbh)

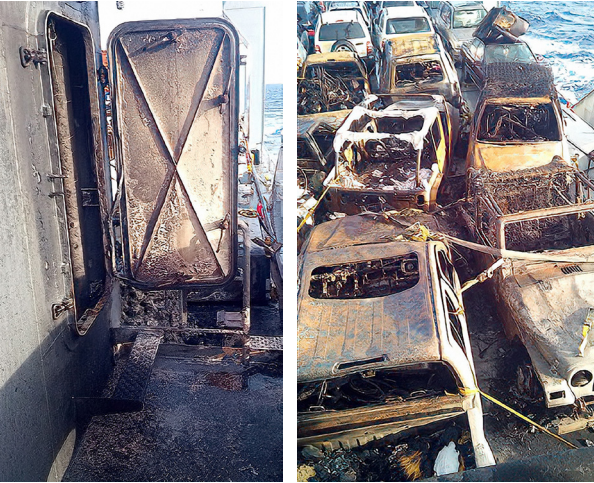
Left: Access door to the fore part of the Beauforte. Right: Fire damage to the cargo of the Beauforte. (Source pictures: Vertom Bereedungs gmbh)

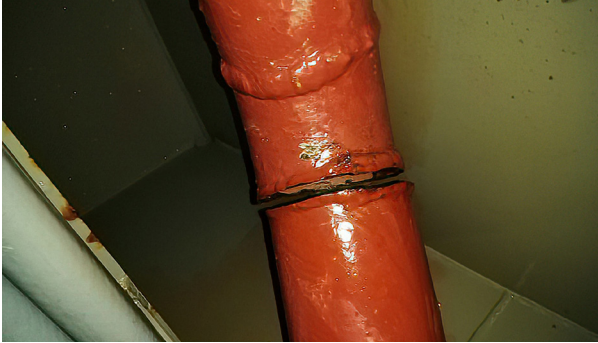
Broken fire extinguisher pipe Zealand Delilah. (Source: Q-Shipping)

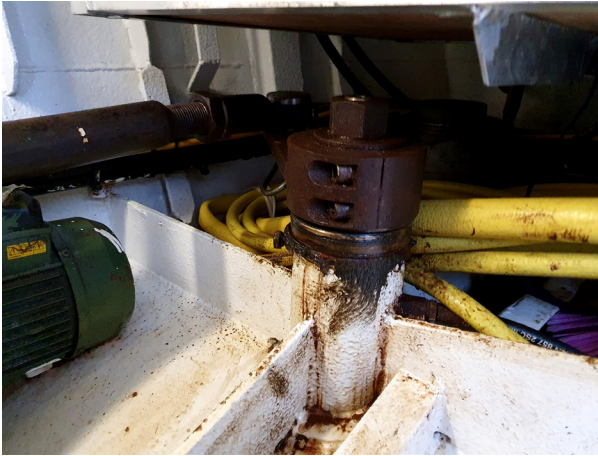
Securing mechanism of the rudder stock on the Libertas. (Source: Braveheart Maritiem)

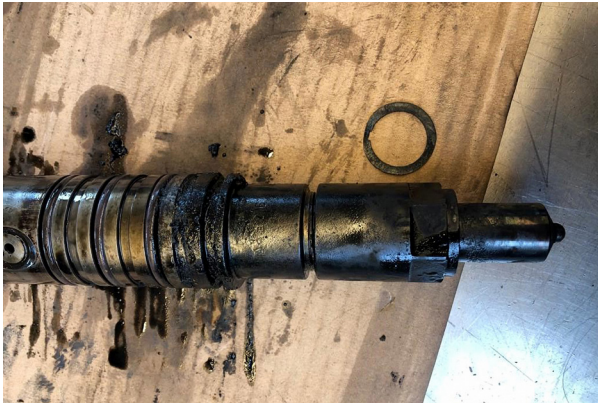
Damage to the injector bush of the main engine of the Peak Bilbao.
(Source: Crew of the Peak Bilbao)
