DUTCH
SAFETY BOARD

Shipping Occurrences Report

May 2021 - December 2021

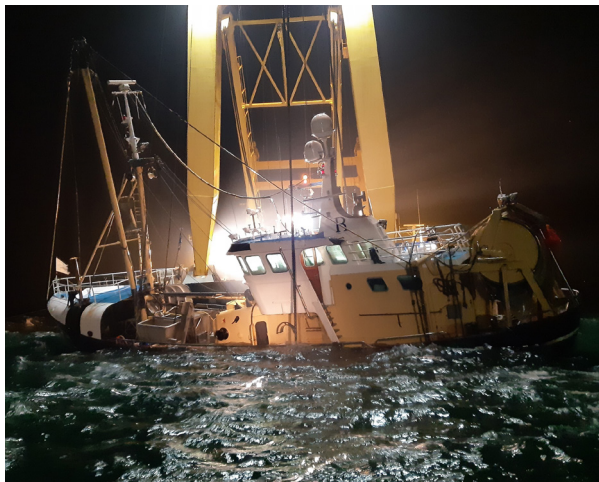
In the morning of 9 December 2020, the starboard fishing net of the fishing vessel UK-171 Spes Salutis jolted suddenly. The crew decided to cut power to the propeller and to pay out the nets. During attempts to retrieve both nets, the trawl wire on the starboard fishing gear shot over the afterdeck, and the starboard outrigger boom suddenly swung upwards. Eventually, the crew was forced to cut through the starboard trawl wire. The starboard outrigger boom then returned to a horizontal position.

The port gear was then retrieved from the seabed. This led to the same type of asymmetric loading condition as on the UK-165. The UK-171 capsized because both sets of gear were suspended from the port side outrigger boom, while there was no further weight at all on the starboard boom.

Salvage UK-171.

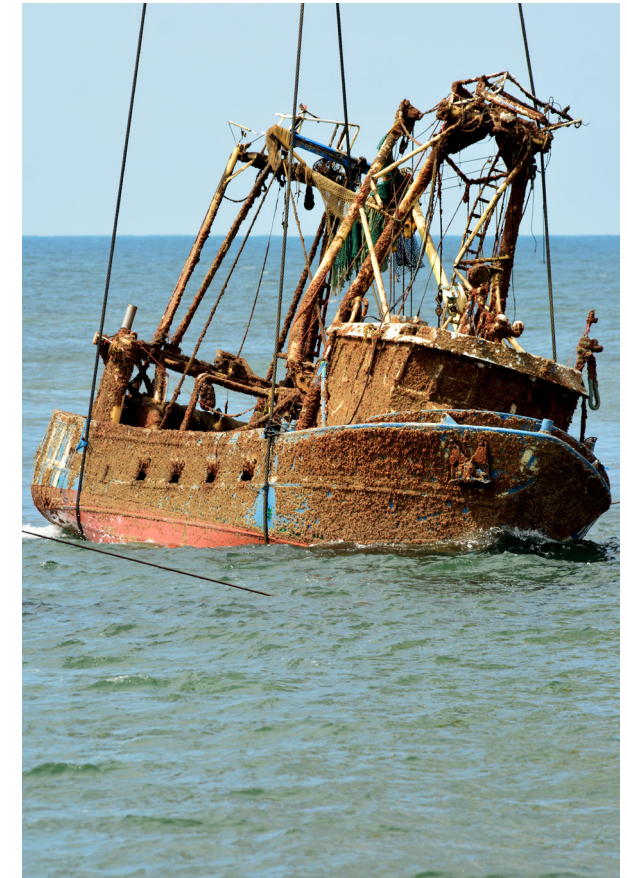
Salvage UK-165.

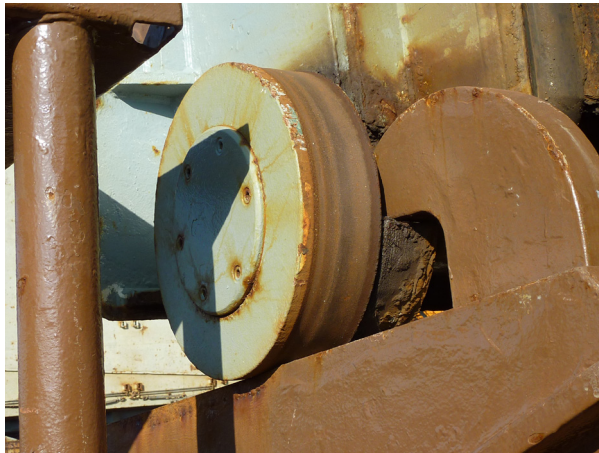
Hatch cover wheel on board a sister ship Marja.

Hatch cover wheel breaks free, fatal accident on board the Marja, Venice, Italy, 9 February 2018.

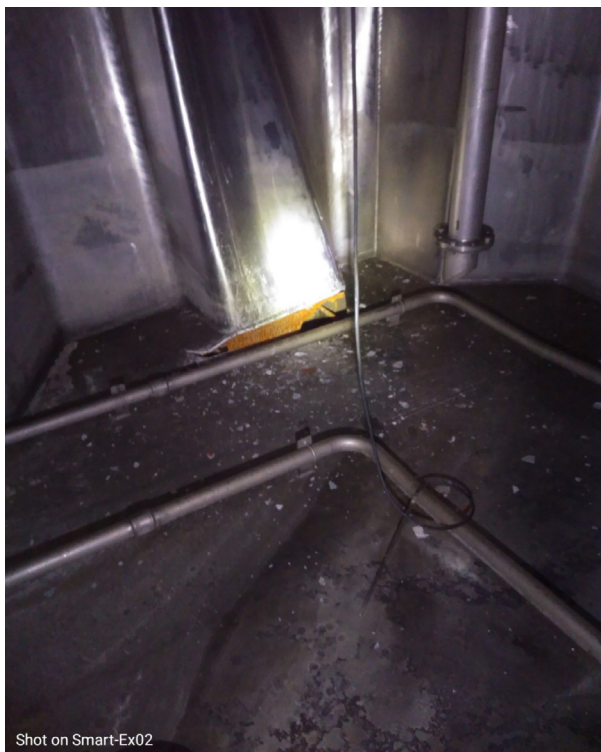
On 15 December 2021 at around 07:45 hours local time, an Italian chemical tanker experienced an explosion in starboard cargo tank 5, which led to the tank tearing open. At the moment of the occurrence, the vessel was moored at the Euro Tank Terminal (ETT) in the port of Rotterdam, to unload a cargo of heptane. Heptane is a highly flammable chemical liquid. The occurrence took place during the vessel unloading operation.

Damage inside cargo tank

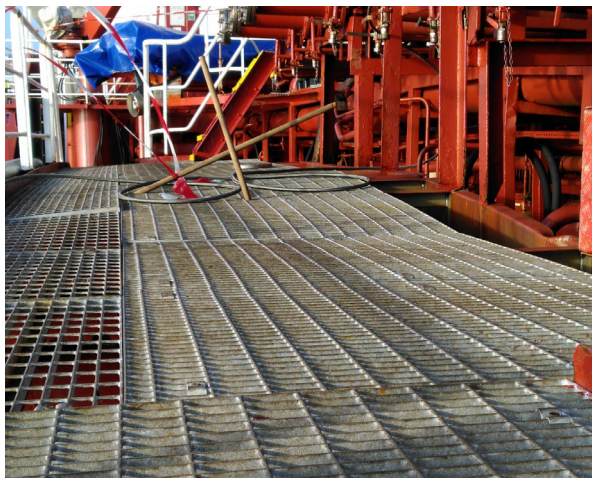
Displaced deck and manifold after the tank explosion

The vessel suffered serious damage. A number of cargo tanks and ballast tanks were displaced including the deck and cargo manifold. The Dutch Safety Board has launched an investigation.

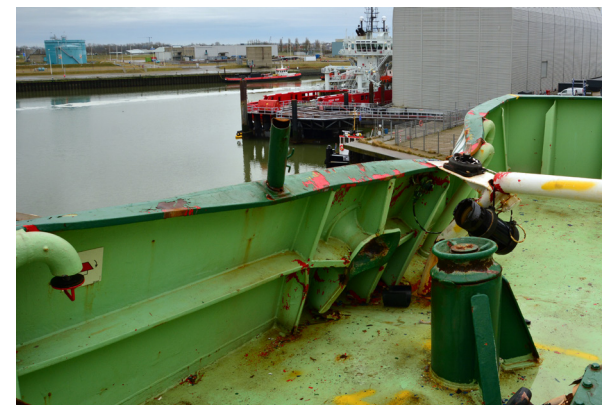
In the night of 23 December 2021, a Dutch general cargo ship was hit from behind by a Belgian fishing vessel. The collision took place on the North Sea in the southwestern channel of the traffic separation scheme near Texel. The damage in particular to the general cargo ship was considerable.

Damage to the stern after the collision

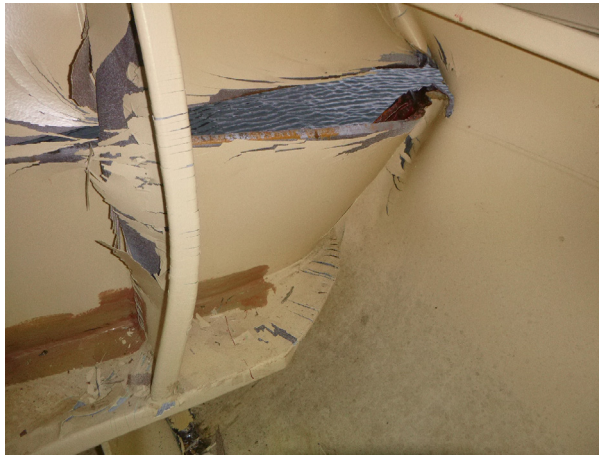
Damage Mazarine. (Source: Crew)

While mooring in one of the Rotterdam docks, the Maltese Ro-Ro cargo vessel Mazarine suffered damage. While manoeuvring, the vessel reduced speed insufficiently and was no longer able to avoid a collision with the mooring jetty. Both the vessel and the jetty were damaged. The vessel in question was exempted from pilot assistance.

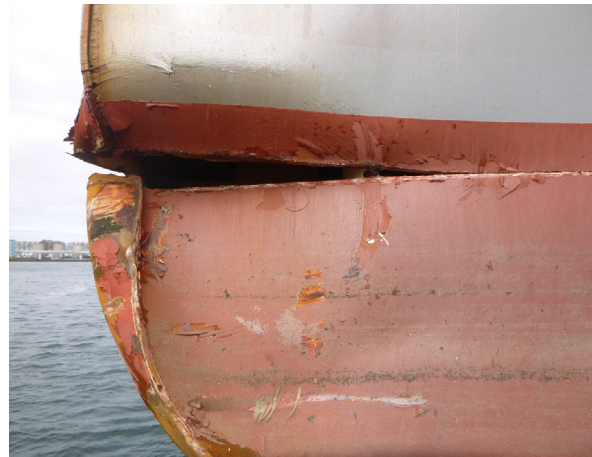
Damage outside hull Mazarine. (Source: Crew)

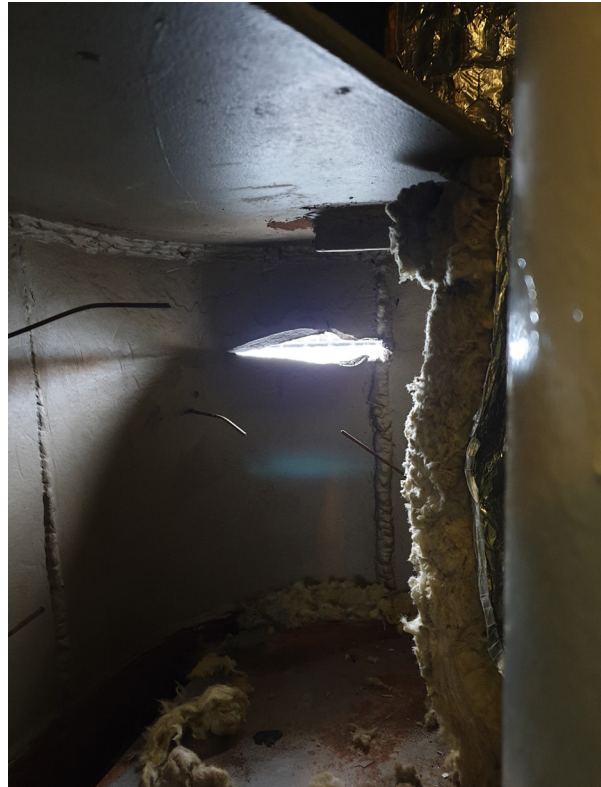
A tear was observed above the waterline at the corner of the port stern part of the Bahamian-flagged vessel Ramform Sovereign. The damage occurred while the vessel was moored in IJmuiden. An examination of CCTV images on board was unable to identify the direct cause. The vessel was only able to continue its journey following permission from the classification society. Repairs were carried out in situ. The vessel may have been hit by a tugboat or bunker boat.

Damage Ramform Sovereign

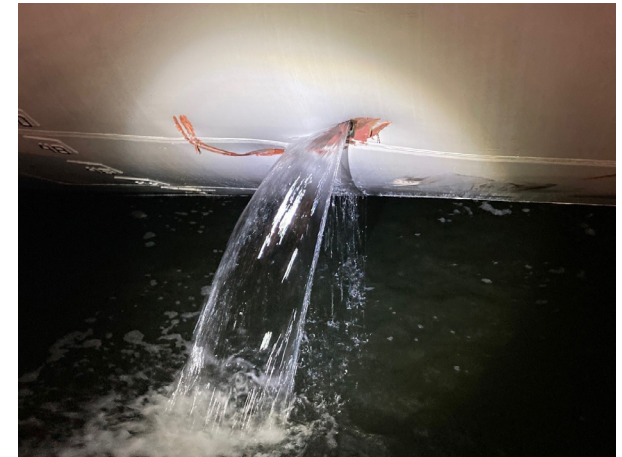
The Norwegian gas tanker Helle collided with a hinge point on the dockside fender while manoeuvring, in Sluiskil. The vessel suffered damage to its stern part at the position of the steering engine room and a ballast tank. The damage had to be repaired before the vessel was allowed to depart.

Holed ballasttank Helle

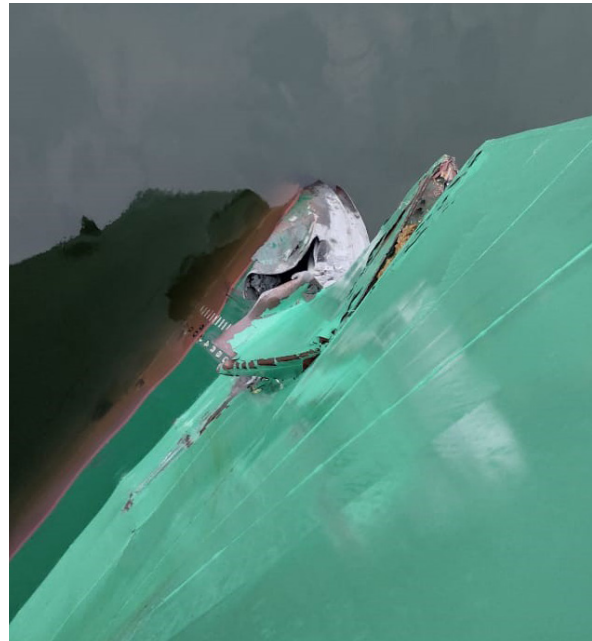
Entering port, the Arklow Valley collided with the Northern pier head. Due to a combination of wind and waves, the vessel manoeuvred more slowly than normal. When the pilot attempted to change course to avoid the pier head, the manoeuvre was initiated too late, which placed the ship in shallow water. The vessel moored independently in the port. Following inspection, it emerged that the hull had suffered damage at the level of the ballast water tanks. The Arklow Valley sails under Dutch flag.

Damage to hull Arklow Valley. (Source: Arklow Shipping)

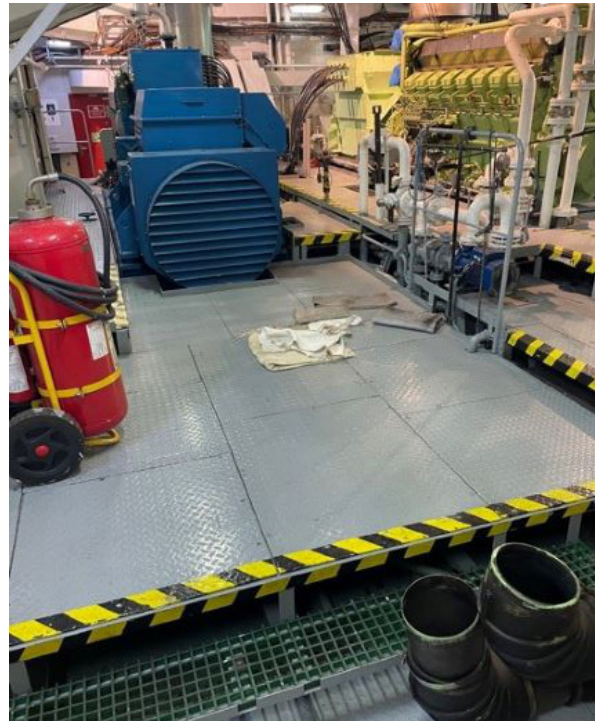
On board the Dutch lift vessel MPI Resolution, the chief engineer tripped over a marked step when entering the engine room. He attempted to arrest his fall by extending his right arm, but broke his right wrist as a result. The vessel was moored in the port of Rotterdam.

Accident Location MPI Resolution (Source: Van Oord)

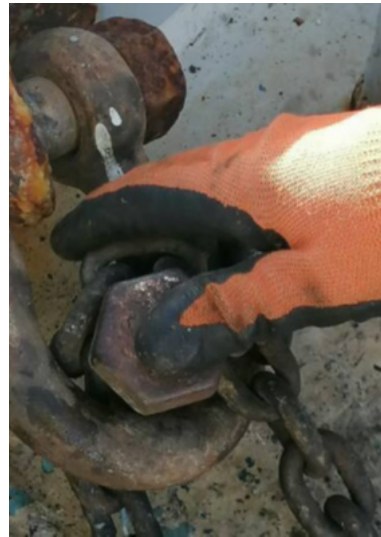
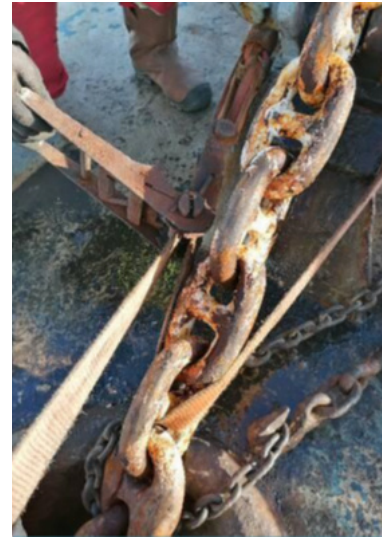
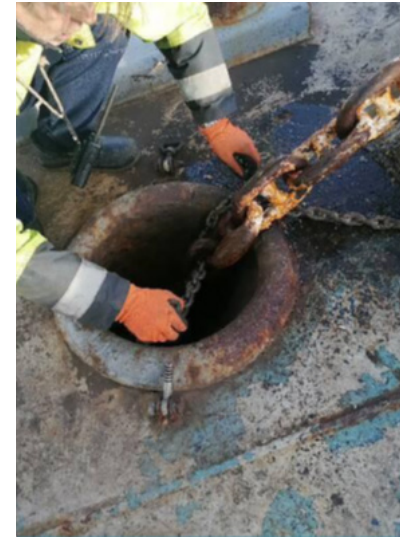
After setting sail from Goole, UK, while fastening the anchors on the fore part of the Dutch vessel Ashley, a steel bolt broke free. At the time, the vessel was sailing on the river Humber. Because the tensioning chain was too long, the crew had inserted an additional bolt, to allow the chain to be made tight. While a deckhand was fastening the tensioning chain, a lashing strip was attached on the other side, and tautened, releasing the tension from the chain. As a result, the bolt broke free and was launched into the face of the deckhand, like a projectile. He suffered facial injuries.

Accident Ashley. (Source: Crew)

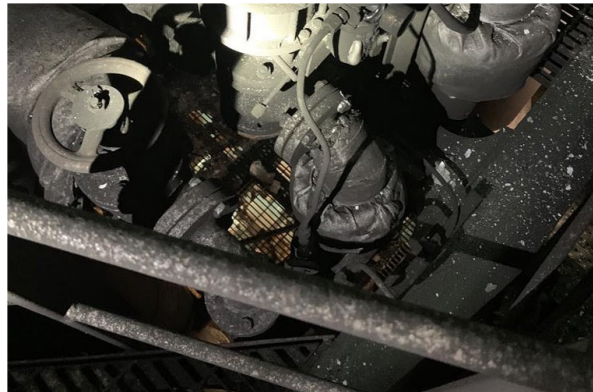
Fire in engine room, St. Eustatius, 13 December 2021
As the Maltese-flagged vessel Curacao Trader approached the anchorage of St. Eustatius, the crew saw black smoke and flames escaping from the engine room. The fire alarm was also sounded. At the time, the second engineer and fitter were working on the lower deck of the engine room. The engine room was evacuated and the permanent CO2 extinguishing system was activated to put out the fire. As a result, the vessel suffered a blackout and set anchor just outside the anchorage. The operator and the accident investigators from Malta have launched an investigation into the cause.

Damage after fire on board Curacao Trader. (Source: Crew)

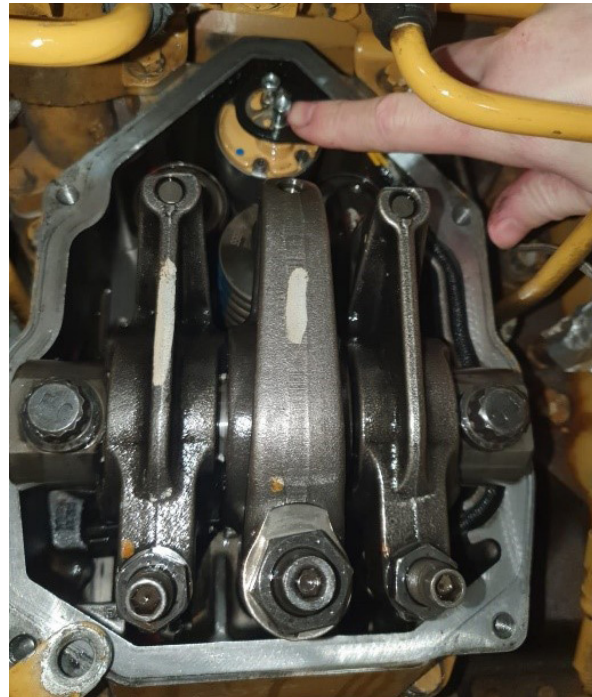
On 1 December 2021, the Dutch-flagged Lady Adele was anchored off the coast of Spain. At around midnight, the main engine was started in order to enter the port of Bilbao. After starting, the engine made a tapping noise and an inspection revealed that one of the injectors had worked loose, creating a hole in the valve cover. Because sailing in this condition was impossible, and the pilot was already on board, tugs were ordered to tow the vessel into port. Once moored, repairs were carried out by external engineers.

Cylinder Head Lady Adele. (Source: Wijnne Barends)

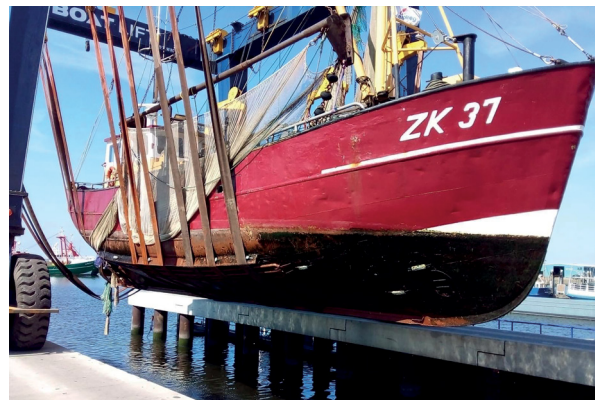
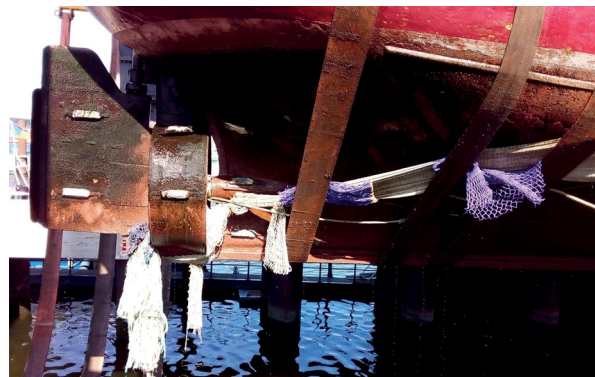
While fishing around Schiermonnikoog in the North Sea, the net of the Dutch shrimper ZK37 Aldert van Thijs became entangled in the propeller. The vessel was towed into Lauwersoog with the assistance of the ZK17 Johannes Dirk. The net was removed from the propeller in the dock.

Fishing net entangled in propeller ZK37. (Source: Owner)

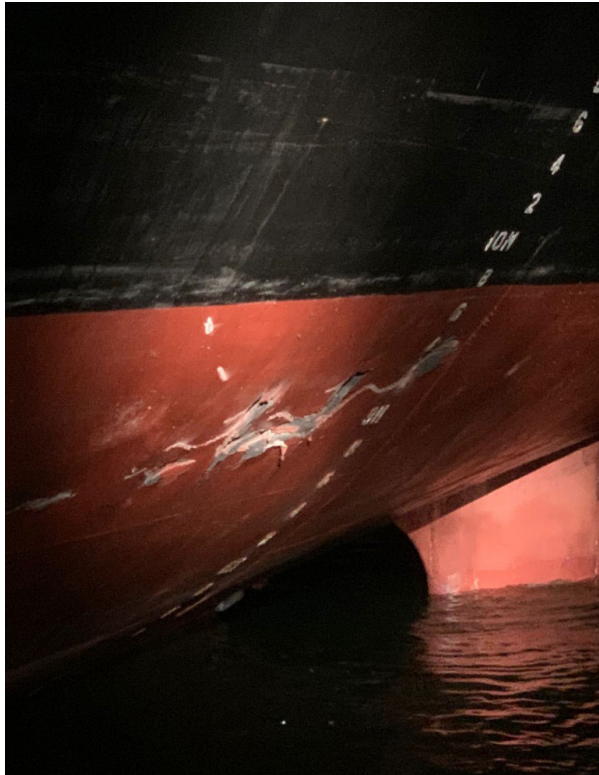
A drifting push barge collided with the seagoing vessel Melina in the port of Rotterdam. The barge hit the port stern section of the moored seagoing vessel. No one was injured, and no pollution was observed. The seagoing vessel suffered a number of scratches.

Damage to hull Melina. (Source: Zeehavenpolitie Rotterdam)
