DUTCH  
SAFETY BOARD

# Shipping Occurrences Report

January 2022 - July 2022

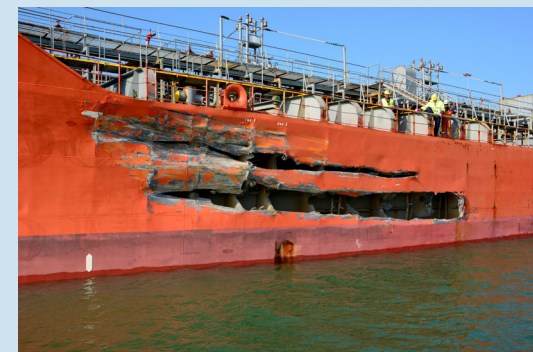
Damage to the Chemical Marketer

One example in which problems with the working language played a role was the collision that took place on the Westerschelde between the river cruise ship Viking Idun and the Maltese-flagged chemical tanker Chemical Marketer in April 2019. At the time there were 137 passengers and 43 crew members on board the cruise ship. The chemical tanker was transporting a cargo of benzene, heptane and methanol. A number of passengers were slightly injured and the damage to both ships was considerable.

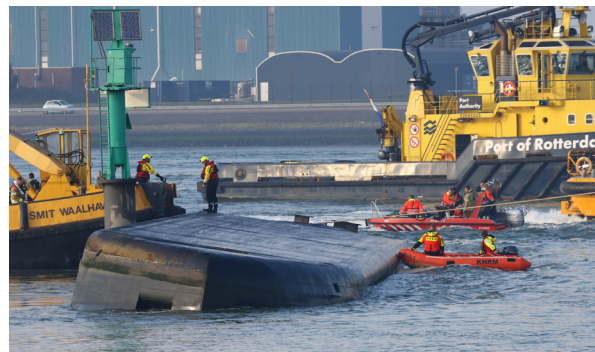
Mar-Grethe capsizes on Nieuwe Waterweg. (Source: GinoPress)

On Thursday 14 April 2022, the inland navigation vessel Mar-Grethe, with a cargo of 880 tonnes of aluminium rods, capsized. The vessel was sailing up the Nieuwe Waterweg when it was overtaken by two seagoing vessels. At the time of the occurrence, the skipper of the inland navigation vessel was in the wheelhouse, and the deckhand was in the vessel's accommodation section. The skipper was rescued from the water; the deckhand was found dead in the water, several days later.

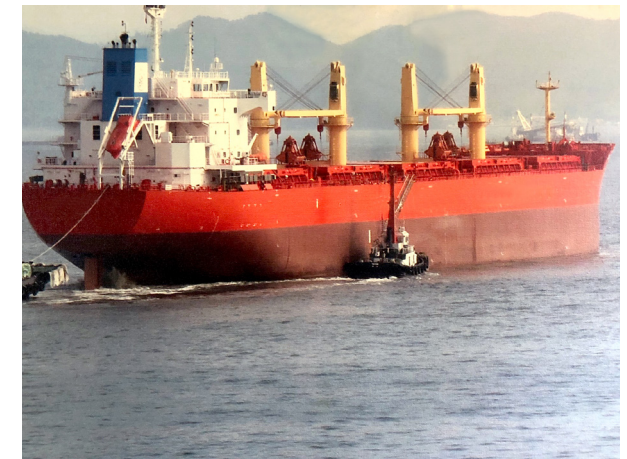
While preparing to unload the cargo, the victim climbed onto a grab of one of the ship's cranes. When the deckhand on the grab was still working to release the lashings on the grab, the lifting block on the crane made a sudden swinging motion, colliding with the deckhand. The deckhand fell over backwards and landed on the deck below, on his head. During the investigation, it was not possible to determine with certainty the cause of the sudden swinging of the lifting block.

The accident was a consequence of a number of causes. Binding agreements from the ship's safety management system (SMS) were not complied with in all cases. The basic rule on board any ship is that all personal protective equipment must be worn or used if specified, and that all tasks must be discussed in advance in a so-called toolbox meeting or a Last Minute Risk Assessment. These rules were not complied with on board the vessel in question. Pressure of time may never be allowed to play a role with regard to these basic agreements.

*Zealand Rotterdam. (Source: Q-Shipping)*

Based on the investigation into this occurrence involving the Zealand Rotterdam, the Dutch Safety Board has issued a series of recommendations to the ship's manager.

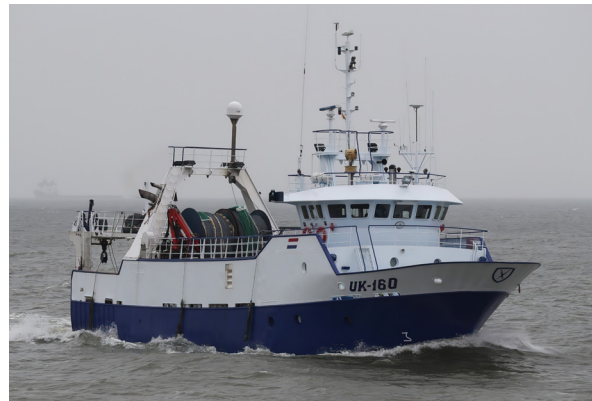
The investigation revealed that the direct cause of the loss of the UK-160 Riemda could not be attributed to a single cause. It is certain that the initial cause was a considerable volume of excess water on the fish processing deck, which must have gradually accumulated. The investigation revealed no unequivocal cause for the way in which this volume of water found its way onto the fish processing deck, but in and of itself, this fact should never result in the loss of a vessel. The fact that the vessel was eventually lost was the result of a combination of multiple failing barriers.

1. A failing bilge pump and the fact that a backup bilge pump system was not continuously available;
2. Failure of the general high-water sensor (fish processing deck);
3. The leaving open of a closable fish waste discharge chute;
4. The insufficient watertight integrity of the vessel.

UK-160 Riemda. (Source: Bram Pronk)

Based on the investigation into this occurrence with the UK-160 Riemda, the Dutch Safety Board has issued a series of recommendations to the owner, the Minister of Infrastructure and Water Management, the Fisheries Sector Council, and a number of international branch organizations.

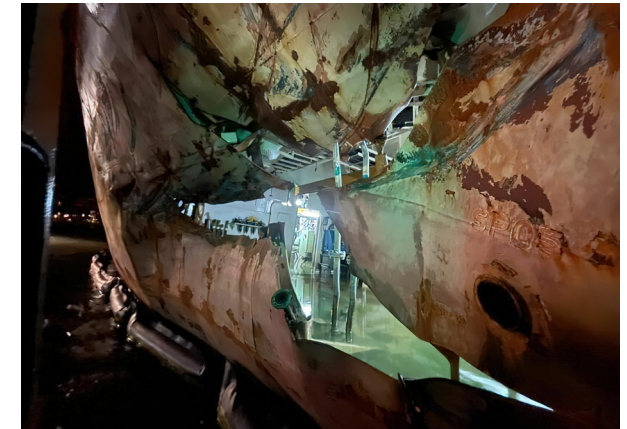
On 31 January 2022 at around 11.30 hours, a collision took place during storm Corrie between a bulk carrier and a tanker. Both vessels are Maltese flagged and were moored in the anchorage of IJmuiden in the North Sea, around 20 miles off the coast. The anchor of the bulk carrier failed to hold and started to drag. As a consequence, the bulk carrier collided with the tanker. The tanker remained stable, and subsequently arrived in the port of Amsterdam without problems. The bulk carrier, that was sailing without cargo, suffered a large hole in the hull near the engine room, through which water was able to enter. Partly as a consequence, the vessel became rudderless, due to lack of propulsion.

*Hole in hull. (Source: zeilen.nl)*

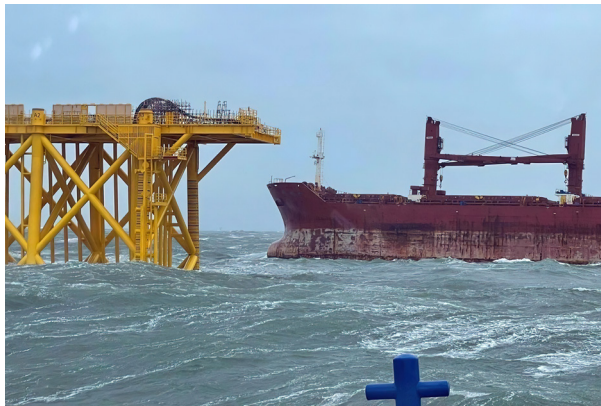
At the request of the crew members, the Coastguard initiated an evacuation process and removed all persons from the bulk carrier. The vessel remained adrift, heading for the Dutch coast and the Hollandse Kust Zuid offshore wind farm still under construction. As a precautionary measure, the oil and gas production company evacuated all personnel from platform Q13a-A. The bulk carrier passed close to platform Q13a-A, and subsequently collided with the foundation of a wind turbine under construction, before hitting the structure on which a transformer platform was later due to be installed. At the end of the afternoon, two sea tugboats arrived on the scene, one Belgian and one Dutch. Due to the poor weather conditions, they had previously been unable to rig a tow connection. Eventually, the bulk carrier was towed to Rotterdam.

*Rudderless vessel passing the platform. (Source: KNRM)*

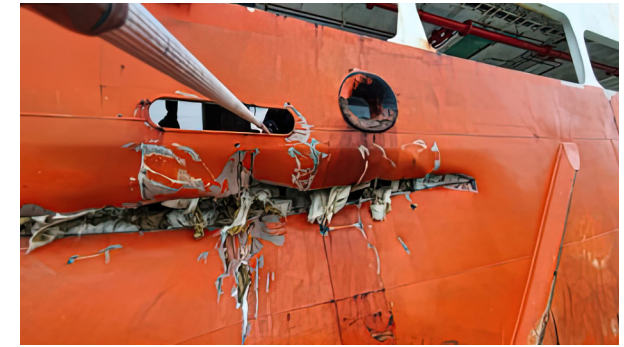
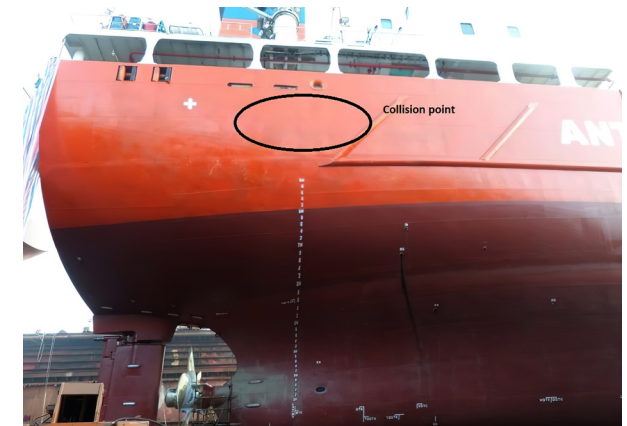
As a result, a hole approximately five metres long was punched in the hull of the Coral Acropora, 40 centimetres below the poop deck. This is the location of the vessel's storeroom. There were no injuries on board, and the vessel was able to sail safely to a shipyard. The bottom photo is an older photograph indicating the location of the damage.

Hole in hull approximately five metres long. (Source: Anthony Veder)

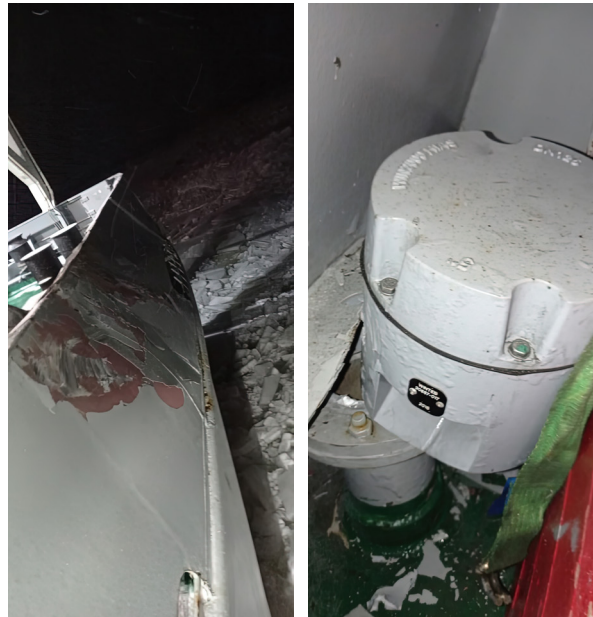
The Dutch cargo vessel *Missouriborg* set sail from Kemi (Finland) assisted by the ice breaker *Atle*. At around 23.30 hours local time, the *Missouriborg* became trapped in the ice, at which point the captain requested assistance from the *Atle*. While manoeuvring to approach the *Missouriborg*, the bow of the ice breaker *Atle* collided with the *Missouriborg*, on the port side, above the poop deck. A section of bulwark approximately nine metres long was bent; the housing of the port raft was broken; the switchbox on the port winch was bent; and ventilation ducts and a gooseneck suffered damage.

Damage following the collision. (Source: Wagenborg)

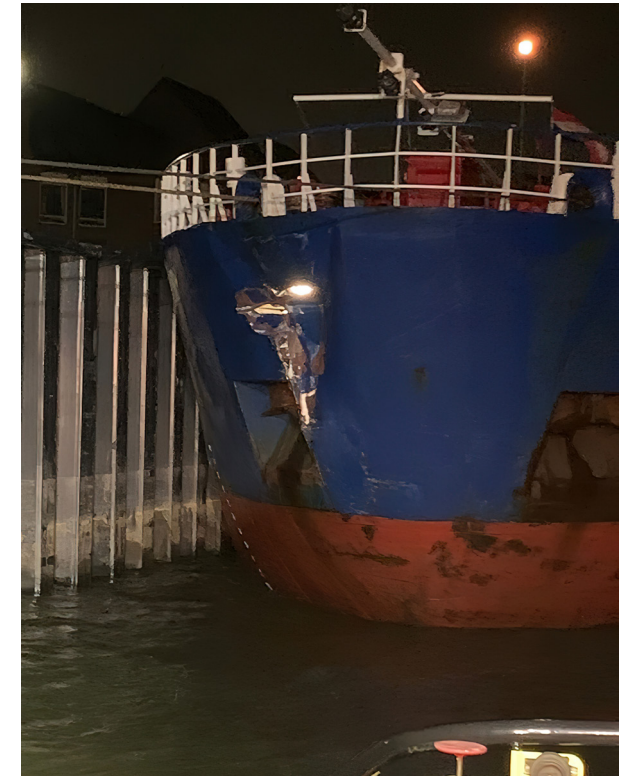
Just after midnight, the Dutch cargo vessel *H&S Bravery* collided with the Dutch inland navigation cargo vessel *Den Bosch Max Groen*, from the rear, on the river Waal. The *H&S Bravery* was in the process of overtaking the *Den Bosch Max Groen*. The statement by the crew revealed that they had not seen the approaching vessel, until too late. The *H&S Bravery* suffered a tear in the bow section, about three to four metres above the waterline. The vessel subsequently travelled to Dordrecht for repairs.

Damage to *H&S Bravery*. (Source: ILT)

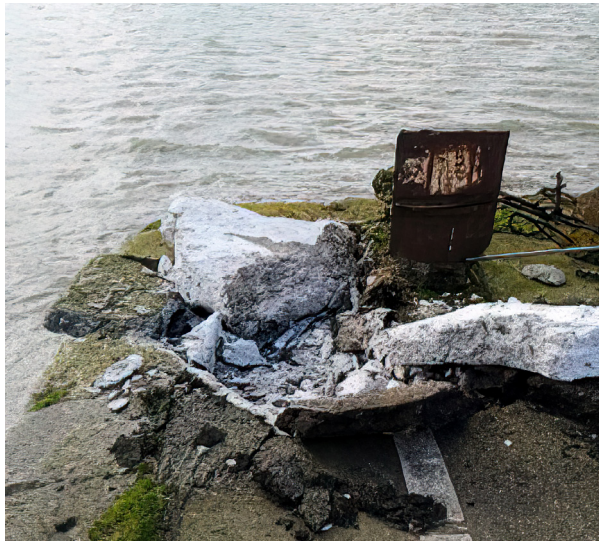
The vessel Amstelborg was moored in the port of Dordrecht. Due to strong winds, nine mooring lines broke and one bollard on the quayside failed. The vessel suffered damage at multiple points, including a tear in the forepeak. The damage was caused by a collision with another vessel and with the quay wall. The Amstelborg was given tugboat assistance until the next morning, to remain in position alongside the quay wall, until the storm died down. Classification society and damage assessment experts were brought on board and a plan was drawn up to transport the vessel to Rotterdam for repair.

Bollard ripped from the quay. (Source: Wagenborg)

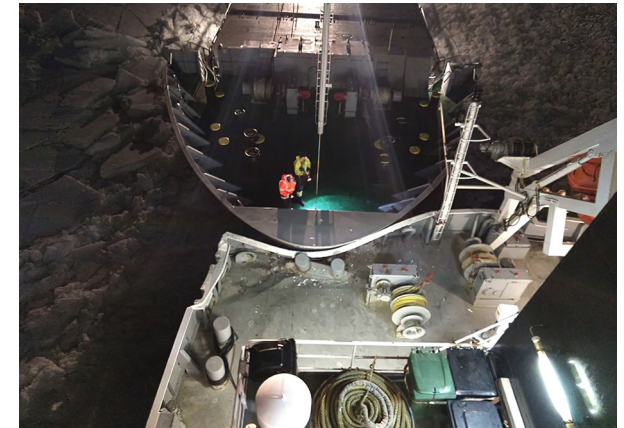
Accompanied by the ice breaker Nordica, the Dutch-flagged vessels Cathy Jo and Delfborg were travelling in convoy formation, at night. At around 02.00 hours local time, the Cathy Jo became stuck in the ice. The vessel's speed reduced to one knot, and following instructions from the bridge of the ice breaker, the main engine was shut down. The Delfborg subsequently collided with the Cathy Jo, from behind. The Delfborg suffered minimal damage to the fore part. The damage to the Cathy Jo was considerable, but the vessel took on no water, and there were no injuries.

Collision during ice convoy. (Source: Corribshipping)

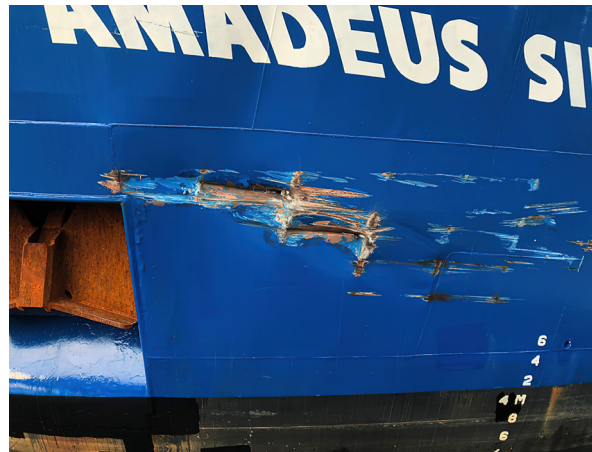
At around 20.30 hours, the Dutch cargo vessel Amadeus Silver collided with a moored inland navigation vessel on the Albert Canal near Ham (Belgium), following engine failure. As a result of the engine failure, the Amadeus Silver had become rudderless. The damage to the Amadeus Silver consisted of two holes in the bow, above the waterline. The engine failure was caused by a faulty regulator in the main engine.

Damage to Amadeus Silver. (Source: De Bock Maritiem)

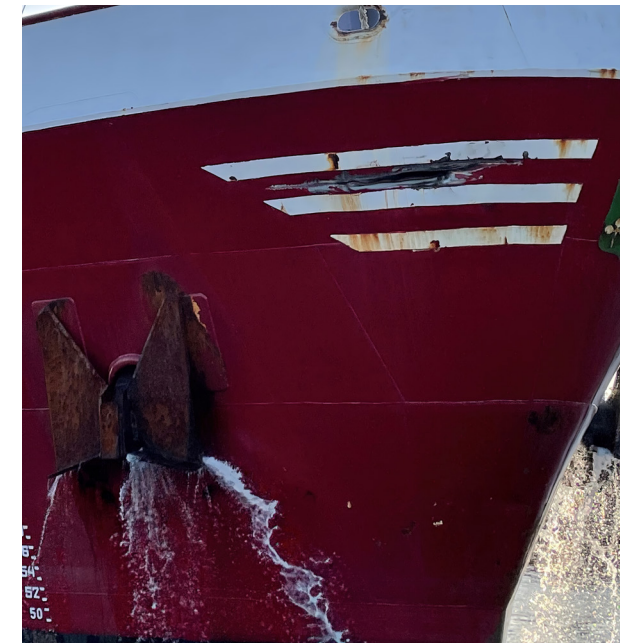
During manoeuvres to bring the Dutch seagoing vessel Priscilla alongside, at a critical point in the manoeuvring process, the rudder was unexpectedly found to be turned to 'full starboard' instead of 'full port'. As a consequence, the bow of the vessel collided forcibly with a mooring post. A tear approximately 1.40 metres long was made in the starboard side, just below the forecastle deck, well above the waterline. The damage first had to be repaired before the vessel was able to set sail once again.

Damage to the bow of the Priscilla. (Source: Port of Rotterdam)

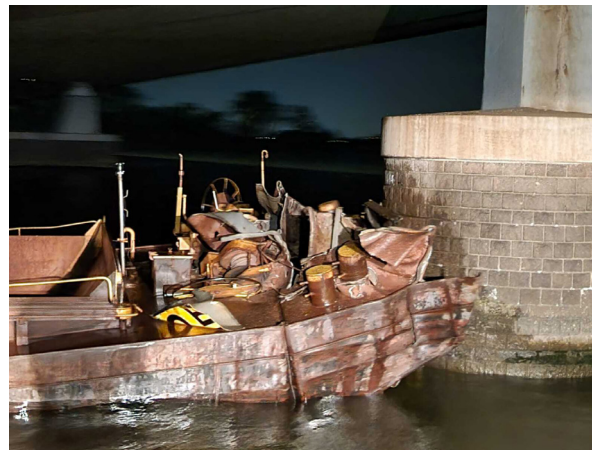
In the night of 30 April, the German-flagged push boat Hercules II collided with the central pillar of the Moerdijkbrug (a road bridge). The vessel was transporting four push barges, each loaded with 2400 tonnes of ore. There were no injuries.

One push barge was punctured. The fire brigade was able to keep the barge afloat with pumps. The other three barges floated free. The push barges were secured and the leak plugged. The vessel was taken to a shipyard. The channel was closed to shipping until around 02.40 hours. The bridge did not have to be closed to road traffic. However, a speed limit was imposed on the traffic crossing the bridge.

Push boat collided with the central pillar. (Source: Rijkswaterstaat, @VLW\_Rolph)

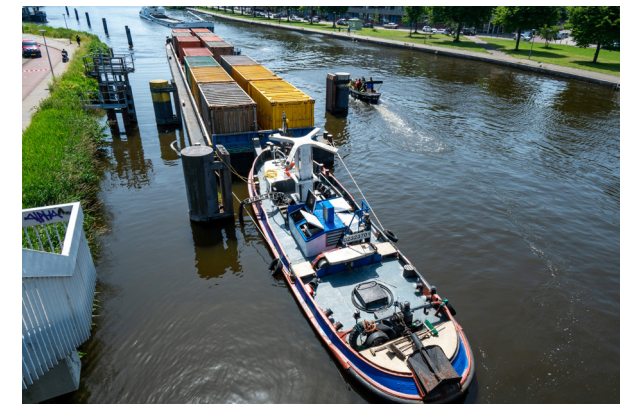
In the afternoon of 17 June 2022, the Reinod 1 collided with the Beukelsbrug bridge in Rotterdam, losing its wheelhouse. The vessel was travelling to a location at the Rijnmond Waste Incineration Plant (AVR). The skipper had to be examined in the ambulance. The fire brigade and police deployed with heavy equipment. A passing barge briefly took the vessel alongside, since it had become rudderless.

Reinod without wheelhouse. (Source: ANP / Video Duivestein VOF inzake MediaTV)

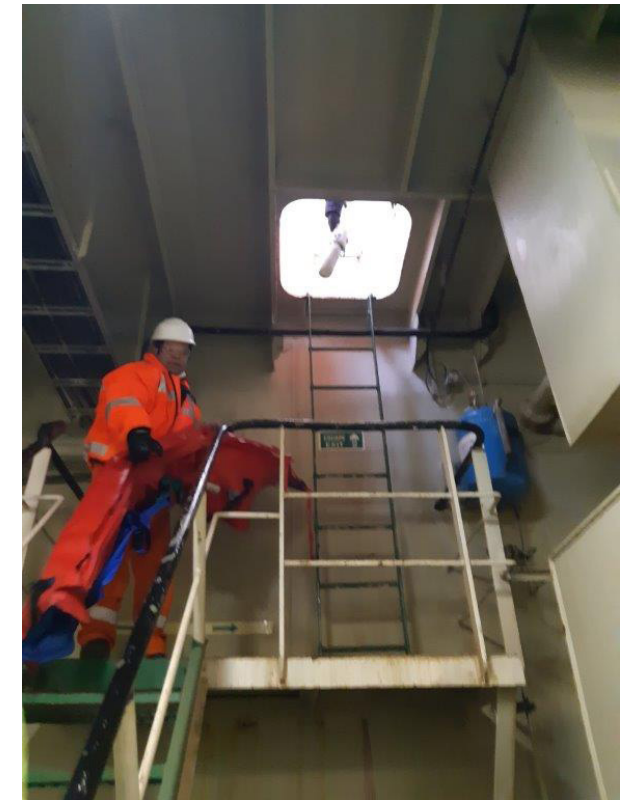
A crew member of the Russian-flagged crane vessel Oceanic 5000 fell almost twelve metres into the thruster room while the vessel was moored in the port of Rotterdam. The occurrence took place when two crew members were descending into the thruster room to carry out maintenance work on a broken electric motor. The victim was the first to make the descent, during which he fell. He initially fell three metres onto a railing and then fell a further nine metres into a stairwell. He himself started climbing back up the stairs before his colleagues instructed him to lie down. The ship's doctor stabilized him. He was subsequently taken to hospital by ambulance, assisted by the fire brigade.

Entry thrusterroom. (Source: ILT)

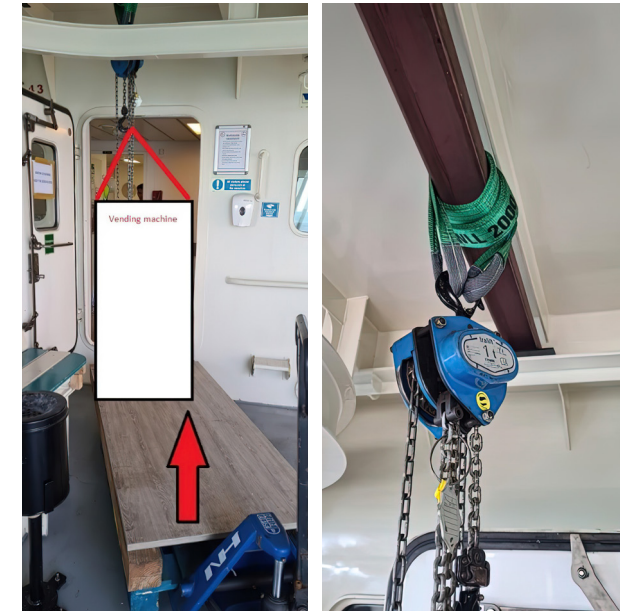
On board the Dutch Construction Support Vessel Acta Orion, the ship's second mate suffered an injury to his hand, when it became trapped under a steel beam. The crew was in the process of moving a snack dispensing machine from outside on deck to the indoor accommodation area. The snack dispensing machine was transported laying down, on a wooden pallet. As the snack dispensing machine was taken inside, it had to be lifted slightly over a hatch before it reached the accommodation entrance. To lift the machine, the crew made use of a steel beam with a chain hoist. The steel beam was placed loose on the trusses above the accommodation entrance. While pushing the snack dispensing machine inside through the entrance door to the accommodation area, the steel beam with the chain hoist slipped and ended up on the hand of the second mate, thereby amputating two fingertips. The injured second mate was medevacked and taken to hospital. He underwent an operation on his hand. Following recovery, the second mate returned to work on board the Acta Orion.

Beam with chain hoist. (Source: Acta Marine)

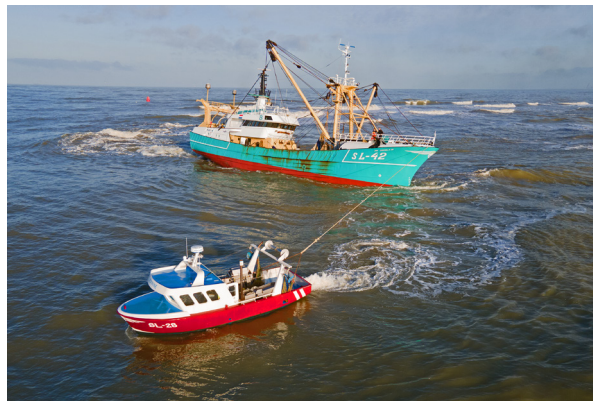
During the approach to Stellendam, beam trawler SL42 Jan Cornelis 3 ran aground. The vessel was pulled free with the assistance of another fishing vessel, and was able to continue its journey independently. No technical problems were identified.

Pulling SL42. (Source: C. Hameeteman)

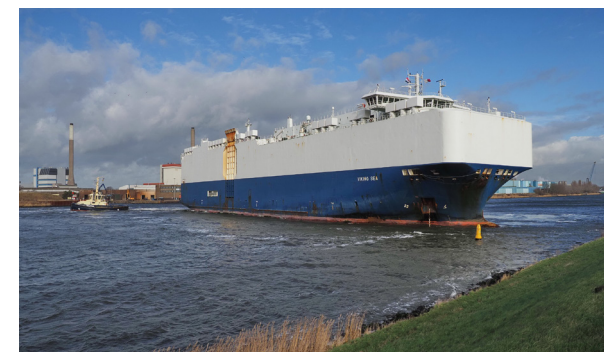
Viking Sea run aground. (Source: Ko van Leeuwen)

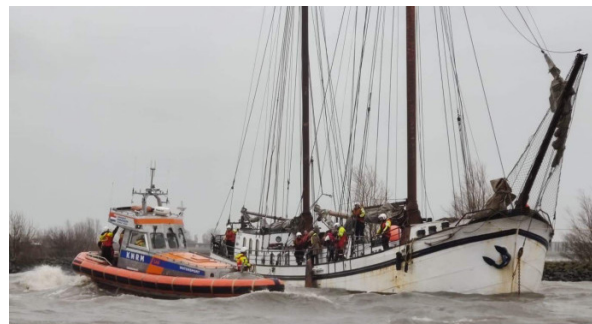
Clipper Succes on the rocks. (Source: Reddingsbrigade Notwin Hoorn)

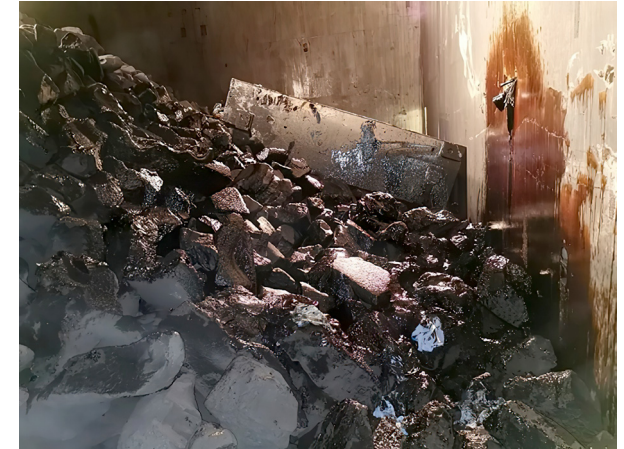
Contaminated cargo Alaskaborg. (Source: Wagenborg)
