This Appendix contains detailed responses to your given arguments. The same order is maintained as in the Attachment to your letter.

<p><b>“The new important fact is that, even assuming the aircraft was brought down by a Buk surface-to-air missile, the description of fragments provided in the report does not match the pre-formed fragments used in the 9N314M warhead.”</b></p>	<p>1. For the assessment of the given arguments of the Russian Federation regarding the tests performed by the Russian Federation, reference is made to the text in the report MH17 About the investigation, Appendix L:</p> <p>Ref.: MH17 About the investigation, Appendix L, Response to the comments of the Russian Federation, page 101-102, under 2, third column:</p> <p><i>(...) The test was performed in a stationary situation on the ground, which is completely different from the detonation of a warhead at an altitude of about ten kilometres. The air density at an altitude of ten</i></p>

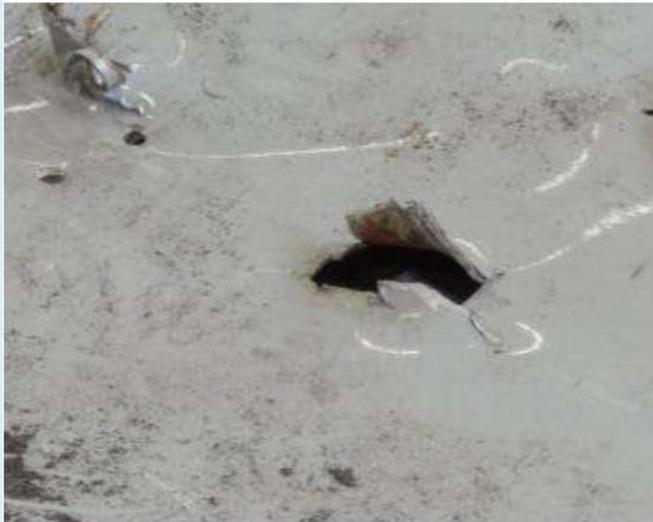
Russian Federation argumentation	Dutch Safety Board assessment
	<p><i>The fact that hundreds of fragments were found in the bodies of the three crew members in the cockpit illustrated that the path of the fragments was affected.</i></p> <p>3. For the arguments regarding the presence of penetration holes in the right side of the cockpit reference is made to section 2.4, page 13 of the NLR report (Appendix X of the MH17 Crash report): <i>Exit damage is observed on the wreckage of the lower right-hand side of the cockpit (Figure 10). This is an indication of a direction of impact from the upper left-hand side of the cockpit towards the lower right-hand side of the cockpit.</i></p>

<p><i>Figure 10: Exit damage on lower right-hand side of the cockpit</i></p> <p>The Dutch Safety Board concludes that on the basis of the arguments put forward, there is no new and significant evidence.</p>
<p><b><i>“The new important fact is that the appearance of the Section 3 encasing fragment found at the crash site does not match the appearance of fragments of the same encasing normally resulting from the detonation of a 9M38-series (9M38M1) missile.”</i></b></p>	<p>For the response to the Russian Federation's argument regarding the so-called 'Section 3 encasing fragment' reference is made to the text in paragraph 2.12.2.8 of the MH17 Crash report:</p> <p>Ref.: MH17 Crash, paragraph 2.12.2.8, pages 82-83: <i>(...) In order to not risk impeding the criminal investigation, the Dutch Safety Board has decided not to publish images of all of the recovered fragments that were presented to the Annex 13 partners during the progress meeting in August 2015. Images of three of the parts are shown in Figure 36.</i></p> <p><i>The shape and form of the parts recovered is consistent with a 9M38-series surface-to-air missile. Images of three of the recovered parts are shown in Figure 36 together with an indication of origin on a 9M38 series surface-to-air missile; namely an engine nozzle (1), part of one of the four stabilizer fins (2) and a data cable (3).</i></p> <p>The text in the report makes it clear that the Dutch Safety Board makes no pronouncements as to whether the 'Section 3 encasing fragment' comes from the surface-to-air missile that downed the aeroplane. That is part of the criminal investigation.</p>

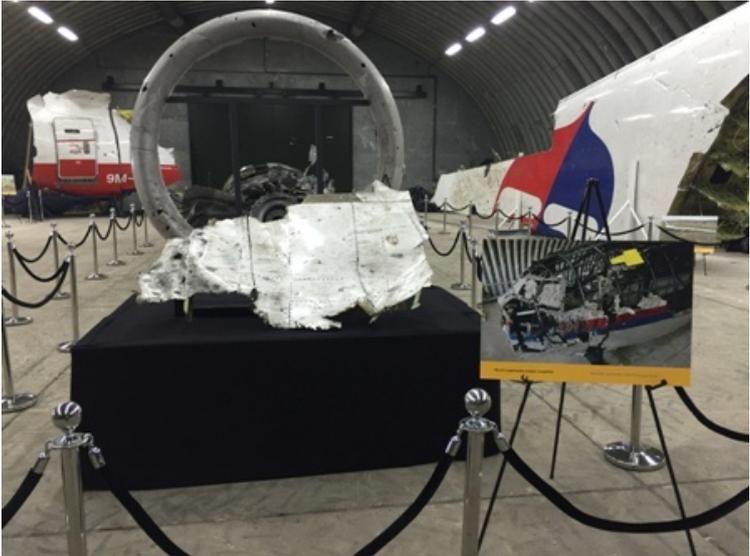
Russian Federation argumentation	Dutch Safety Board assessment
<p>2. the missile warhead detonation area;</p> <p>3. discrepancies in static and dynamic warhead simulations.</p>	<p>Furthermore, for the response to the first argument of the Russian Federation, reference is made to the text in Appendix V of the MH17 Crash report in response to the Russian Federation's comments on paragraphs 2.19.4, 3.7.1 and 3.7.2 of the draft Final Report:</p> <p>Ref.: MH17 Crash, Appendix V, Consultation Part A: Causes of the crash, page 6/21 and 11/21:  <i>(...) it is a well known fact in the study of terminal ballistics of fragments that a fragment hitting a plate at an oblique angel (not perpendicular to the plate) changes its direction of travel after penetration. The initial angle is typically reduced after penetration. This change in angle is dependent on several factors and can be as small as several degrees or as large as the original oblique angel. As a result, it is usually not possible to obtain accurate data on the direction of travel of fragments outside the structure by studying parts inside the structure.</i></p> <p>With regard to the three pieces of wreckage provided by Channel RT (see photo below):</p> <p>These pieces of wreckage came from the upper left side of the cockpit. Two of these pieces were received in Ukraine on 30 September 2015 and the last piece was received on 3 October 2015. On 8 October these three pieces arrived at Gilze-Rijen Air Base. The Dutch Safety Board has assessed these pieces in the same manner as all the other pieces of wreckage.</p> <p>The damage and damage pattern of these three pieces matched the damage and damage pattern of the pieces of wreckage already recovered.</p>

<p><i>Figure: The three pieces of wreckage provided by Channel RT, as presented (in reconstructed form) on 13 October 2015 (Source: Dutch Safety Board)</i></p> <p>2. For the response to the second argument of the Russian Federation regarding in this matter, reference is made to Appendix L of MH17 About the investigation report:</p>

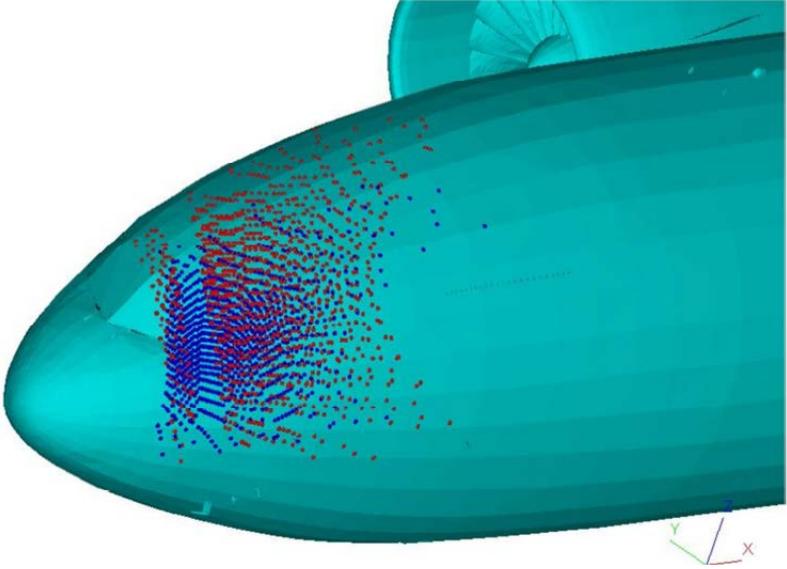
Russian Federation argumentation	Dutch Safety Board assessment
	<p>In section 5.4, pp. 22/25 - 23/25 of the TNO report (Appendix Y of the MH17 Crash report) it says:</p> <p><i>During the Investigation the possibility of a lighter warhead (lighter than 70 kg) was discussed. The hypothesis is that a match with the observed damage is found when a lighter warhead would detonate closer to the airplane. In consultation with the DSB a simulation was set-up whereby a 40 kg warhead detonates within 1.5 m from the airplane.</i></p> <p><i>Detailed results are included in Appendix B. Three different 40 kg warhead designs (A, B, and C) with two possible terminal velocities each (500 m/s and 800 m/s) have been considered. The main difference between the designs is the range of possible fragment ejection angles (design C has the largest range). A partial match is found with design C, which moves at 500 m/s. The other designs do not match because of non-compliance with the set conditions (see Section 5.2). Figure 5.8 illustrates the differences between the best fitting 70 kg and best fitting 40 kg warhead. The 70 kg match is better.</i></p>

<p><i>Figure 5.8: Red: fragment impacts for "best match" warhead design II (70 kg 9N314M). Blue: fragment impacts for "best match" warhead design C (hypothetical 40 kg). Design C results in a less fitting match.</i></p> <p><i>Design C is extreme, in the sense that the angular range of the fragment ejection is made as large as physically possible. Only with an extreme angular range it proves possible to remotely approximate the observed damage pattern.</i></p> <p><i>The damage pattern of a lighter warhead closer to the airplane does not resemble the damage pattern of a heavier warhead further away from the airplane. Therefore, TNO judges the hypothesis that a lighter warhead can cause the observed damage as being improbable.</i></p>
