Asphyxiated after entering cargo hold

Hudsonborg - North Sea, 12 March 2014

The Hague, May 2015

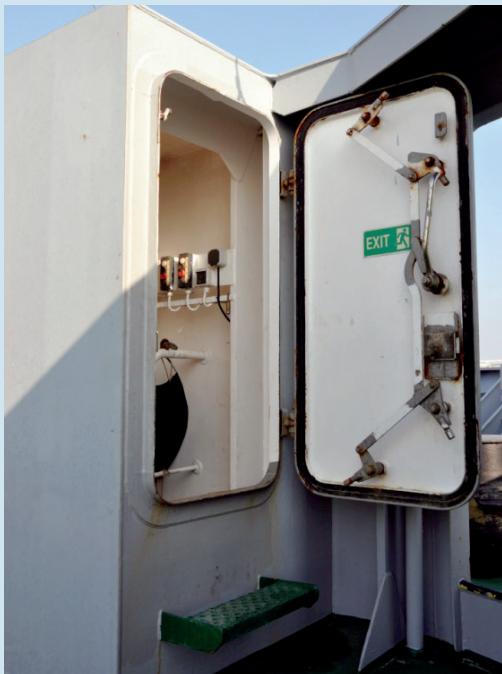
Figure 2: Entrance from the outer deck on the forecastle to the stairwell leading to the hold. (Source: Dutch Safety Board)

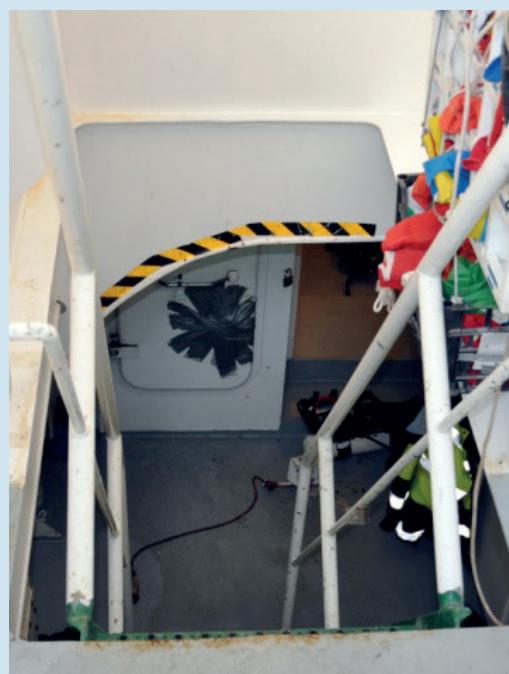
Figure 3: Access stairway to the forecastle and access door to the stairwell leading to the hold. (Source: Dutch Safety Board)

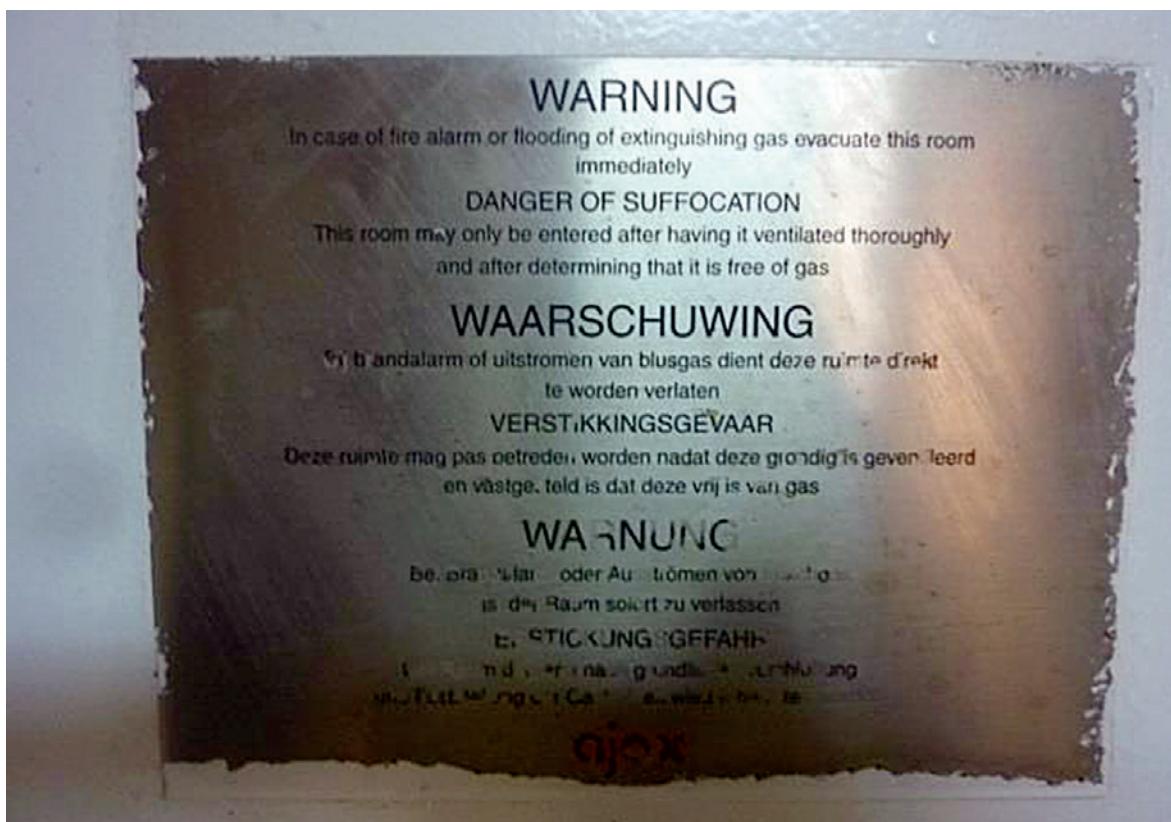
Figure 4: Warning on the access doors to the stairwell. (Source: Ameyde Marine)

- The access doors to the stairwells leading to the hold displayed warnings highlighting that the door provided entry to an enclosed space. These warnings were prominently placed and could not be overlooked. The first mate, one of the senior officers on board, failed to take adequate measures irrespective of the warnings, or had not been motivated to do so.
- The first mate was not supervised when executing his daily activities.
