# SHUNTER UNDER RAKE OF WAGONS

*IN ROTTERDAM WAALHAVEN ON 20 AUGUST 1999*

# **COUNCIL FOR TRANSPORT SAFETY**

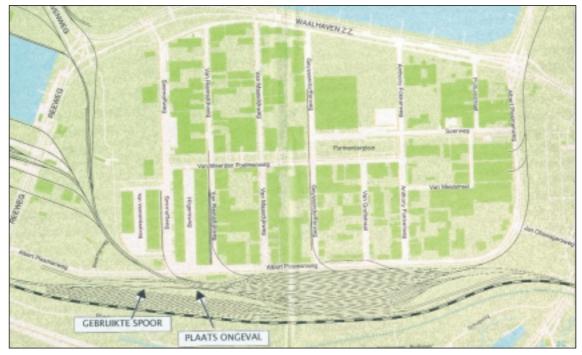
Fig. 2. Waalhaven marshalling yard with connection tracks to companies. On dead-end tracks, push-shunting is unavoidable.

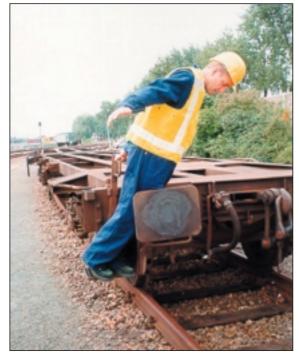
Afb. 6 Shunter falls over buffer

The radio-controlled train driver braced himself. He succeeded in absorbing the shock, by pushing against the buffer, with his foot. The shunter was less fortunate. Due to the forwards force exercised on his body, he was unable to remain standing. It is assumed that he rotated inwards around the point of contact at his left hand. The buffers prevented his legs rotating with his upper body, which continued to rotate over the buffer, and the shunter fell between the two buffers, onto the ground between the rails. By this time, the rake of wagons had not halted. The wagon drove over the shunter. He suffered a skull fracture, a head wound, his foot was driven over, and he received a severe arm injury.

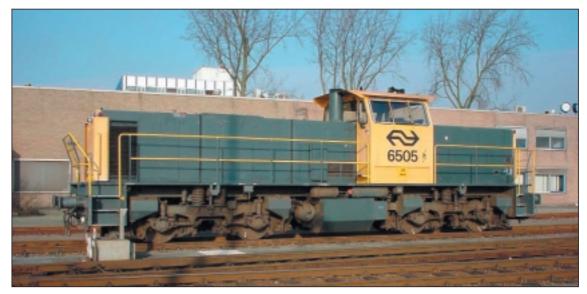
Fig. 7 The locomotive remotely controlled by radio signals, operated by Railion. In the background the office building, containing the traffic control post.

The locomotive type 6400 is a modern locomotive with good fall protection in the form of handrails, which provide support at the correct height. The statutory regulations for fall protection are exclusively linked to fall height, and not the fall hazard. For shunting, the statutory regulations for fall protection are therefore not applicable, because the fall height is too low. During push-shunting, whereby the shunter stands on the footboard of a freight wagon, this form of protection is entirely absent. In current practice, push-shunting unavoidably represents a considerable proportion of the total. Shunter and radio-controlled train driver have only one hand available, with which to
