DUTCH
SAFETY BOARD

Collision during pushback

The Hague, March 2022

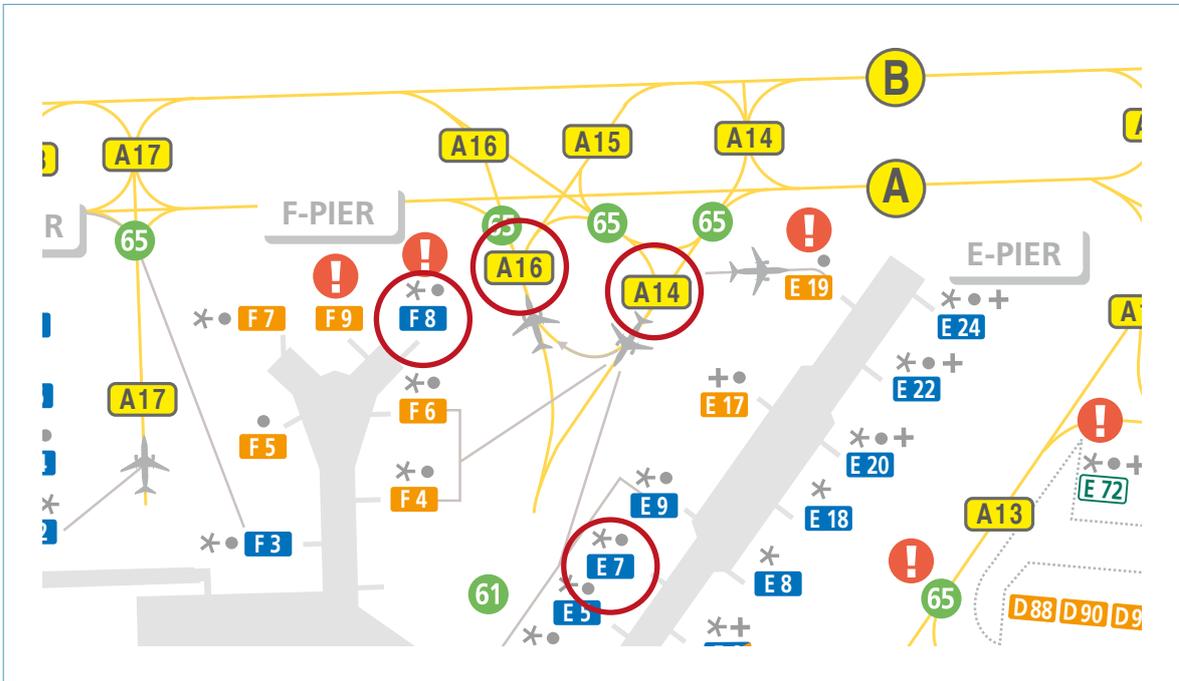
The accident occurred in the northern area of the airport, in the EF-bay which is connected to taxiway A. Amsterdam Airport Schiphol has standard pushback procedures in the form of a general standard pushback directions chart⁷, and procedures per stand. The standard pushback directions chart for taxiways A16 and A14, as applicable at the time of the accident, are depicted in Figure 4.

Figure 4: Standard pushback directions (blue=right; orange=left; *=remarks apply). Red circles for F8, E7, A14 and A16 added. (Source: Amsterdam Airport Schiphol)

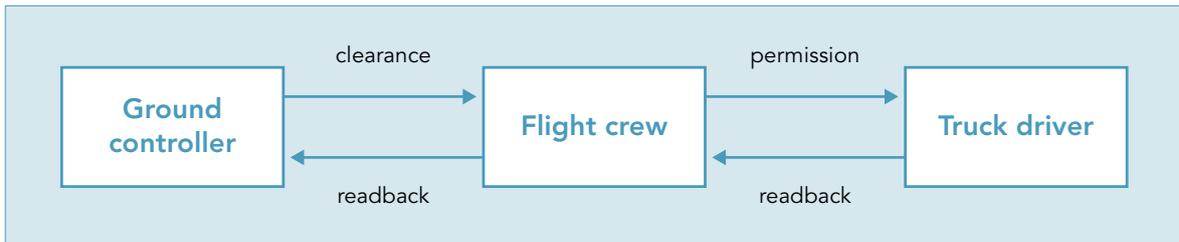
The pushback process starts at the instant the flight crew receives the pushback clearance from Ground Control. The flight crew passes the clearance to the pushback truck driver, see figure 7. The pushback truck driver has to wait the authorization of the flight crew before moving the aircraft.

Figure 7: Communication schematic Pushback clearance.
