Breaking of mooring lines whilst mooring  
m.v. Edisongracht between two mooring buoys  
in the port of Soyo, Angola, 1 April 2010

The Hague, May 2011

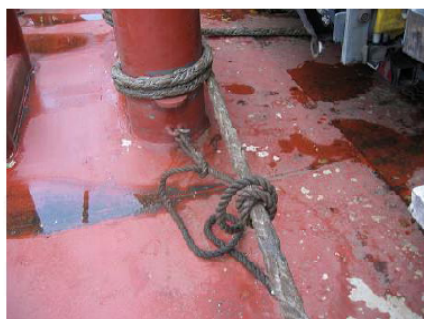
- ✓ For preference, do not just belay a rope by using figures-of-eight: instead first hitch it twice around the lower side of the bollard (see picture)
- ✓ Using a winch to handle ropes and warps should never be done by one single person.
- ✓ Level out stress on ropes as much as possible
- ✓ Be aware of the different elasticity of the various materials
- ✗ Do not leave stoppers attached to rope after use (see picture)

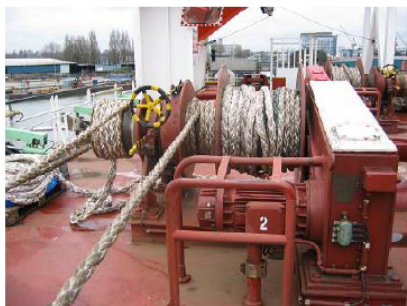
- ✗ Avoid too many turns on the drum (picture)
- ✗ Steel cables must not be belayed on top of ropes.
- ✗ When using 'split drum' never allow a double layer on the working part to avoid fouling and/or trapping/damaging ropes.

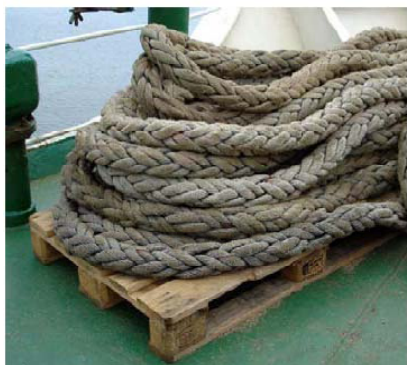
- ✓ After use, ropes should be stored clear of the deck (picture)
