DUTCH
SAFETY BOARD

Pitch-up Upsets due to ILS False Glide Slope

The Hague, June 2014

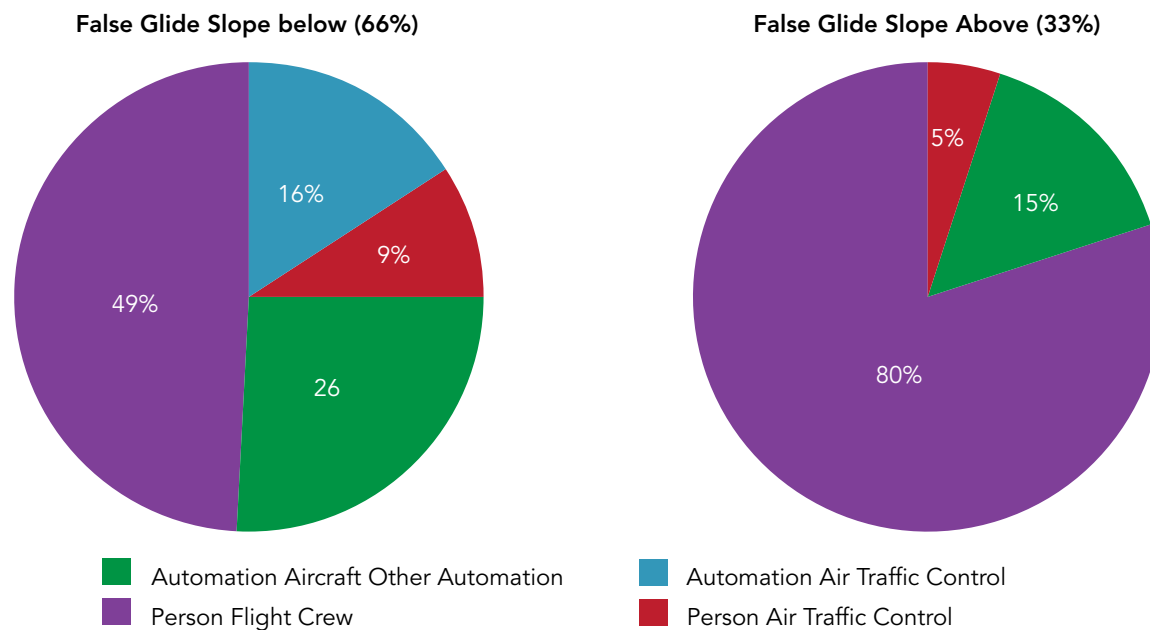
Figures 1 and 2: Division of False Glide Slope below and above Glide Path events.

The data showed that in 66% of the cases the False Glide Slope event was characterised as occurring 'Below' the Glide Path. The 'Below' Glide Slope events are characterised as descents prior to the 'published' Final Approach Fix. In general from the reported occurrences the crew noticed either a high descent rate, a low altitude alert by ATC or a combination of the two. In approximately 50% of the cases the event was detected by the flight crew and 25% by ATC (automatically – low altitude warning or in person).

In 33% of the cases the False Glide Slope event was characterised as occurring 'Above' the Glide Path with a pitch-up to a varying pitch attitude. These 'Above' events were detected by the crew in 80% of the cases and in 15% by the automation (loss of signal).

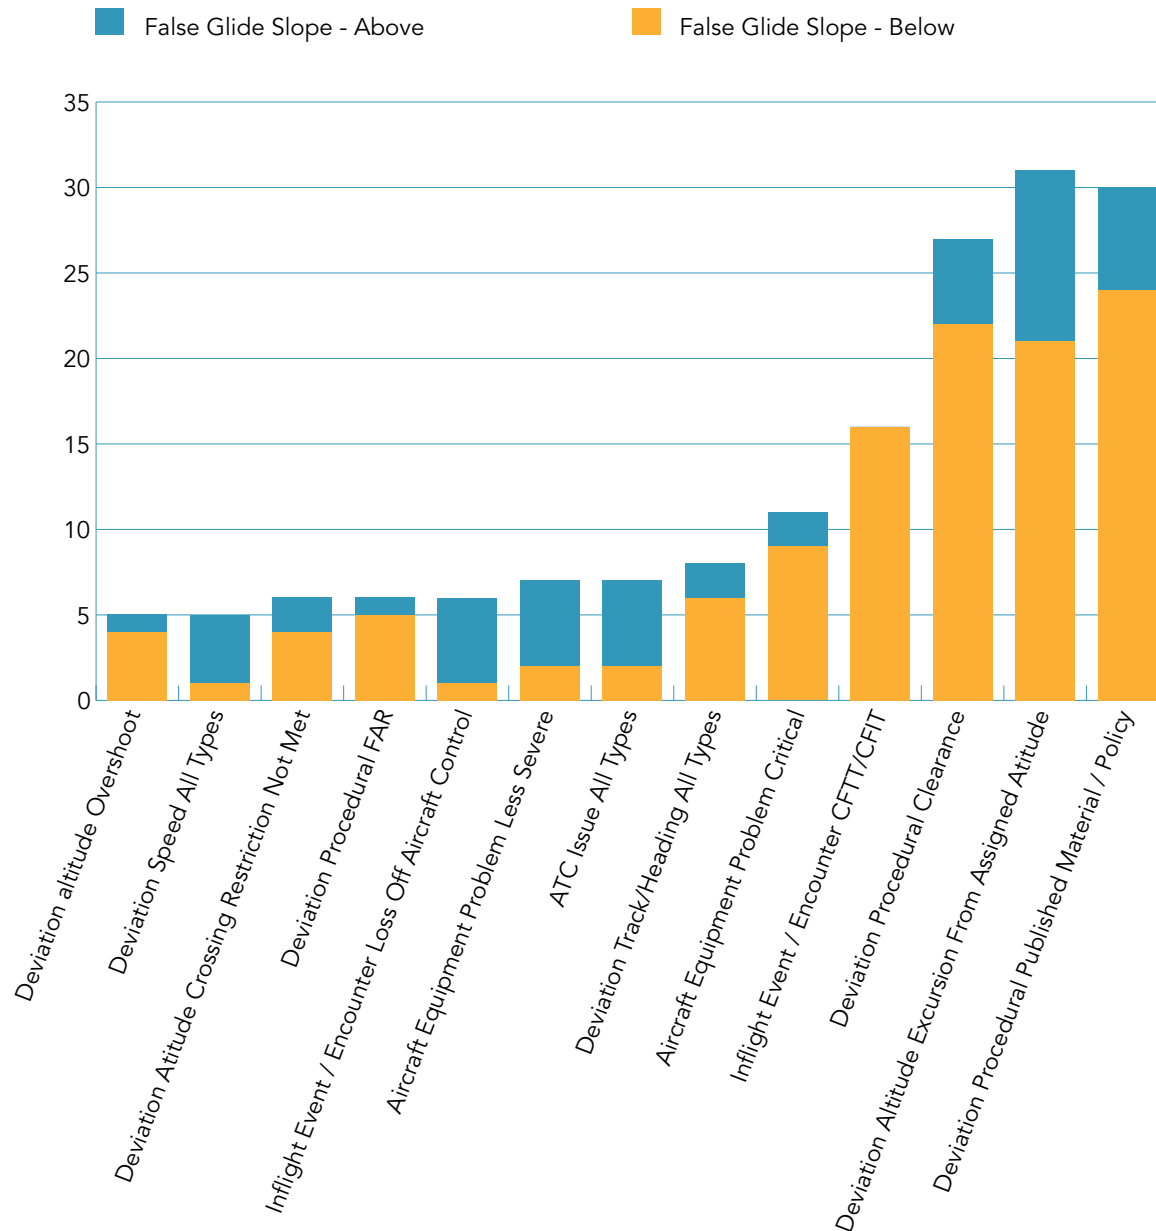
Figure 3: Overview of False Glide Slope event anomalies.

The classification labels for the anomaly focus on deviations in 'procedural published material', 'assigned altitude' and 'procedural clearance'. With respect to aircraft equipment the False Glide Slope anomaly is classified in 11 instances (9 Below and 2 Above) as Aircraft Equipment Problem Critical. In 7 instances the problem is classified as Aircraft Equipment Problem Less Severe (2 Below and 5 Above). Furthermore in 6 instances the event was classified as an In-flight Event / Encounter Loss of Aircraft Control (1 Below and 5 Above).

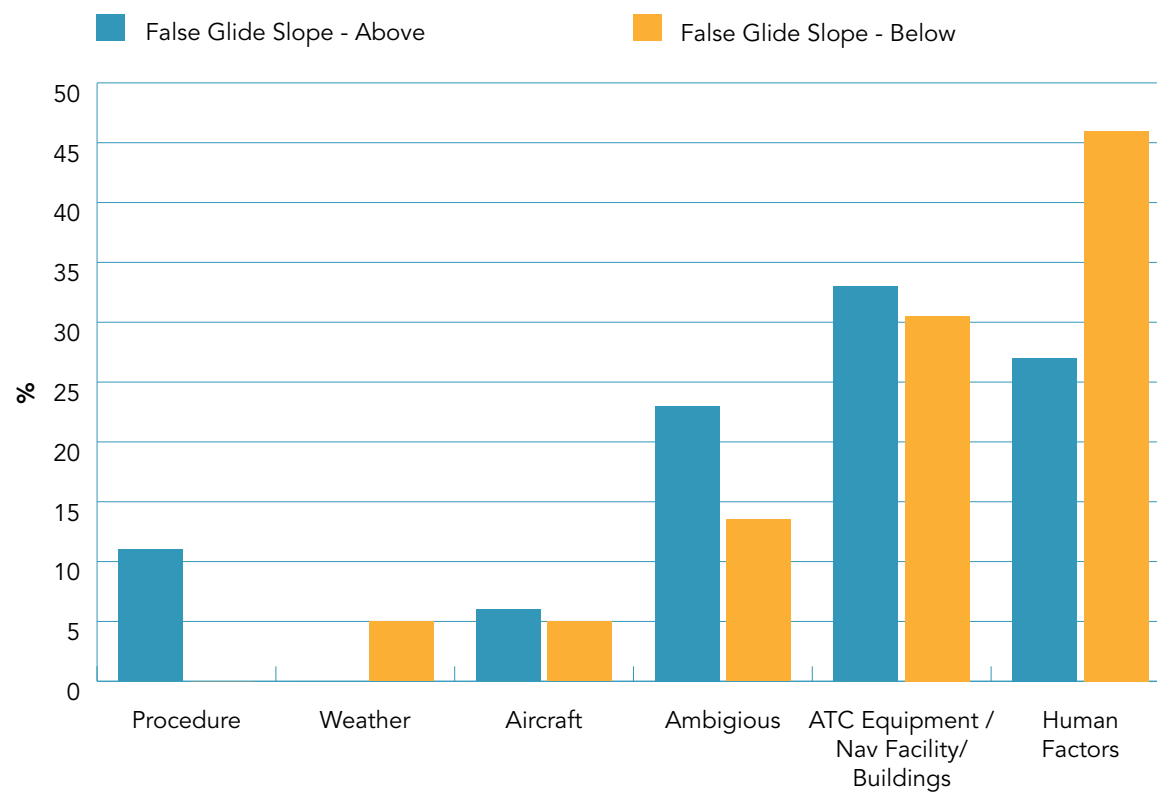
Figure 4: Overview of False Glide Slope assessments as primary problem.

The assessment of the primary problem adjusted for percentages shows that Human Factors (45% Below and 27% Above) have a large contribution. Additionally, ATC equipment is assessed as the primary problem for 30% of False Glide Slope events.

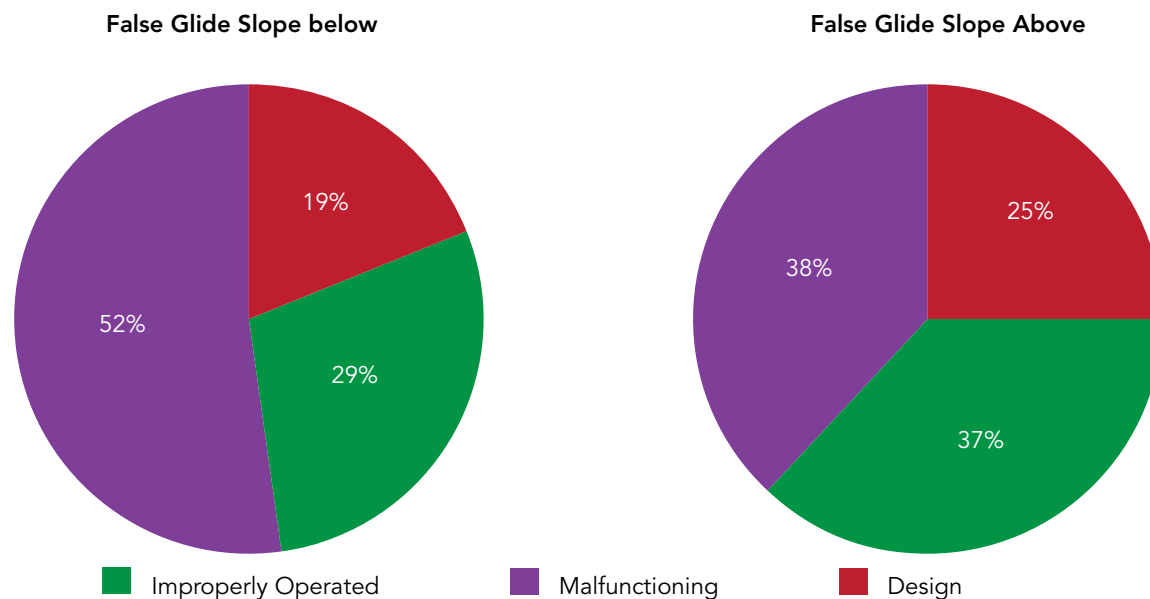
Figures 5 and 6: Division of False Glide Slope below and above Glide Path as component problem.

In 25 cases a component problem was inserted into the database as a contributing factor. The three descriptions in the database for the component problem were: Design, Improperly operated or Malfunction. For the Glide Slope 'Above' events the contribution is spread equally. The data show a larger percentage is attributed to Malfunction for Glide Slope 'Below' events, but due to the smaller number of events this is not considered significant.

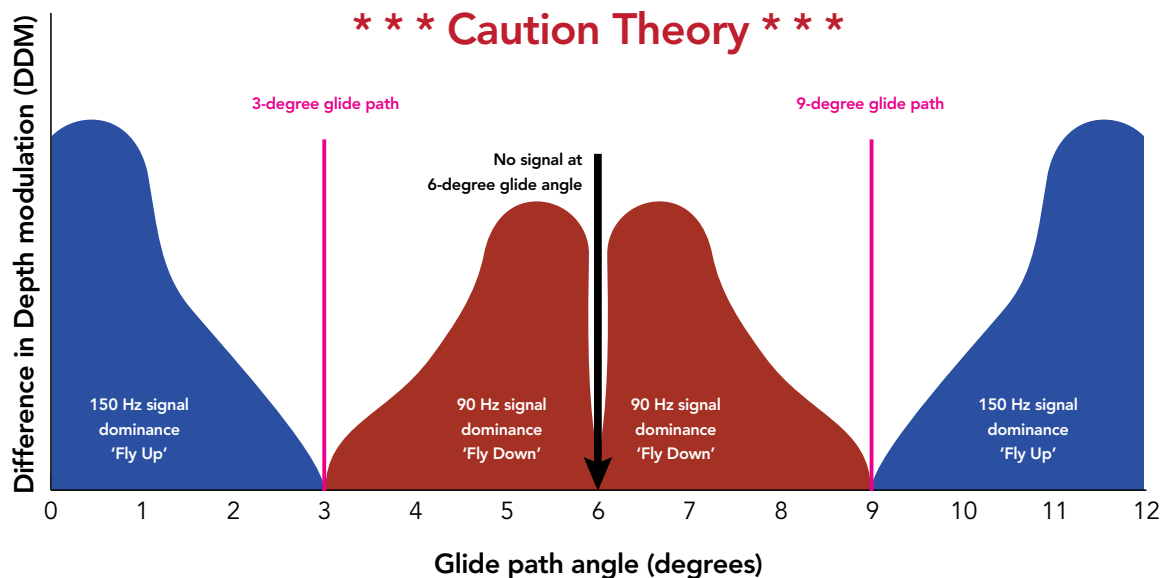
Figure 12: Theoretical plot of the M-array type radiation pattern (90 Hz and 150 Hz) resulting in a 'Fly Up' and 'Fly Down' with the Glide Path angle depicted on the x-axis [0-12 degrees].

The M-array system has also been widely used since 1960 and is often referred to as the Capture Effect array. The M-array system uses a three-element array with the upper, middle and lower elements being driven with SBO signals, and the middle and lower elements both being driven with CSB signals. The upper and lower element SBO driving signals have the same amplitude and are out of phase, whilst the middle element SBO signal has twice the amplitude. The middle element CSB drive signal has amplitude and is in phase and the lower element CSB signal has twice the amplitude and is out of phase. The M-array Glide Slope field is a complex addition and subtraction of 90 Hz and 150 Hz signals, the result is shown in Figure 12.

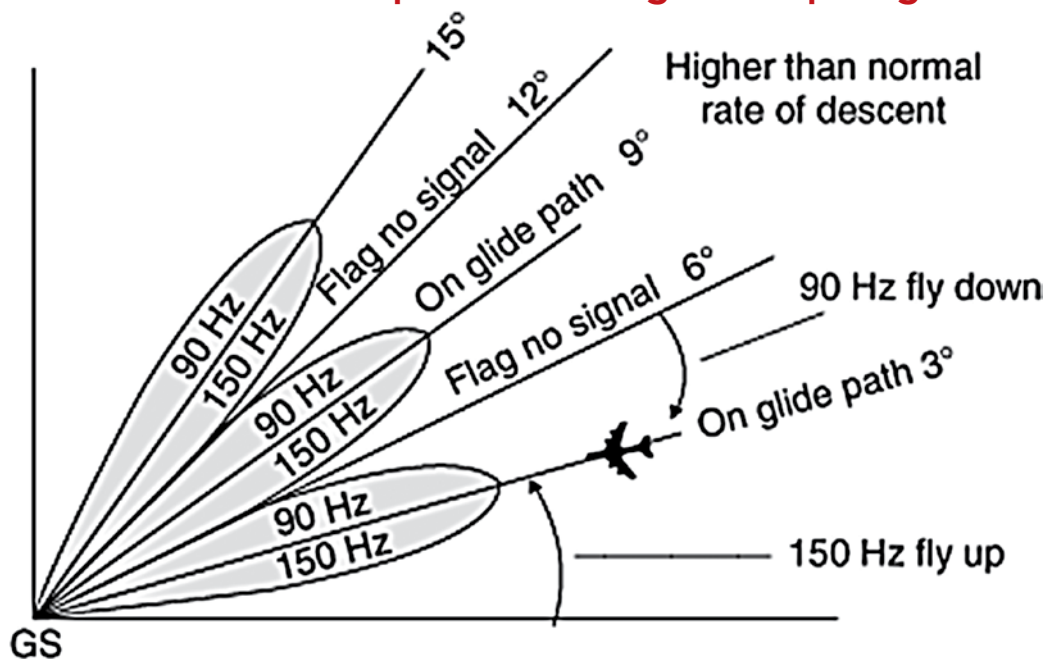
Figure 13: Depiction of the False Glide Slope as can be commonly found on the internet [source: <http://www.answers.com/topic/false-glide-slope> (McGraw-Hill Dictionary of Aviation: False Glide Slope)].

To get quick access to information related to a False Glide Slope, an internet search will show Figure 13. This picture shows that at a 6 degree Glide Slope a (warning) Flag will appear and at 9 degrees a False Glide Slope is present. This is a Glide Path with a higher than normal descent rate.

**** Caution: Incorrect representation glide slope signals ****
