DUTCH  
SAFETY BOARD

# Collision between a passenger train and a man lift at Dalfsen

*The Hague, December 2016*

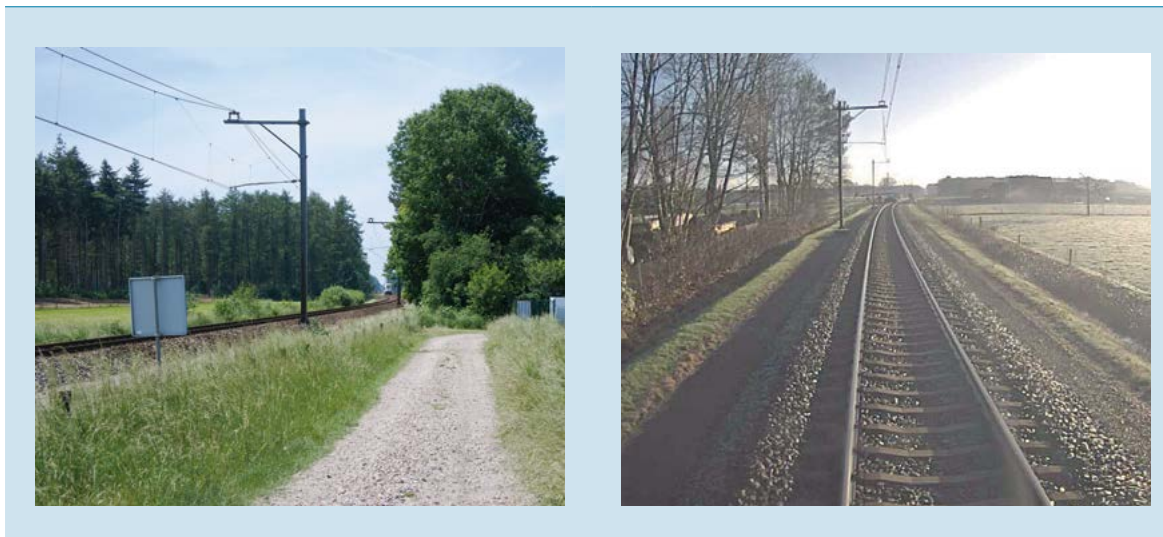
Figure 5: The photo on the left shows the view of the straight length of track beyond the curve, seen from the bend in the road on the north side of the level crossing. The photo was taken in June 2016. The photo on the right shows the view that the driver of the train in the accident had when entering the curve; the distance to the level crossing at that time was still approximately 150 metres. Photos: Dutch Safety Board (left), Arriva front camera (right)

Because of the curve in the track, the train driver only had a view of the level crossing when he had approached to within approximately 350 to 400 metres. The train driver, once he had a line of sight to the level crossing, had to look into the light while having driven in shade shortly before this. The sun was low and at one o'clock for the train driver (see the right-hand photo in figure 5).

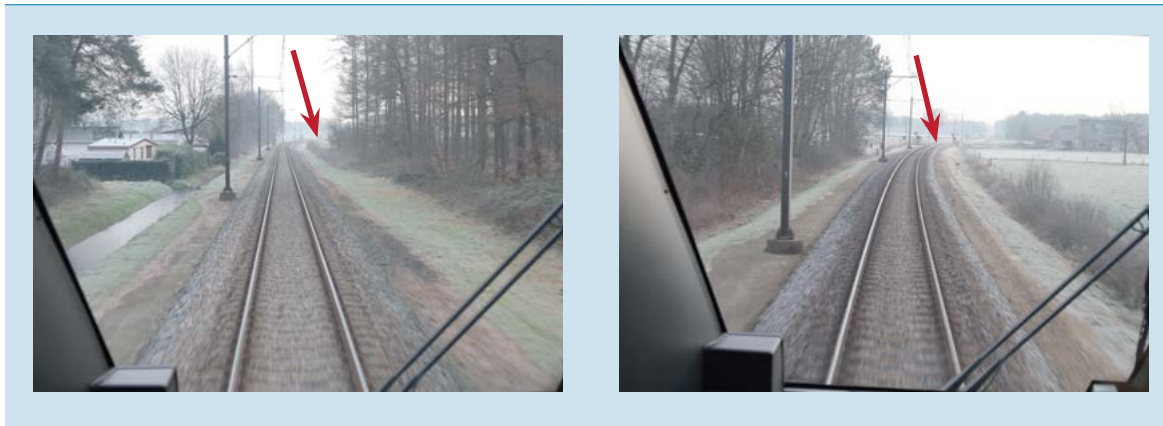
In the accident in Dalftsén, the train driver, because of the curve in the track, only gained sight of the level crossing when the train was approximately 350 metres away from it (see photo on the left in figure 13). The accident threat would not, however, have been immediately apparent when the train driver caught sight of the level crossing. This is because there is a curve in the intervening track section, as a result of which it was not, initially, perceptible that (part of) the man lift was still on the level crossing, and that it would probably not clear the level crossing in time. When that too had become reasonably perceptible, the distance from the train to the level crossing had already decreased to approximately 175 metres (see photo on the right in figure 13). The analysis of the trip data (see Appendix C1) reveals that the remaining distance was covered in four to five seconds. This means that the period available for an escape manoeuvre was less than the time reasonably required for it. In the accident in Dalftsén, the train driver did not have the opportunity to make a timely escape from his cab into the passenger compartment.

Figure 13: View from the cab on approaching the Het Lage Veld level crossing. The left-hand photo is the moment at which the level crossing becomes visible; the distance is a good 350 metres. The right-hand photo is the stage at which it was reasonably possible for the train driver to assess the situation on the level crossing (including any accident threat); the distance had then decreased to approximately 175 m. These pictures were recorded during a train journey on a similar train on 01 March 2016.<sup>21</sup> Photos: Police

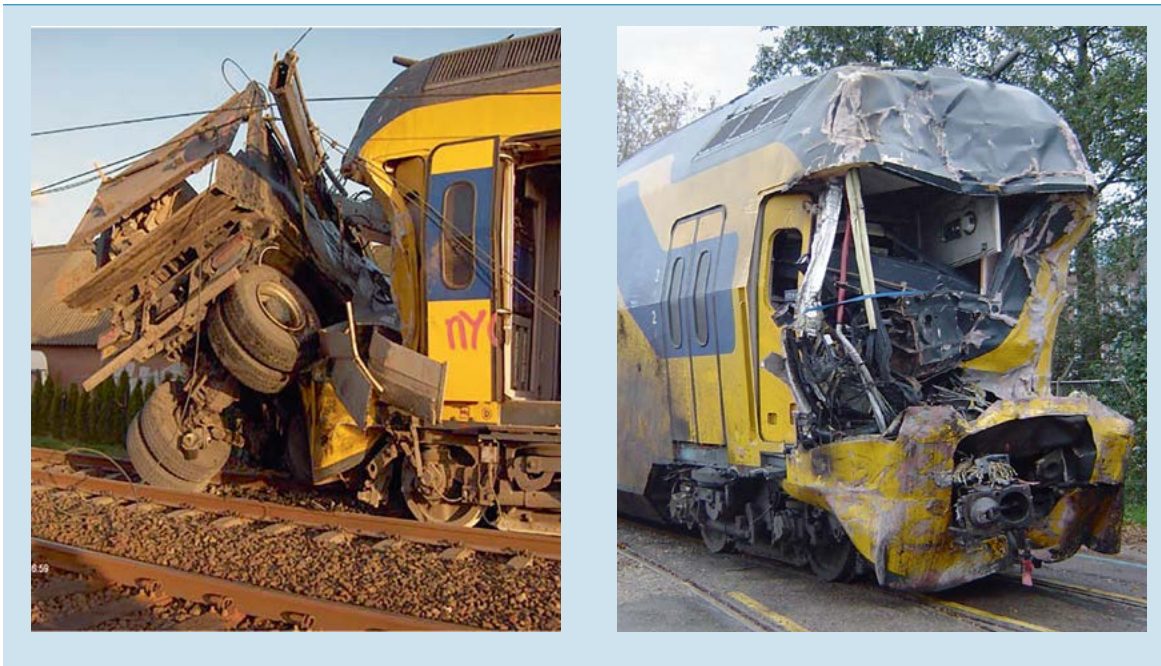
Figure 14: Wijhe (2005), train driver seriously injured as a result of level crossing collision with truck. Photos: IVW (left), Dutch Safety Board (right)

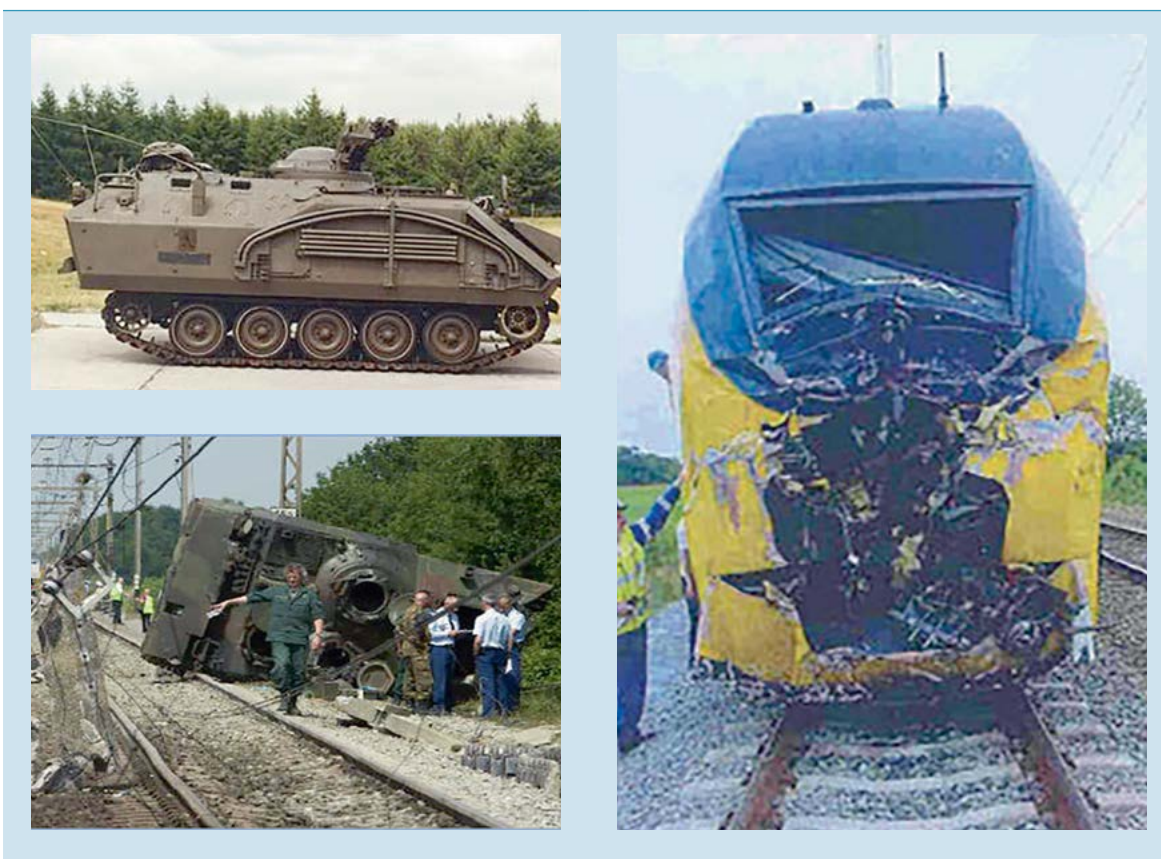
Figure 15: Assen (2003), driver of passenger train seriously injured as a result of level crossing collision with an armoured vehicle. Photos: TCOD-report "Botsing YPR met trein nabij Assen op 17 juni 2003"

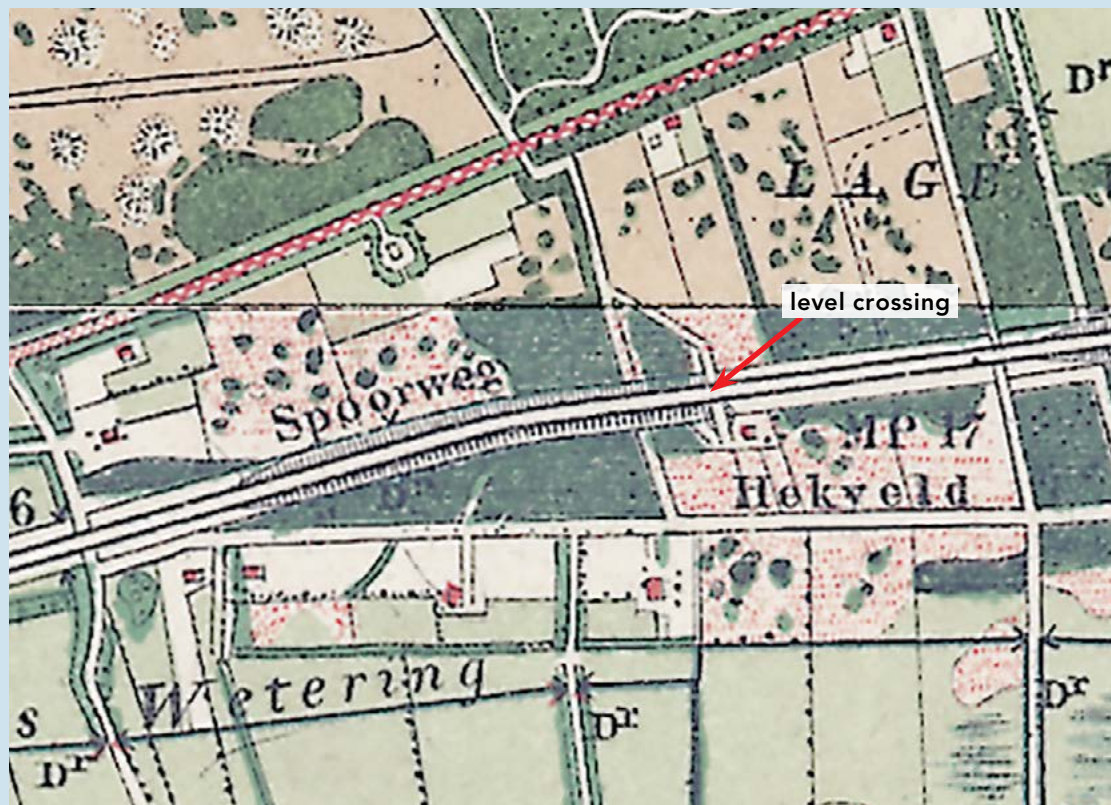
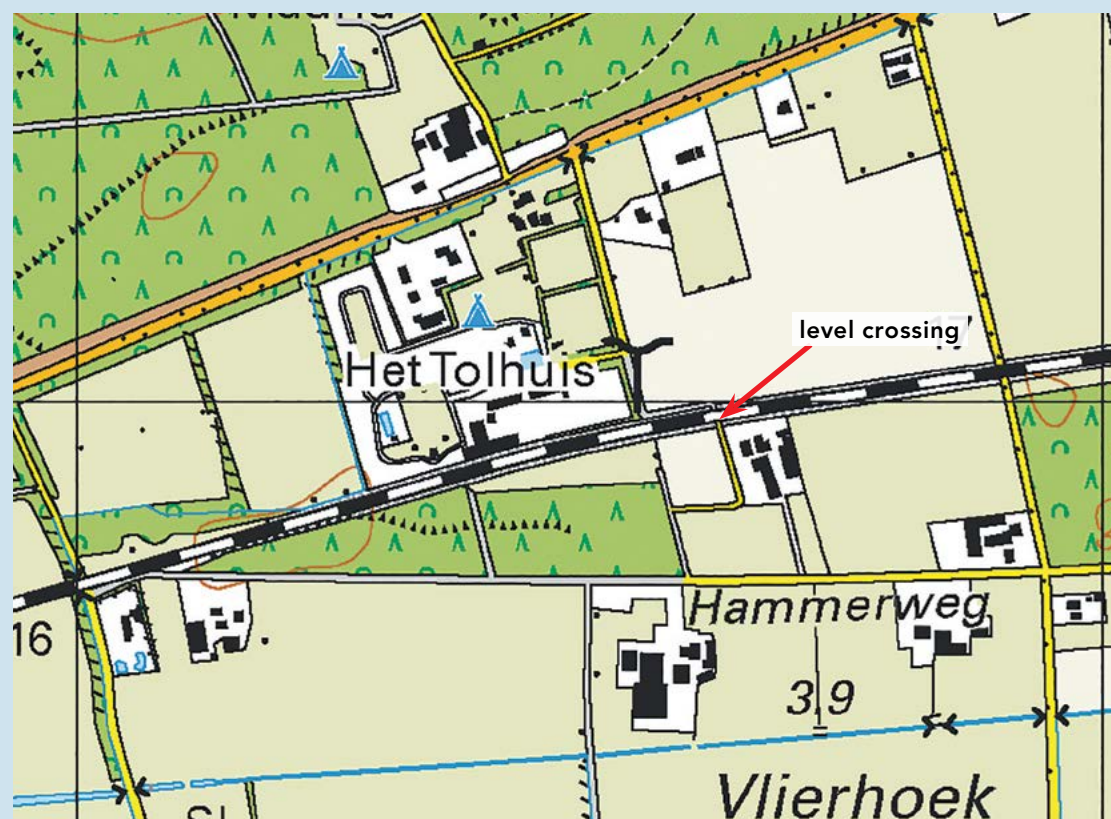
Historical maps show that the road ran straight on before the railway line was built; when the railway line was built (around 1900), the road situation changed and there is now a level crossing at the current location (figure 16). The situation of the road changed once again since then and this probably happened between 1910 and 1935. The road situation, which is not ideal by current standards because of the bend in the road shortly before the level crossing and the inability for low loaders to use the level crossing, was established long ago and has not changed substantially since then.

Figure 16: Het Lage Veld level crossing, maps dated 1908/1911 (upper) and map dated 2015 (lower). Source: Kadaster

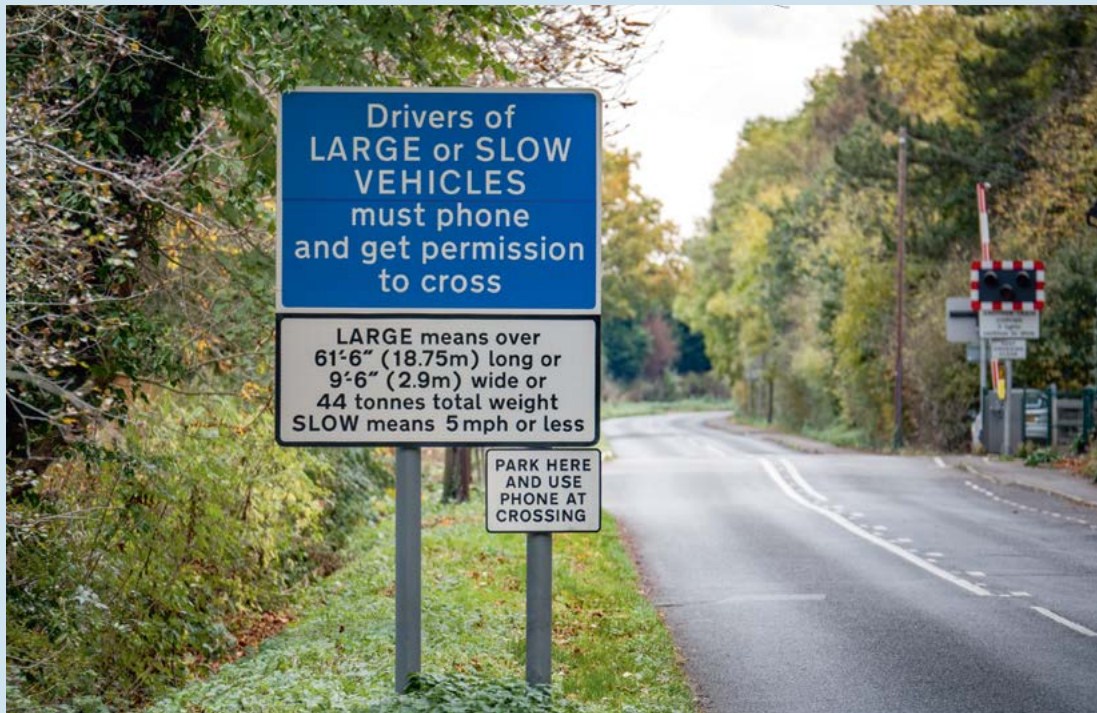
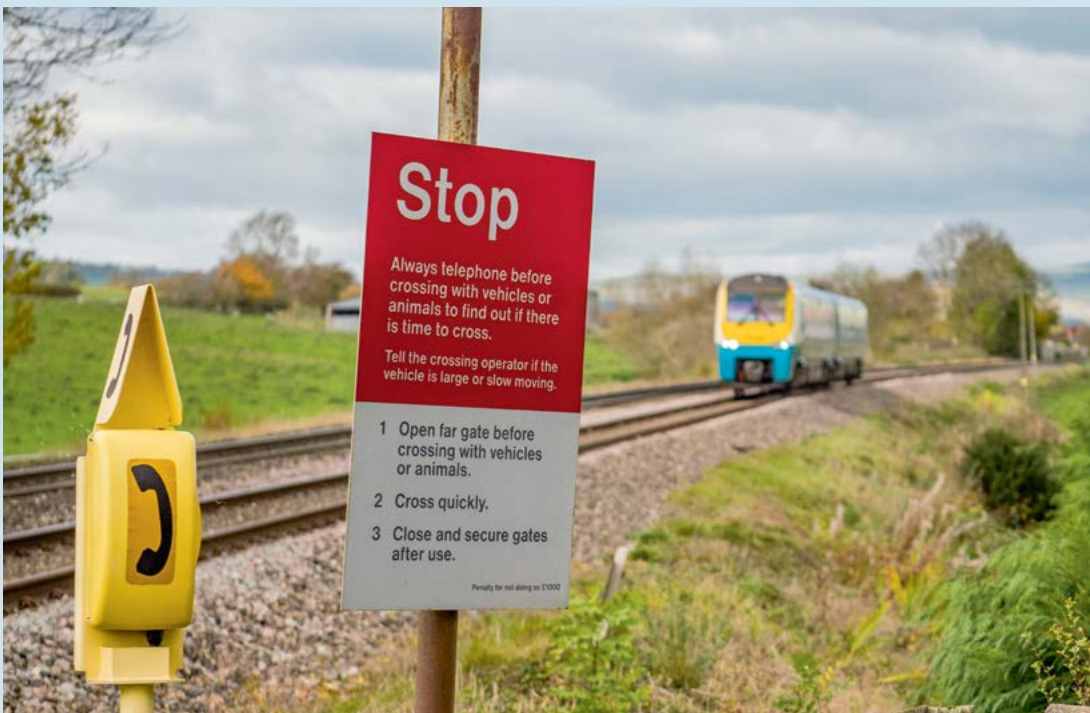
In the United Kingdom, level crossings with automatic half barriers have signs explicitly stating that drivers of heavy, long or slow vehicles must stop and request permission to cross the railway (figure 18). Apart from drivers being explicitly informed of circumstances in which crossing is hazardous, they are obliged to contact rail traffic control and are provided with the capability to do so.

Figure 18: United Kingdom: warning signs for drivers of heavy and slow vehicles with the capability to contact rail traffic control. Photos: Dutch Safety Board

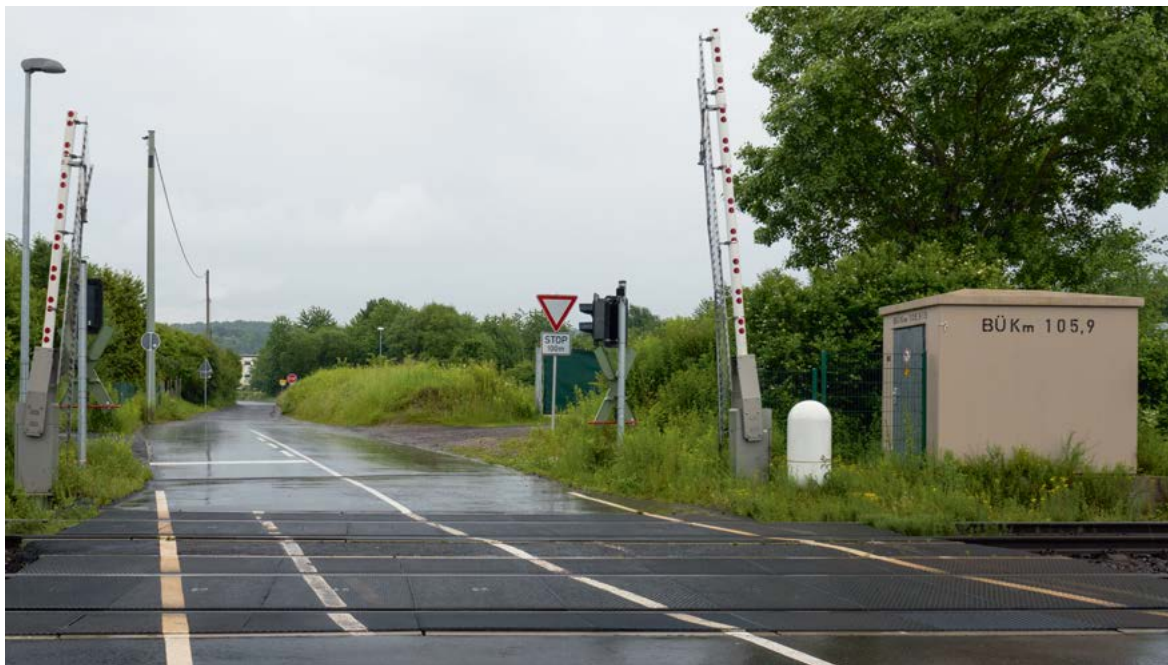
In Germany, obstacle detection is a requirement in certain cases, either visually by the level crossing operator or using technical aids such as mirrors, cameras and/or radar systems. Figure 19 shows an example of radar detection. In these cases, train traffic is only allowed onto the crossing after it has been confirmed that the crossing is actually clear. The level crossing must be closed and reported clear when the train is still approximately 1500 metres away if train traffic is not to be disrupted. This means longer waiting times for the road traffic than at level crossings with half barriers; the duration of the closure for a single train is approximately three minutes, compared to approximately one minute for half barriers.

Figure 19: Germany: level crossing with radar system that monitors whether or not the intersection is actually clear. Photo: Dutch Safety Board

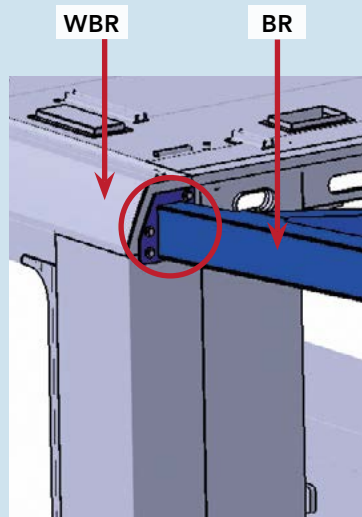
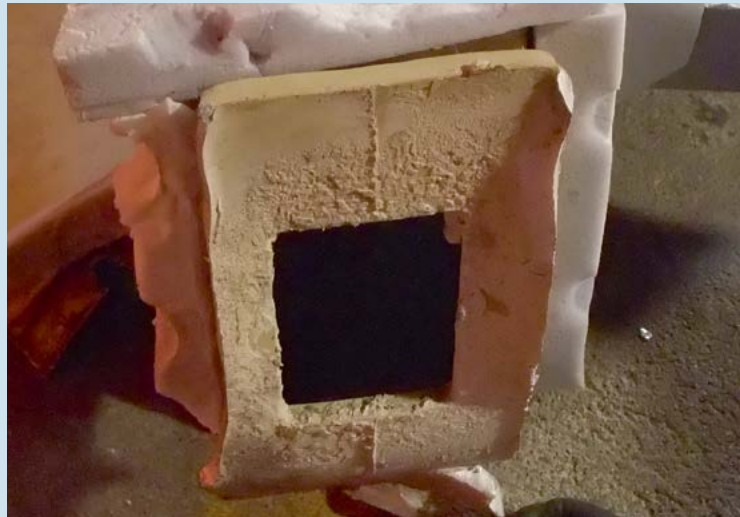
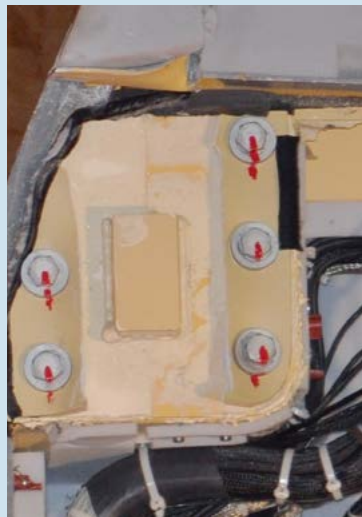
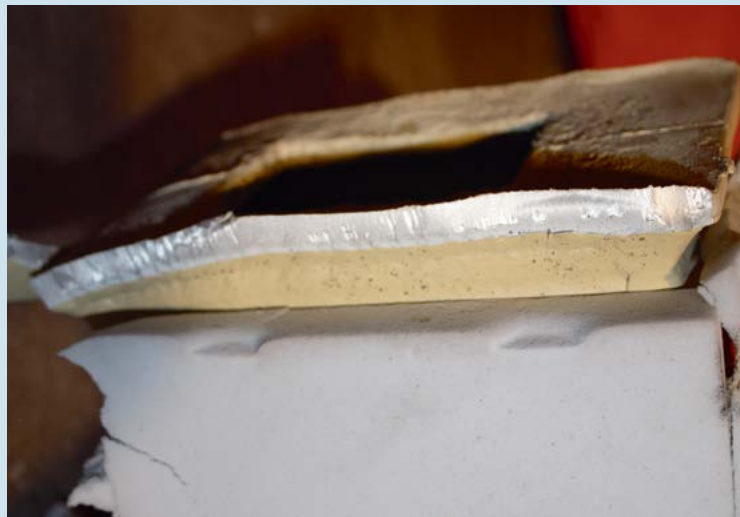
Figure 35: Assessment of the collapse of the left-hand carriage wall/top frame joint. Photos: Dekra Rail/Dutch Safety Board

Assessment:

- There are impact fractures that go through the base material (alongside the welds).
- There are deformations alongside the broken surfaces.

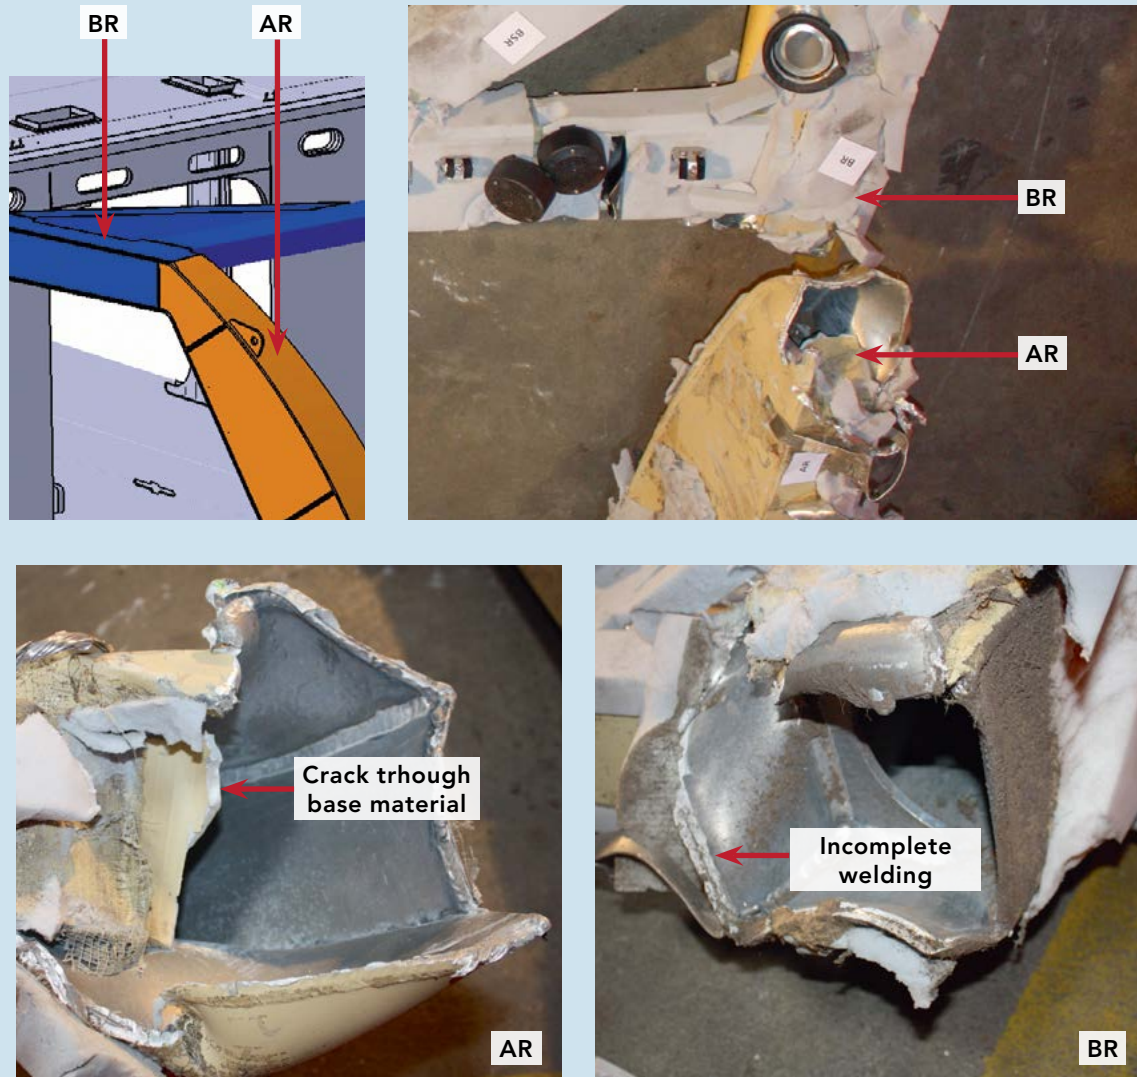
Figure 37: Assessment of the collapse of the left-hand top frame/frame pillar joint. Photos: Dekra Rail/Dutch Safety Board

**Assessment:**

- There are impact fractures that go partly through the base material and partly through the welds.
- There are deformations alongside the broken surfaces.
- The broken welds show incomplete penetration during welding, adhesion failures and porosity.

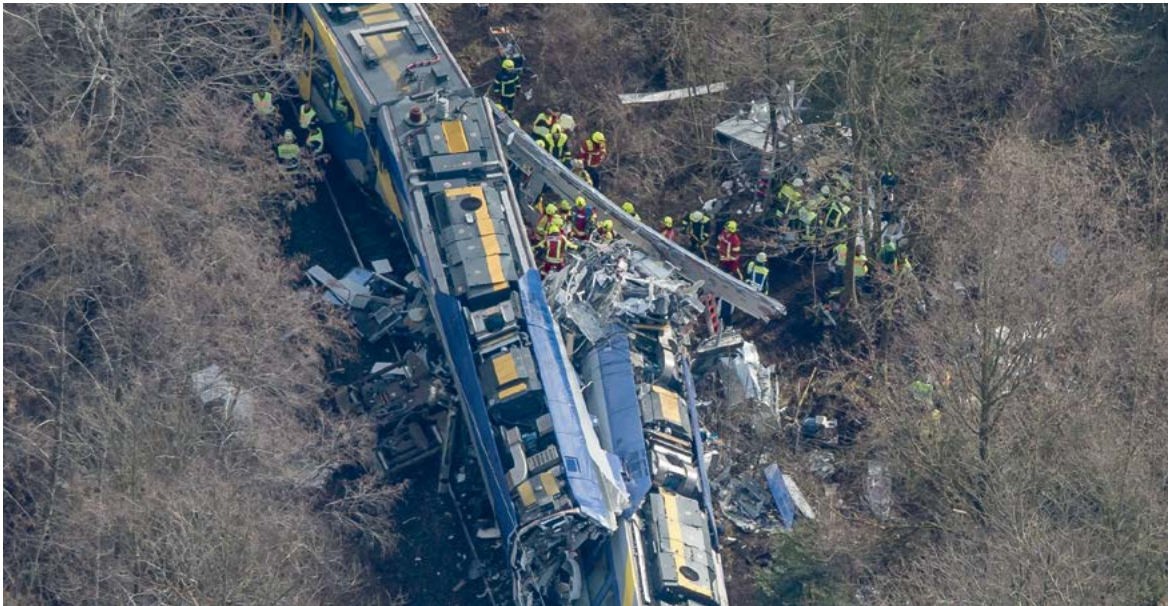
Figure 45: On 09 February 2016, two Stadler FLIRT-3 type trains were involved in a frontal collision at Bad Aibling (Germany). Photo: ANP

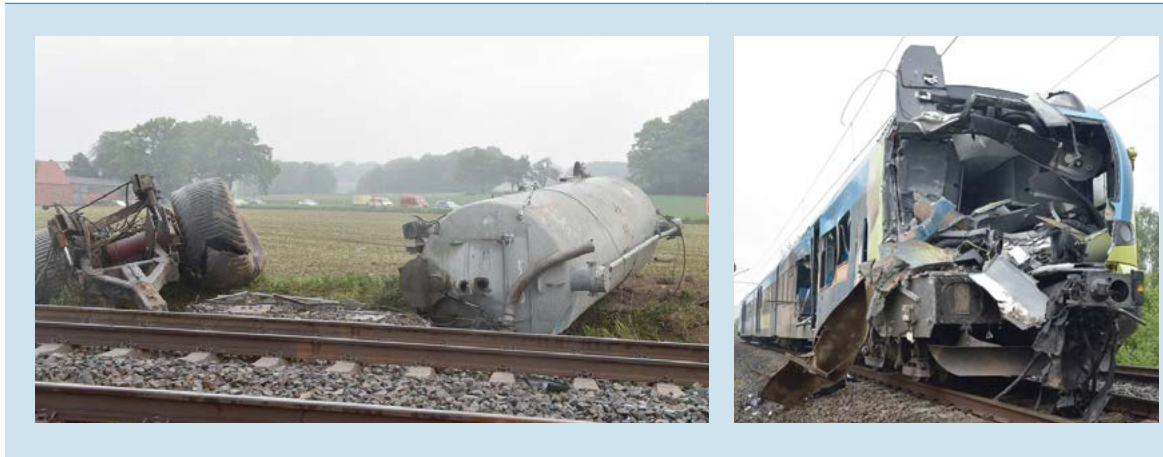
The train was of the FLIRT-1 type, a type which does not have a crash structure in the cab and which does not yet comply with the crashworthiness requirements in EN-15227. The agricultural vehicle involved in the collision was a manure spreader hitched to a tractor, but it broke free while crossing the level crossing and was left behind.

Figure 46: On 16 May 2015, a train of the Stadler FLIRT-1 type collided with a manure spreader that was stranded on a level crossing at Ibbenbüren (Germany). These photos show the end situation. Photos: Tobias Vieth, ivz-aktuell.de

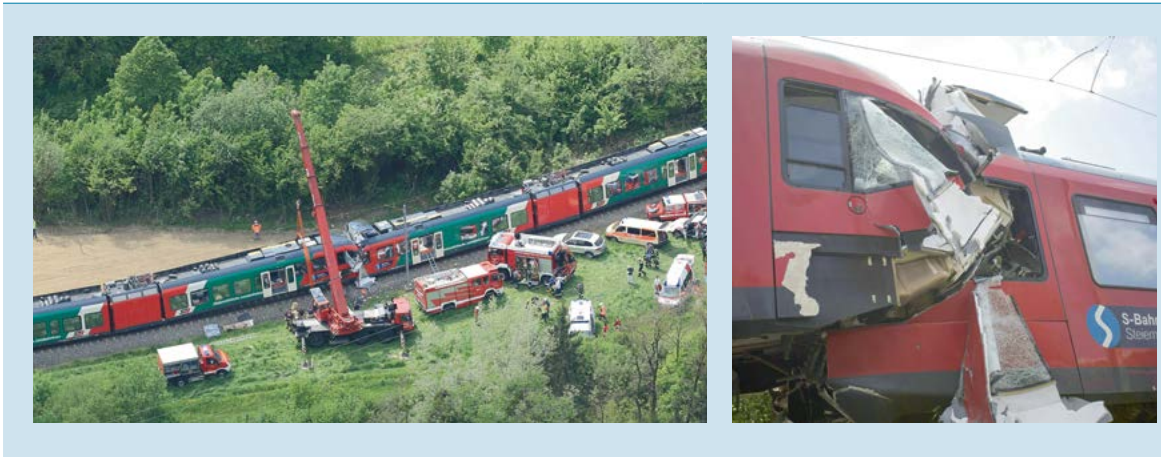
Both trains were of the same type as the train involved in the accident in Dalfsen (Stadler GTW). Both trains were also from the series where the crash frames have weld defects.

Figure 47: On 06 May 2015, two Stadler GTW type trains were involved in a frontal collision at Übelbach (Austria). Photos: ANP

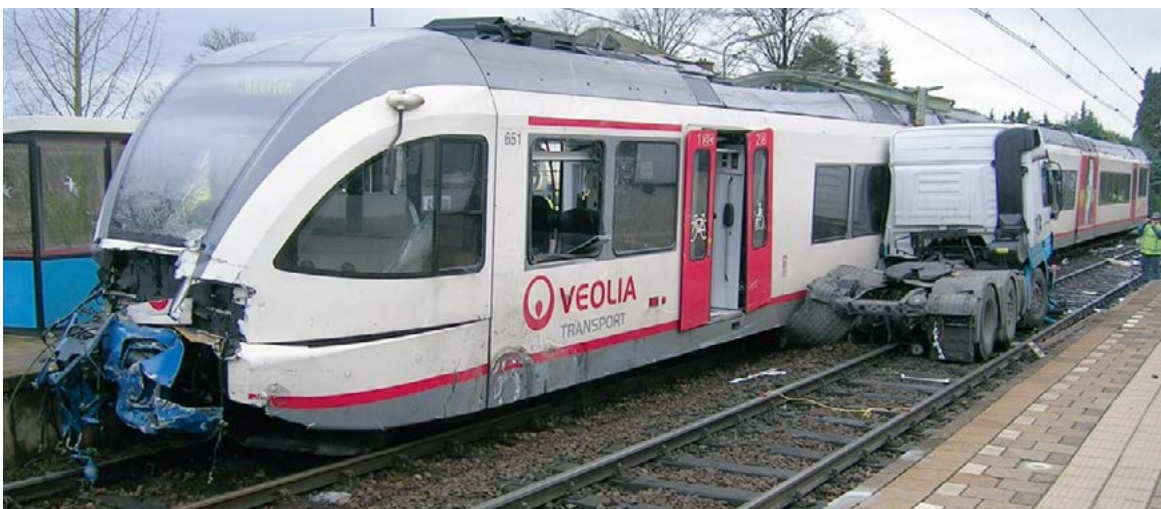
The front of the train was damaged, but the cab remained intact. A driver and a driver under instruction were in the driver's cab; both were able to escape from the cab into the adjoining passenger compartment prior to the actual collision.

Figure 48: On 08 December 2009, a train of the Stadler GTW type collided with a truck on a level crossing in Houthem (the Netherlands). These photos show the end situation. Photo: Veolia Transport Limburg/ René Hameleers

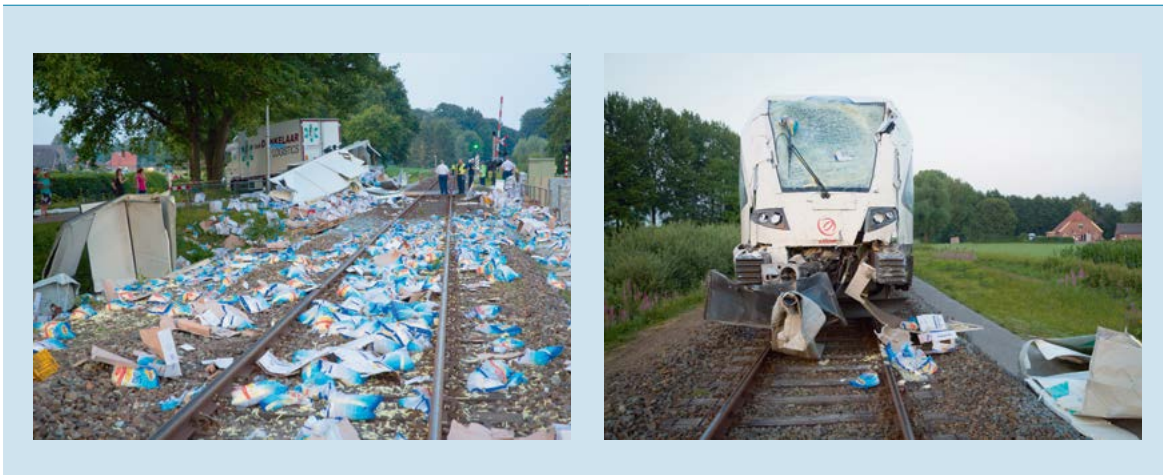
The train was of the same type as the train involved in the accident in Dalfsen (Stadler GTW). It was also from the series where the crash frames have weld defects. The truck, a box-body with trailer, became stranded while crossing the level crossing. The train crashed into the side of the trailer, which was laden. The train's collision speed was approximately 80 km/hour. The collision totally destroyed the trailer and the front of the train was damaged. The driver's cab remained intact.

Figure 49: On 16 July 2014, a train of the Stadler GTW type collided with a truck on a level crossing in Ruurlo (the Netherlands). Photos: Stefan Verkerk
