DUTCH  
SAFETY BOARD

# Quarterly Aviation Report

January - March 2017

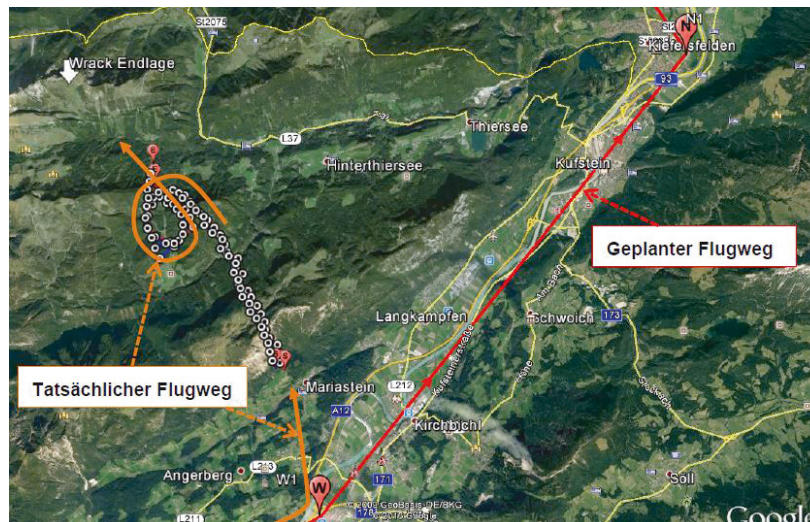
Near Wörgl the aeroplane departed from the original plan, turning directly left towards Munich, and began a descent. During this descent the aeroplane made a 360 degree turn to the left. During this phase of the flight the altitude dropped from 7,800 to 5,600 feet. There are no radar images available from the portion of the flight after this latter altitude was reached. Around three kilometres further on, at an altitude of 5,100 feet, the aeroplane collided with a mountain with the fuselage more or less parallel to the rising terrain and the wings in a horizontal position.

*The planned and the actual flight path of PH-RCV. (Source: VERSA)*

Based on the radar data and radio traffic that was examined it was concluded that the captain had misjudged his position. In the radio traffic with Munich Info he had said that he was 8,000 feet above Kufstein, while he was actually just north of Wörgl, approximately seven to ten kilometres southwest of Kufstein. Because of the deteriorating weather conditions, the captain no longer had any ground visibility and it was impossible to navigate visually.

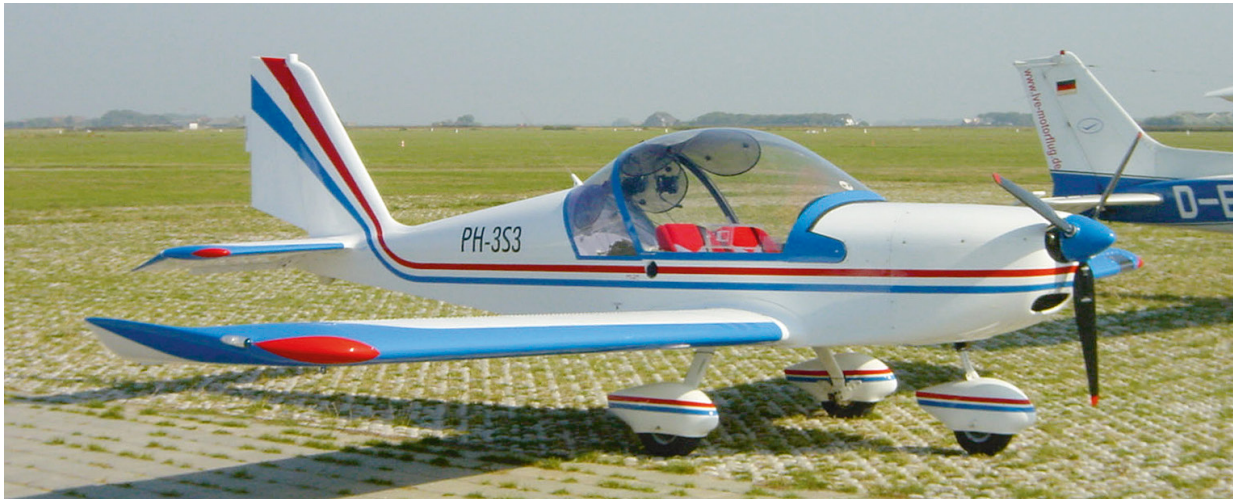
Archive photo of PH-3S3. (Photo: Texel Airport)

The investigation shows that the engine had worked properly during the flight. Post-mortems on the two pilots failed to find any physical disorders that could have affected their performance during the flight. The most likely explanation of the accident is that the crew lost control of the aeroplane while flying above a layer of clouds.

Shortly before the loss of control the aeroplane performed a manoeuvre to avoid high tops of clouds, and probably ended up in worse weather conditions. It is likely that spatial disorientation occurred because of the limited visibility outside. The speed of the aeroplane increased above the maximum speed, as a result of which the structure of the aeroplane failed.

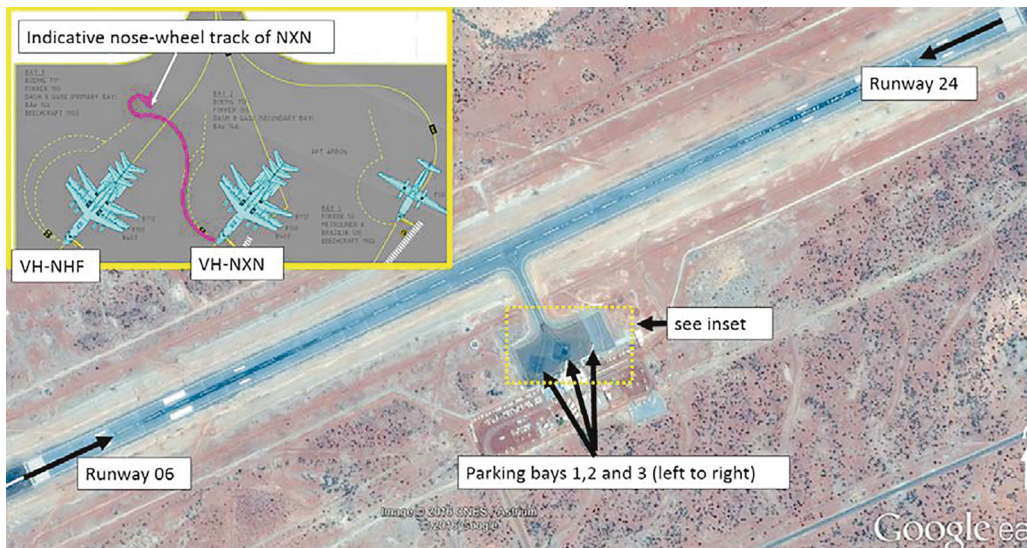
- The maintenance engineer who was working on the parked Fokker 100 was unable to communicate verbally with the cockpit crew of the Boeing 717. This is what led to the cockpit crew of the Boeing 717 interpreting the maintenance engineer's thumbs up signal as a signal that the Boeing 717 was clear to continue taxiing.

The layout of Paraburdoo Airport and the route followed by the Boeing 717. (Photo: ATSB)

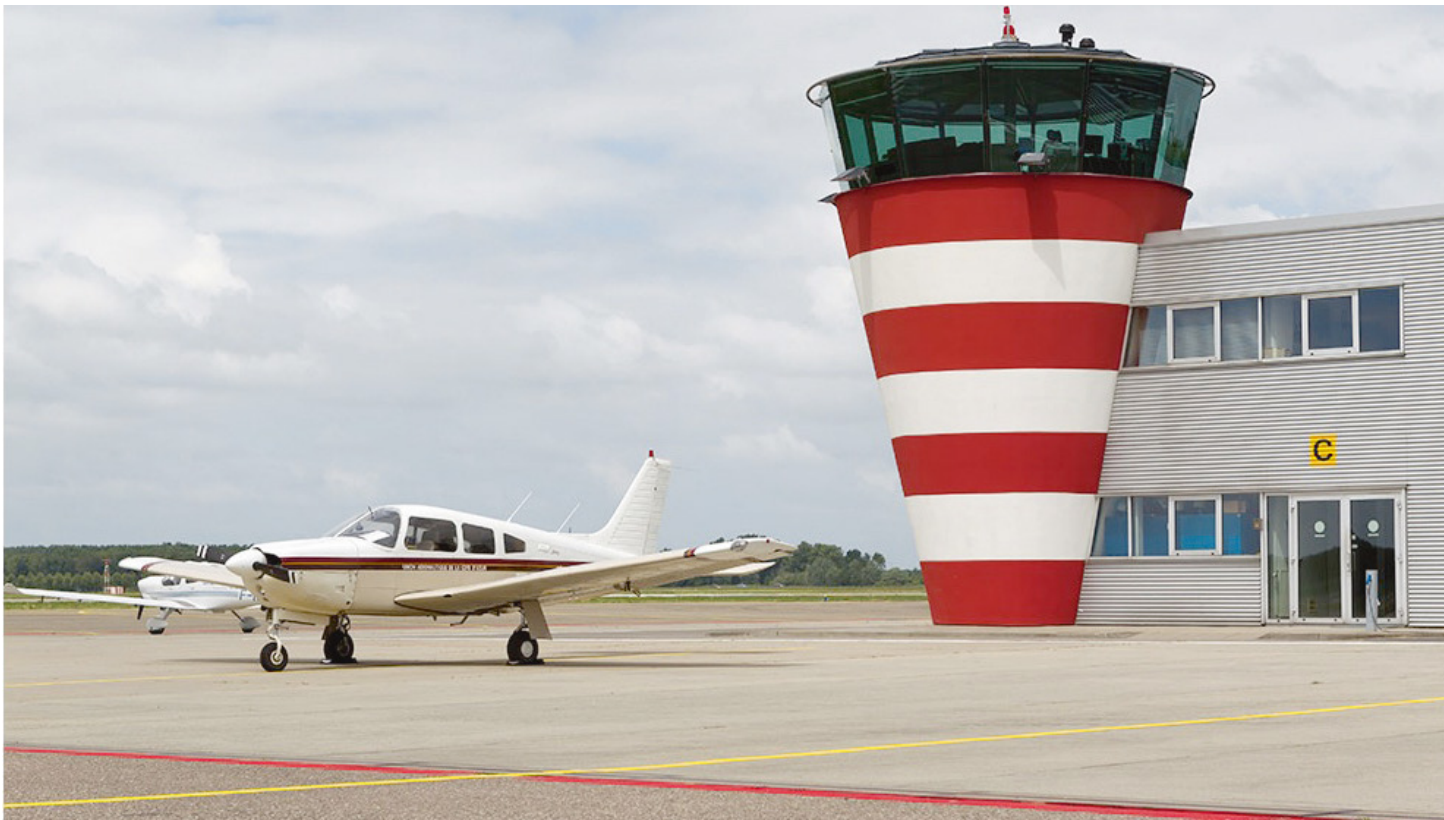
Lelystad Airport Tower.

This incident shows the importance of listening carefully to the landing information that is provided by airport operations on the radio. The incident also emphasises the importance of referring to the runway in use while using the radio in the traffic pattern.
