DUTCH
SAFETY BOARD

Shipping Occurrences Report

May - November 2017

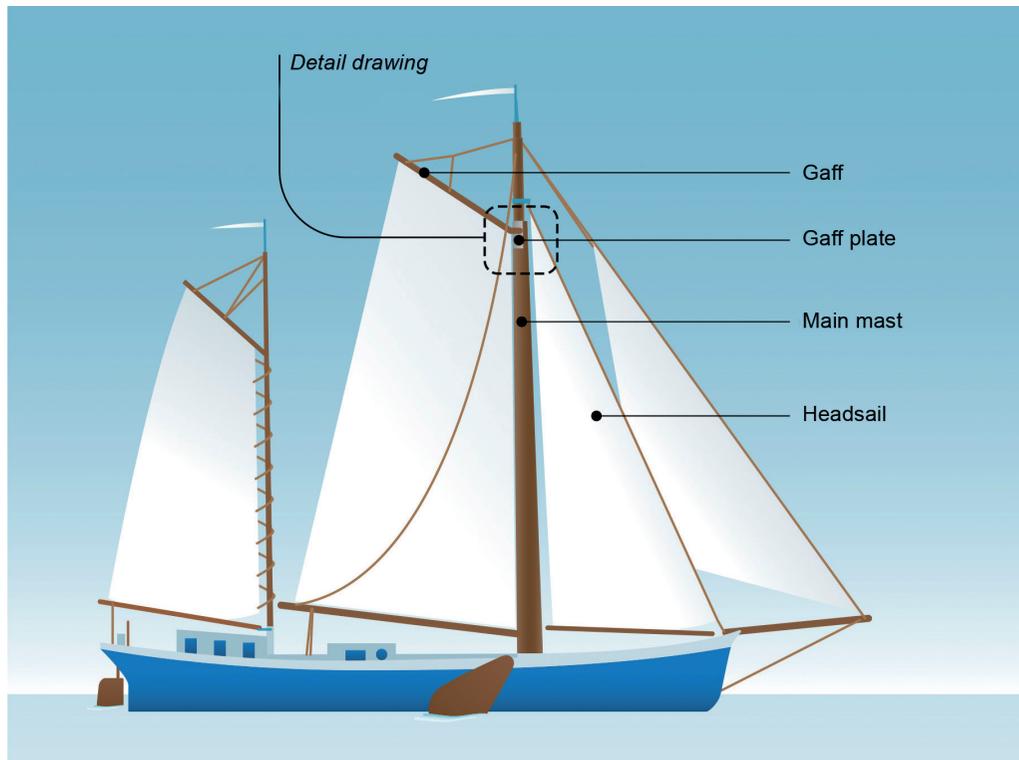
Wood rot

Although the mast breaking came as a complete surprise to those involved, the investigation showed that a process of at least four years preceded this. Water penetrated deeply into the mast during this period after which it could not leave the mast any more. This water started a rotting process in due course in the inside of the mast. The wood rot continued to such an extent during the last two years that the mast lost nearly all its strength.

Amicitia clipper infographic.

It is generally known that wood rot can occur in a wooden mast. If identified on time and treated appropriately, it does not have to put the safety of the mast at risk. It is therefore important that the mast is checked regularly with regard to potentially vulnerable places. There was no maintenance plan for the involved mast and the mast was not checked regularly. This meant that changes and vulnerable places were not seen. The master trusted the expertise of the maintenance personnel because he lacked the expertise himself.

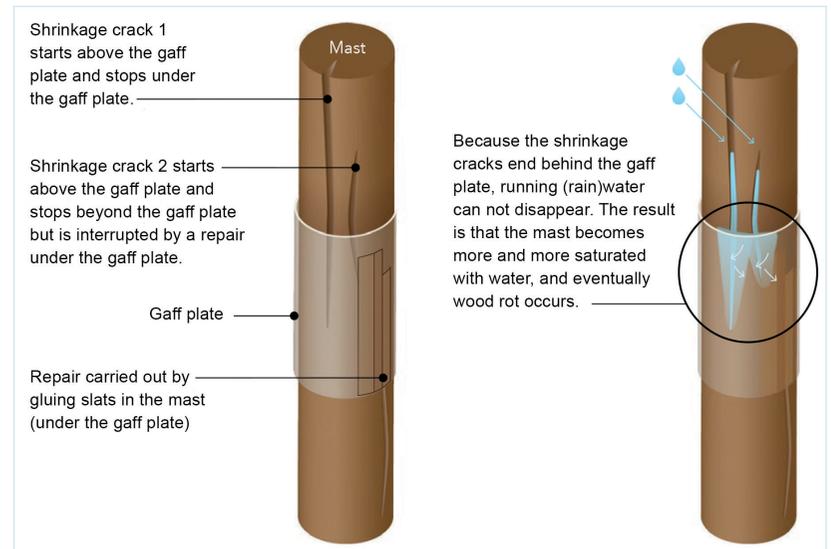
Saturation process

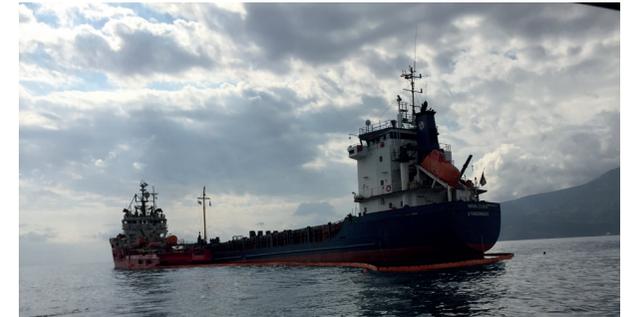
Nova Cura.

The investigation showed that the voyage preparations on-board the Nova Cura were made for the route to Izmir that runs to the west of Lesbos. When the destination become Aliaga, the route was changed. The new route run to the north of Lesbos and new voyage preparations were not made for this. Although new waypoints were set, no other information was used in changing the route. The Pilots for the area were not consulted for potential hazards, the sector lights were either not identified and the available ENC (Electronic Navigational Chart) was not checked for reliability.

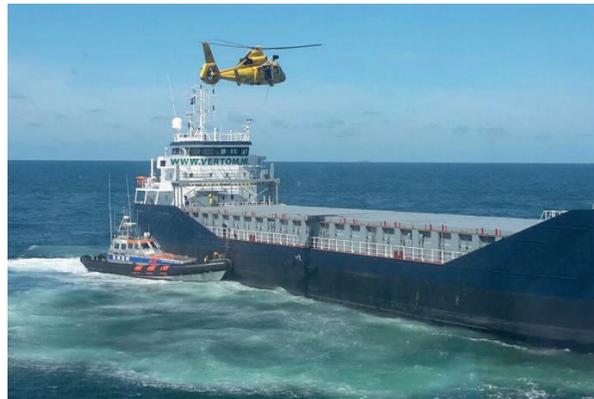
On 26 June 2017 a fire started in the engine room of a Dutch cargo ship. The crew managed to extinguish the fire after which the ship was towed to the port. The ship was on its way to Rotterdam and was already at the approach to the port. Two crew members were injured by the fire and the ship suffered serious damage. The Dutch Safety Board started an investigation into this accident.

Photo of the emergency assistance. (Photo: Floris Visser)

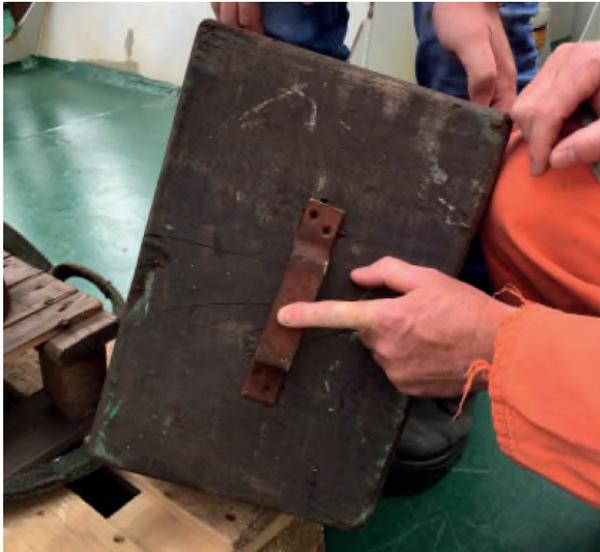
An auxiliary spud became loose and hit a crew member's head during lifting activities on-board the ship Artemis sailing under the Dutch flag on 29 May 2017. The auxiliary spud, a wooden block to secure something, was lifted up by a soft sling using a handle. The handle, however, became loose during lifting. The block initially fell on a discharge pipe after which it changed direction and hit a crew member's helmet and face. The crew member suffered several fractures.

The block with where the handle should be. (Photo: Van Oord Dredging and Marine Contractors)

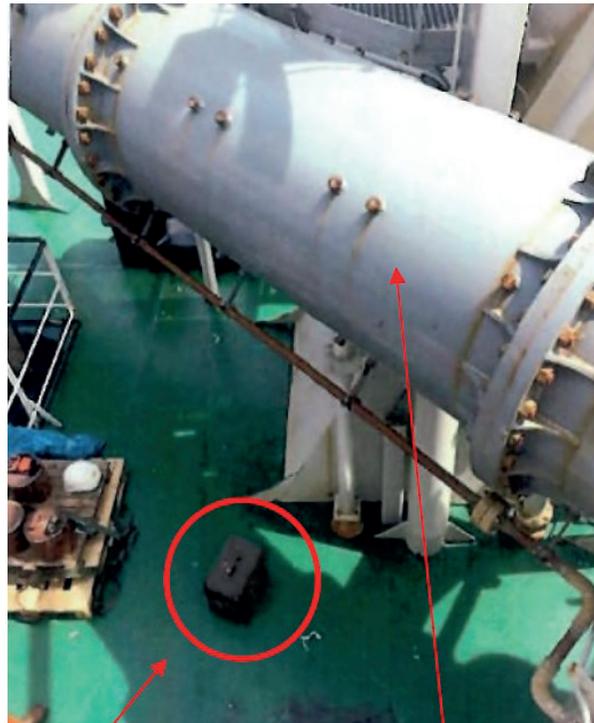
The block and the discharge pipe. (Photo: Van Oord Dredging and Marine Contractors)

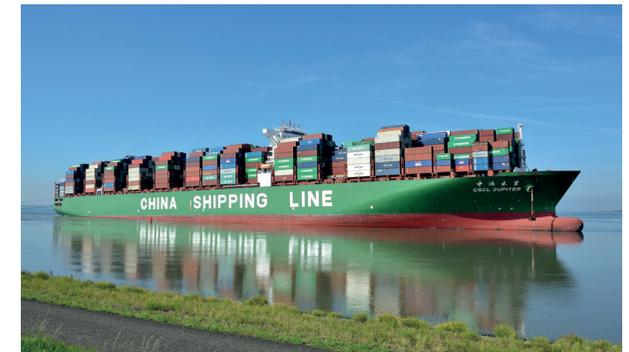
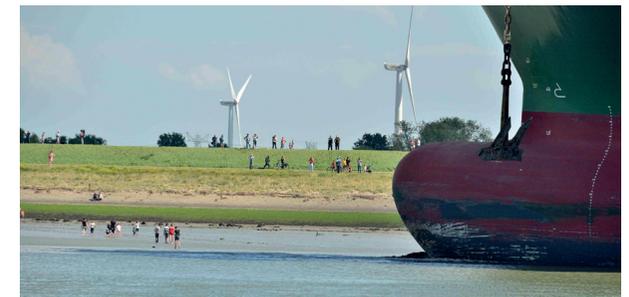
On Monday morning on 14 August 2017 the container ship CSCL Jupiter that sails under the flag of Hong Kong run aground in the Nauw van Bath. The ship had left the Port of Antwerp to complete a voyage to Hamburg. While making the manoeuvre to take curve in the Nauw van Bath, the rudder became stuck. Emergency measures had no effect and the CSCL Jupiter run aground. The passage on the Wester Schelde to and from Antwerp was closed completely for shipping traffic. On Monday evening on 14 August 2017 the ship was salvaged at high tide. The ship was, subsequently, towed to the Port of Antwerp. The CSCL Jupiter did not have any visible damage to the outside.

CSCL Jupiter runs aground. (Photo: Police)
