Collision with tug due to loss of brake pressure, BAe Avro RJ85

The Hague, January 2019

Identification number:	2015109
Classification:	Serious incident
Date, time of occurrence:	15 December 2015, 19.45 ¹
Location of occurrence:	Amsterdam Airport Schiphol, A8 taxiway
Registration:	EI-RJT
Aircraft type:	BAe Avro RJ85
Aircraft category:	Four engine turbofan
Type of flight:	Commercial air transport – passenger
Phase of operation:	Pushback
Damage to aircraft:	Substantial
Crew:	Four (two flight crew, two cabin crew)
Passengers:	52
Injuries:	None
Other damage:	Slight damage to towbarless tug
Light conditions:	Night

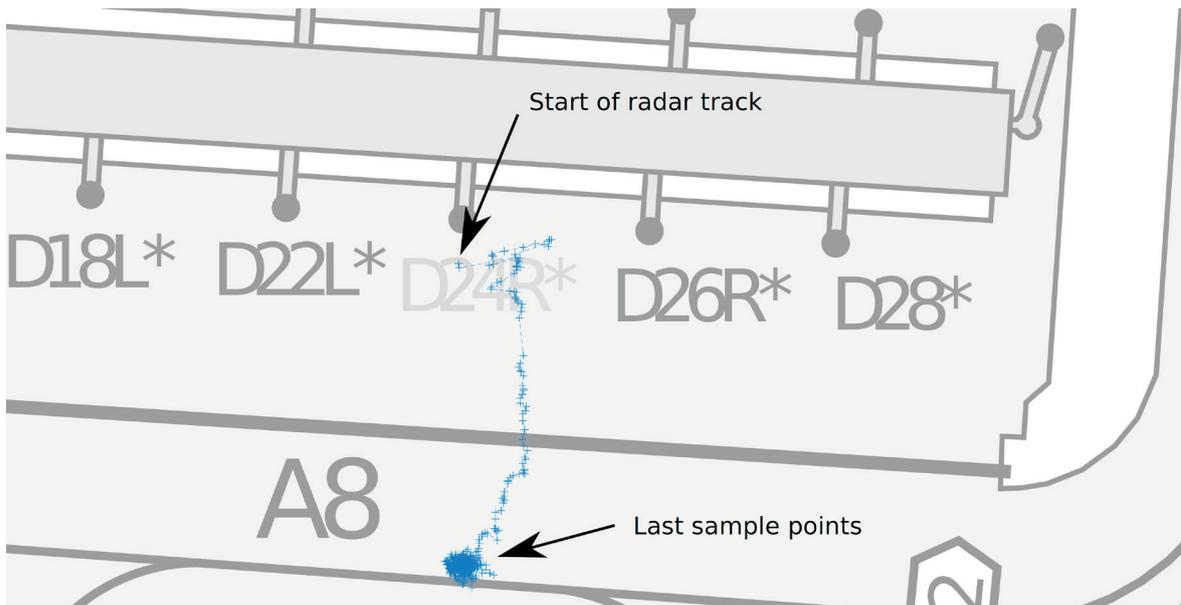
Figure 6: Plot of radar track leading up to the event. Background image adapted from aeronautical information publication. (Source radar data: ATC The Netherlands/LVNL)

The radar data, plotted in Figure 6, shows that the aircraft was pushed back and turned onto taxiway A8 before the event.

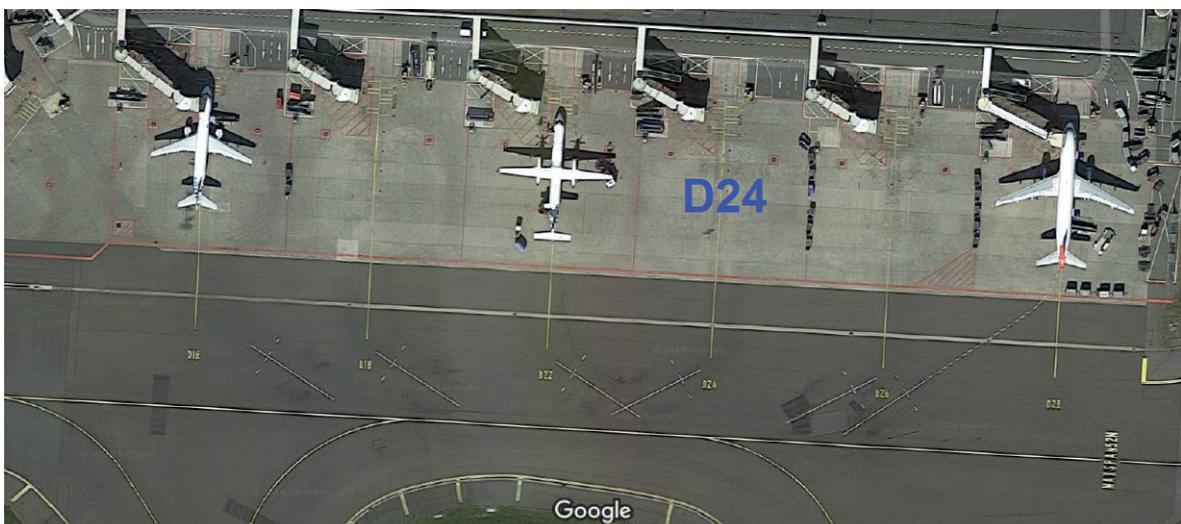
According to the AIP, the magnetic declination at the aerodrome is less than 1°. Figure 7 shows a satellite image of the surroundings of the event. The solid white lines are the pushback lines, the perpendicular dashed white lines are the pushback limit lines. Aerial survey data of the elevation variation in the vicinity of gate D24 was made available by the aerodrome. There are no restrictions given for engine start-up at gate D24.

Figure 7: Satellite view of gates D16 through D28. The blue text for gate D24 was added for clarity and the aircraft on the image are not relevant. (Source: Google Maps)

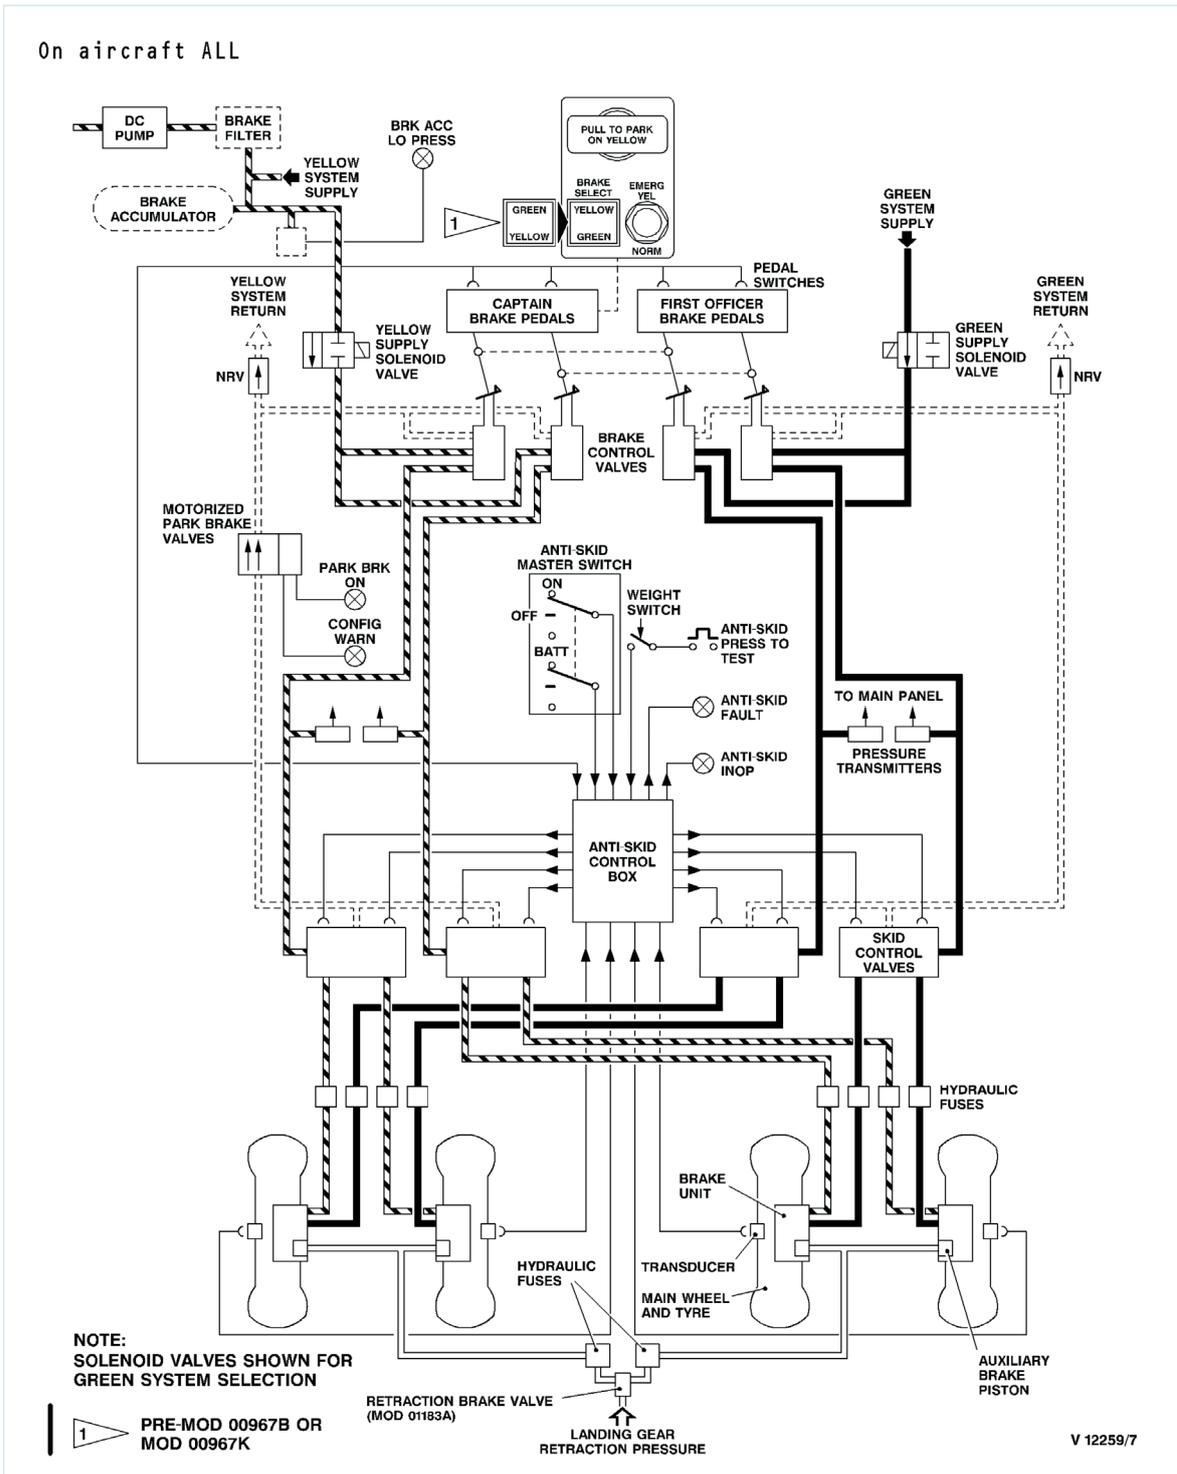
BRAKE SYSTEM

Solid black line is green system, dashed line is yellow system, dotted line is return. (Source: BAe)

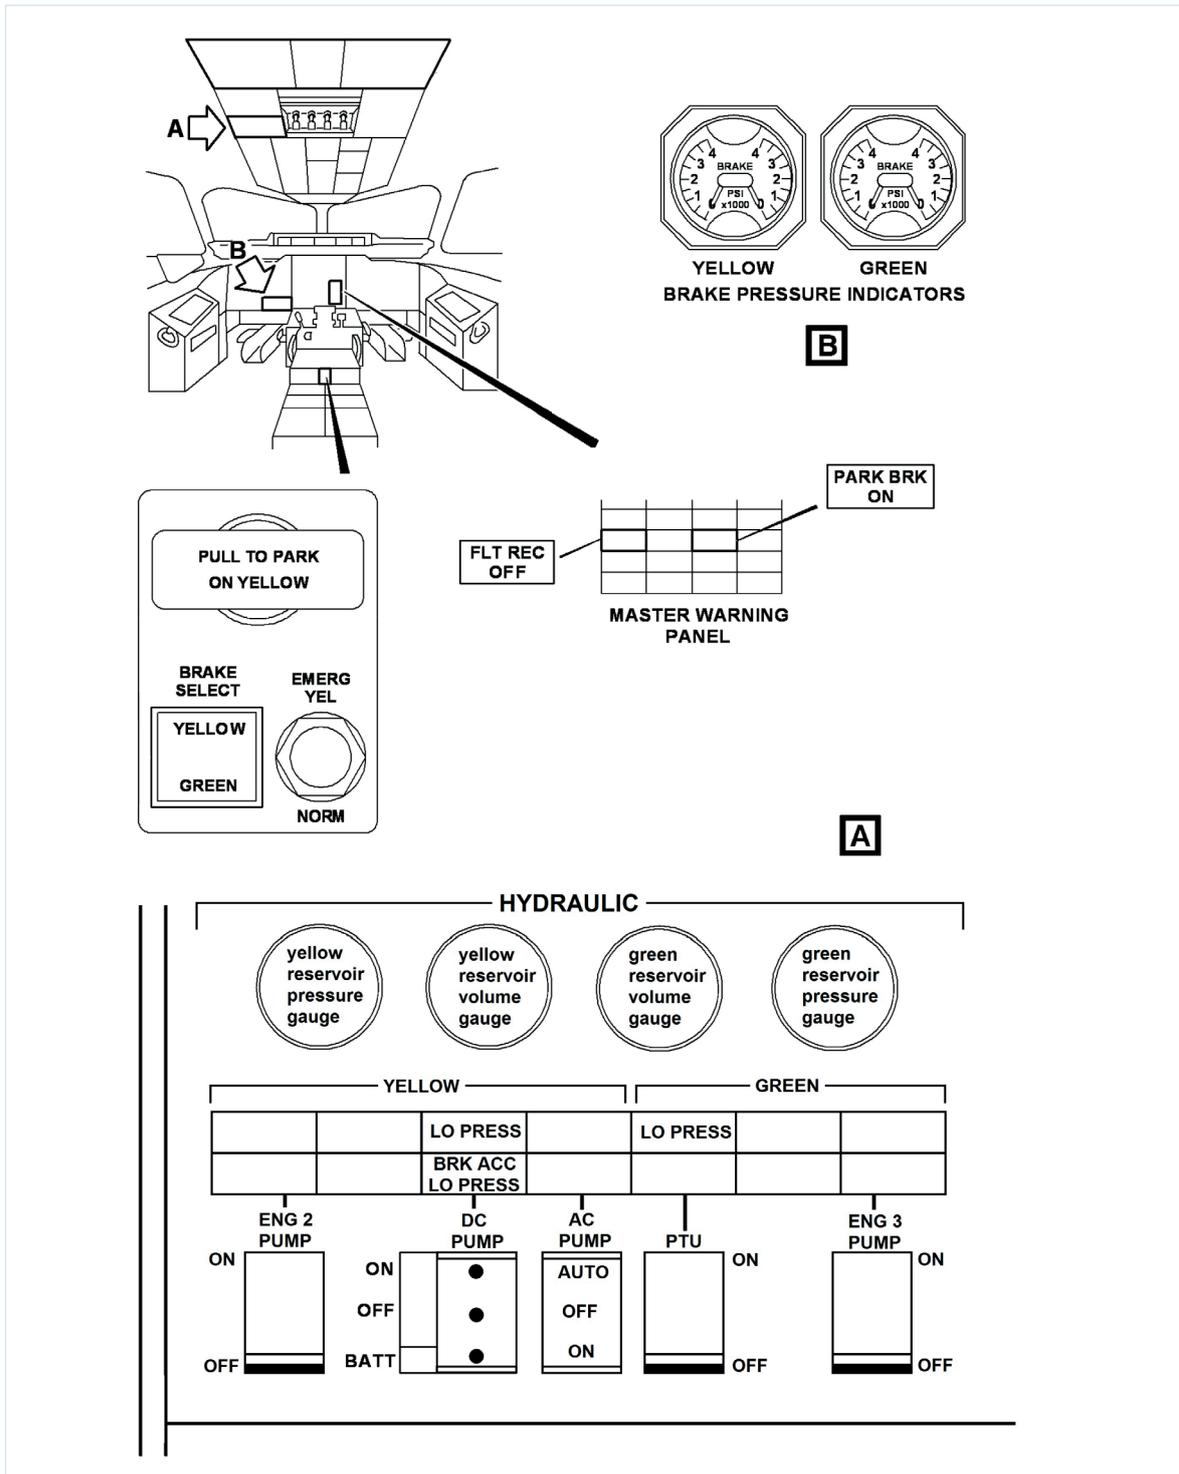
CONTROLS AND WARNINGS

Overview of all relevant controls and warnings. No specific situation is shown. (Sources: BAe and Dutch Safety Board)
