DUTCH
SAFETY BOARD

Shipping Occurrences Report

November 2020 - May 2021

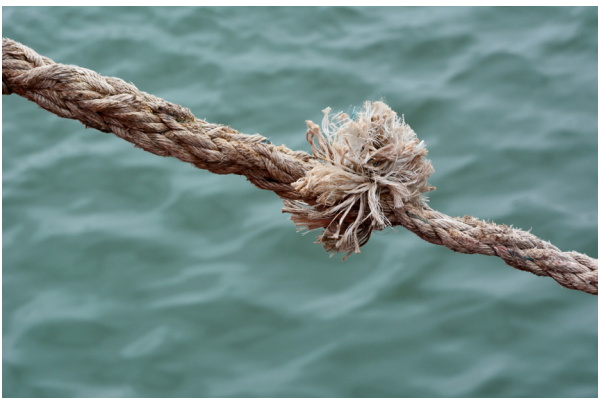
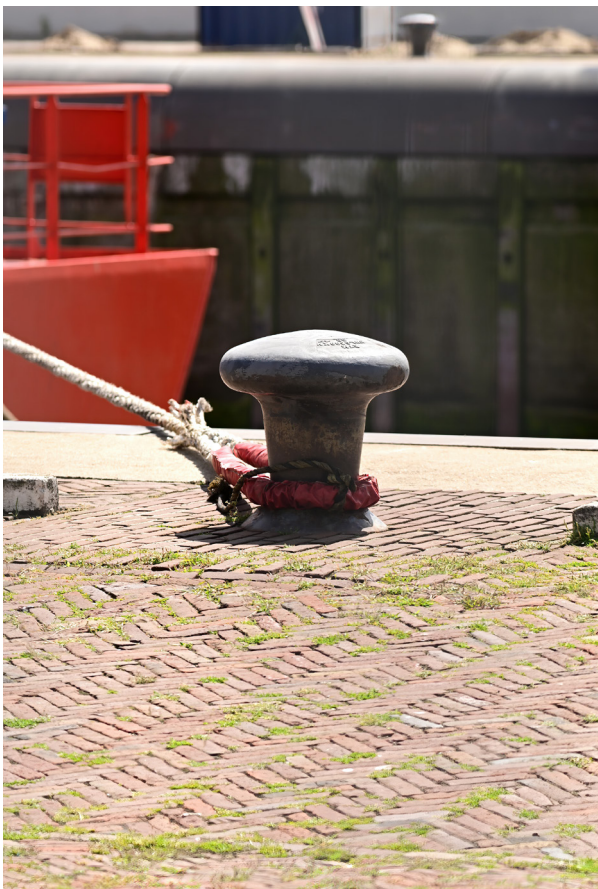
The stern line became entangled in the ship's propeller due to lack of clear communication. The victim was not equipped with a walkie-talkie, and the orders of the mooring team leader had not been passed on. The mooring team leader was beyond the hearing range, and out of view of the victim and the cadet. As a result, the mooring team leader was unaware of what was happening on the afterdeck, and was unable to warn the victim in time.

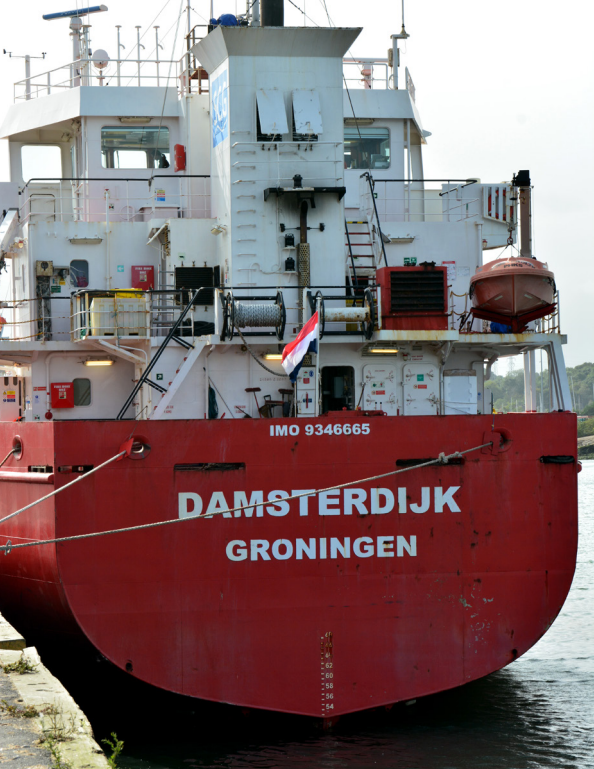
Damsterdijk.

Communication became unclear because the cook/AB was not issued with a walkie-talkie and the AB in charge was beyond his field of vision and out of hearing due to the nature of the work. During mooring and unmooring, the afterdeck is a hazardous zone where a mooring line can snap back, if it breaks. The afterdeck or snap-back zone were however not marked as such, or indicated with signals.

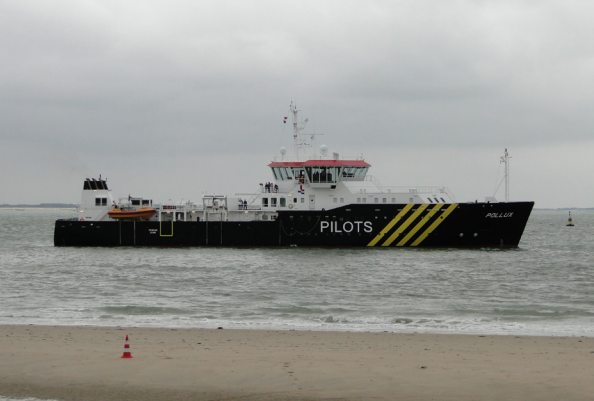
Pollux.

A system whereby two pilot vessels are located close together during a pilotage operation can result in confusing situations, in particular if a pilot vessel that is not participating in the operation is nonetheless clearly recognizable as a pilot vessel. At the time of this collision, the Pollux was carrying its pilot lights, creating the impression on board the bulk carrier that the vessel was in fact monitoring the pilotage operation, and was on hand to offer assistance, if necessary. However, this was not the case. The captain of the Pollux did not recognize the risk of collision with the Nord Taurus until it was too late. This resulted in a risky situation that eventually led to the collision.

Work was carried out routinely, and a number of safety barriers failed. Space was created for assumptions that were not assessed. Both the Nord Taurus and the Perseus assumed that the Pollux was monitoring the pilotage operation and was on hand to offer assistance, if necessary. They therefore both also assumed that the Pollux would change heading, so as to not hinder the course to be followed by the Nord Taurus. This occurrence teaches us that it must be clear to all parties in and around a pilotage operation exactly how the manoeuvres are to be undertaken. There must be no room for unassessed assumptions.

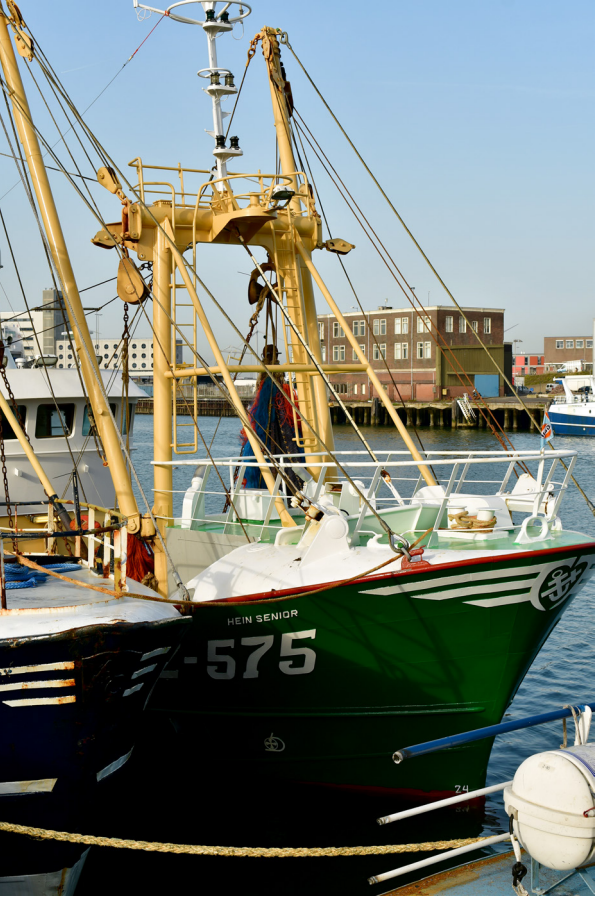
Z-575 Hein Senior.

On Monday 12 October 2020, at around 03.45 hours, the main engine of the fishing vessel Z-575 Hein Senior failed while the vessel was sailing inside the Zuider Stortemelk fairway, north of the island of Vlieland. The direct cause of the shutting down of the main engine was the failure of a solenoid valve in the gearbox. As a result, the vessel lost all propulsion and the Z-575 Hein Senior started drifting towards the coast of Vlieland. Because no anchor was set and there were no vessels in the vicinity to offer towing assistance, the Z-575 Hein Senior ran aground at 04.10 hours.

As the tide rose, the Z-575 Hein Senior was refloated by the tugboat Hunter. The main engine was by this time back in operation, and the fishing vessel was able to sail to the port of Harlingen, under its own power. The damage was restricted to damage to the propellor blades. The propellor has now been replaced.

During the period when the Z-575 Hein Senior was drifting, the decision was not taken to lower the anchor. The crew focused all its attention on repairing the main engine and establishing a possible towing connection to another vessel. During an inspection, it subsequently emerged that the anchor was stuck in the hawse. At a certain point, the clump for the nets had been thrown overboard, to slow down the vessel. There were no procedures or instructions on board to prevent the vessel running aground in shallow water. No emergency exercises were held.

FOSO/FEBIMA (Belgium) issued a series of recommendations to various parties, in response to this occurrence. These recommendations are focused on developing inspection and an appropriate Safety Management System (SMS) on board fishing vessels.

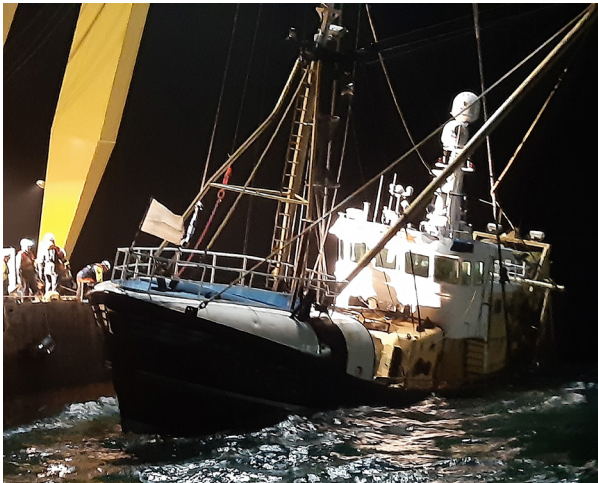
Recovery of the UK-171 Spes Salutis that sank on 9 December 2020. (Source: National Police)

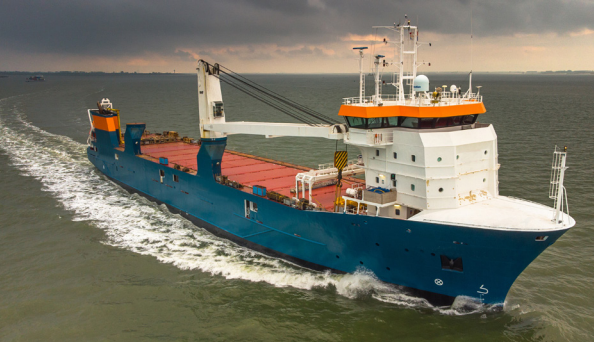
A Dutch cargo vessel experienced problems off the Norwegian coast near Ålesund, whilst in heavy weather. At the time of the occurrence, winds were gusting at force 8 to 9, with waves in excess of eight metres. The vessel was sailing from Bremerhaven (Germany) to Kolvereid (Norway). The cargo in the hold had shifted, subsequently punching holes in a number of ballast water tanks. As a result, ballast water leaked into the hold. Due to the bad weather, the shifting of the cargo and the water in the hold, the vessel started to heel severely. The twelve crew members were evacuated and the vessel was towed to Ålesund.

Dutch ship in trouble in the Norwegian Sea. (Source: Mateo Witte)

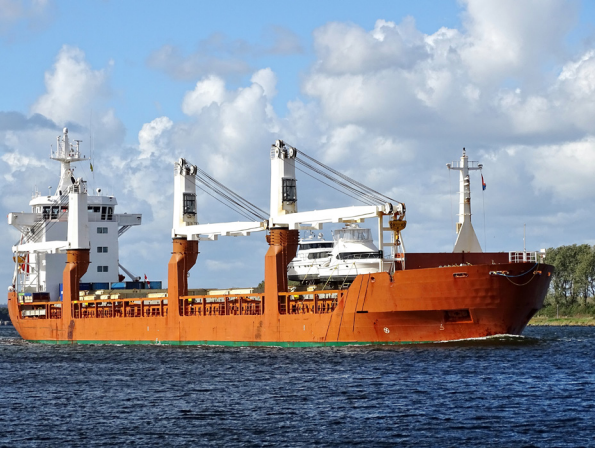
In the port of Cristobal in Panama, a cargo of steel girders was being unloaded from a Dutch cargo vessel. The work was carried out by local stevedores in the port of Cristobal, who were responsible for both attaching the cargo to the crane, and operating the ship's cranes. The stevedores made use of their own slings for this purpose. While lifting the cargo, these slings broke, causing the steel girders to fall. Two stevedores were hit by the falling girders. One of the two stevedores lost both legs, the other one foot.

Ship on board which two stevedores suffered serious injuries. (Source: Peter Beentjes).

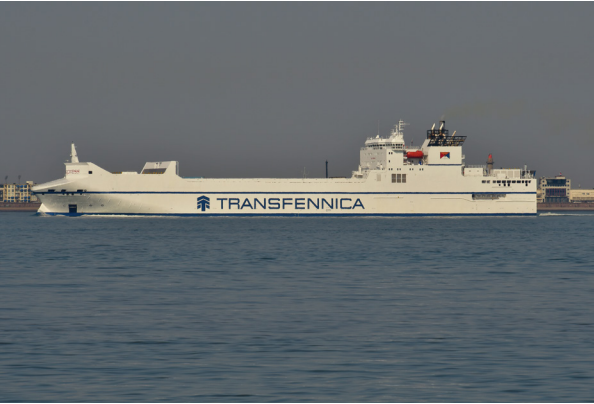
Early in the morning, a Dutch Ro-Ro cargo vessel ran aground just outside the navigation channel, in the approach to the port of Rauma. Several double-skinned tanks were punctured, and one of the engine rooms started making water. The vessel was able to reach the port of Rauma under its own power, where it was safely moored. There were no injuries and no oil leaks.

Vessel that ran aground close to Rauma.

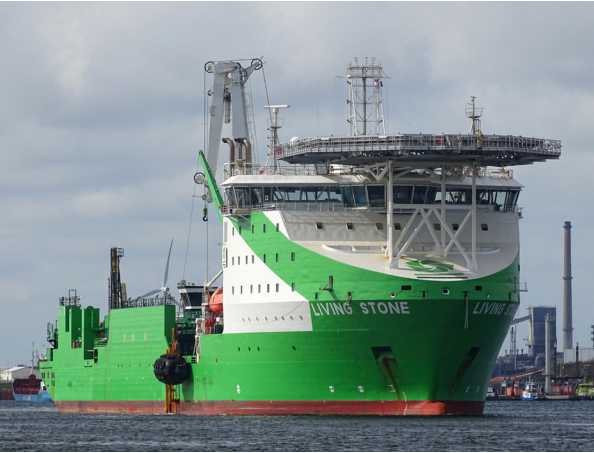
Living Stone. (Source: Peter Beentjes)

On board the Dutch offshore support ship Living Stone, the crew were in the process of retrieving a cable from the seabed. An ROV (remote operated vehicle) was deployed for this purpose. The ROV was attached to a cable, connected to a winch on board the ship. The ROV had to be manoeuvred further away from the ship, which meant that more cable had to be paid out. This involved the use of a capstan. While carrying out this task, the fingers of a crew member became trapped between the cable and the capstan. As a result he lost the tips of two fingers. The decision was taken to have him evacuated by the coastguard. The accident took place on the North Sea, approximately 80 nautical miles east of Hull.

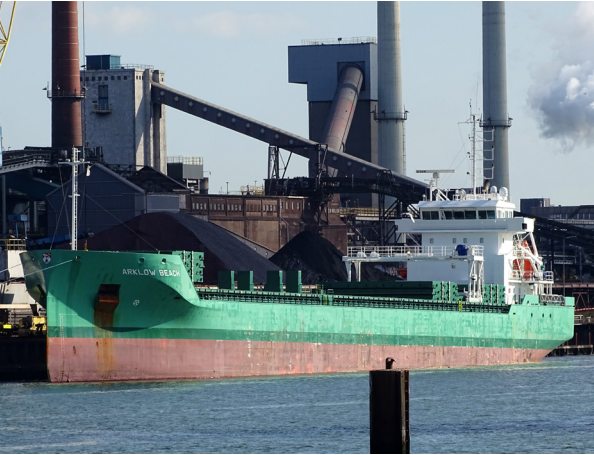
Arklow Beach. (Source: Peter Beentjes)

While fastening the deck hatches, a fastening rod broke off on board a Dutch cargo vessel. The accident took place in the port of Glomfjord. The rod hit one seaman on the middle finger. The seaman was transported to hospital, where he received 18 stitches. As a result of the injury, he was out of work for four weeks.

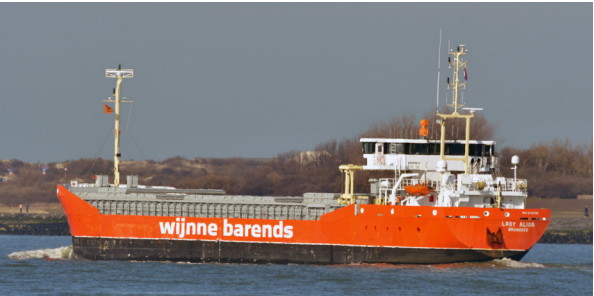
Lady Alida.

On board the Dutch cargo vessel Lady Alida, the second mate slipped while adjusting the lashing of steel reels. In the port of Vlaardingen, he was in the process of tightening a tensioning strap with a ratchet. The ratchet slipped on one tooth and slipped out of position. As a result, the second mate himself slipped and broke his leg. He had to be transported to hospital by ambulance.

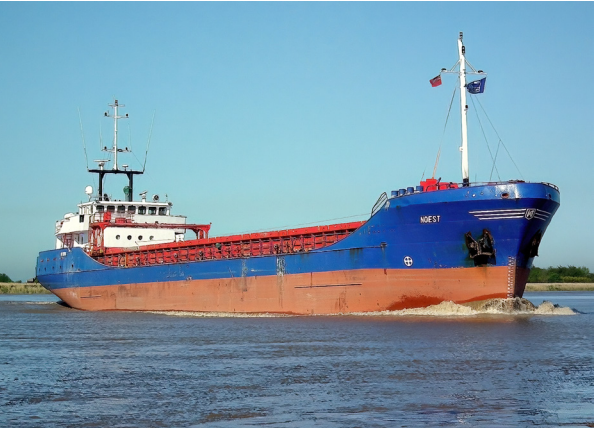
The first mate on board the Dutch cargo vessel Noest broke his right foot when he slipped on deck, after catching his foot behind a hatch. While still in port, the first mate disembarked for hospital treatment.

Noest. (Source: Eddie Walker)

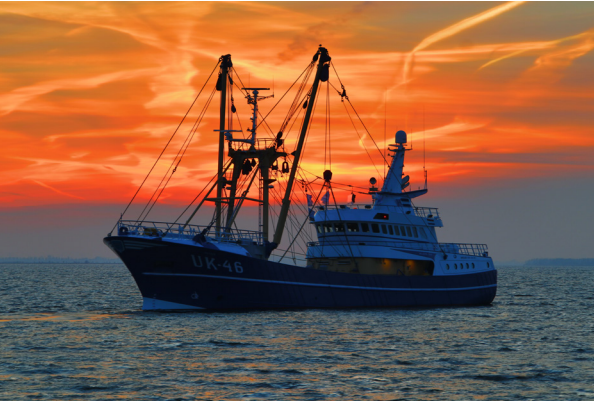
In bad weather, an accident occurred on board the Dutch beam trawler UK-46 Willeke. While raising a full net, a fishing line broke, causing the net to end up partly in the sea and partly on deck. To maintain balance, once of the crew members took hold of the bulwark, at which point a (steel) cable dragged across his hand. The open wound caused by the cable was treated on board, before the boat returned to IJmuiden, to allow the crew member to be further examined in hospital. Examination revealed that the crew member had broken his arm in two places.

UK-46 Willeke. (Source: Peter de Klerk)

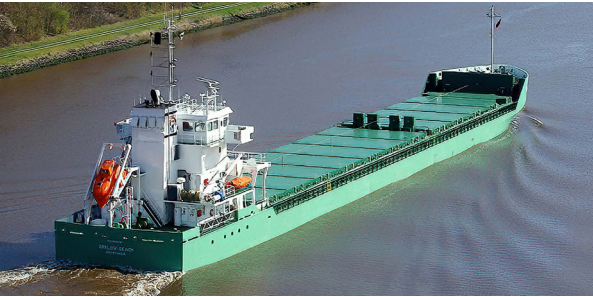
The second mate of the Dutch cargo vessel Arklow Beach was preparing to drop anchor. As he withdrew the locking pin from the ground stopper, the anchor chain came under tension, trapping his finger between the locking pin and the ground stopper. In the incident, the second mate suffered an injury to his finger. Following hospital treatment, he was sent home.

Arklow Beach. (Source: Arklow Shipping)

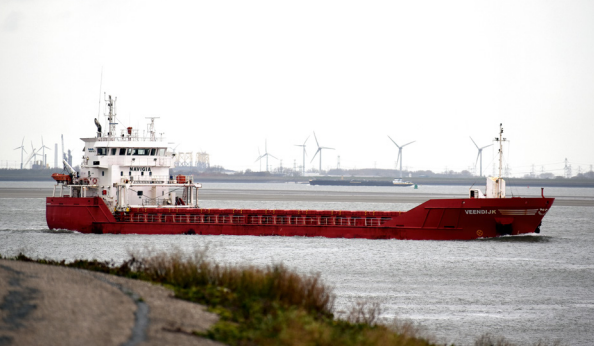
A fatal accident took place in the port of Taranto in Italy, resulting in the death of a stevedore. The stevedore was on board the Dutch cargo vessel Veendijk, loading the ship with turbine blades. After loading the final turbine blade in the second layer, two stevedores started climbing to unhitch the hooks. One stevedore, the victim, climbed up the front side, and the other the rear side. While the hook on the rear side was still engaged, the stack fell, at which point the dock crane started lifting. As a result, the stevedore at the front fell from height, landing on shore. The fall proved fatal.

Veendijk. (Source: Patrick Westeel)

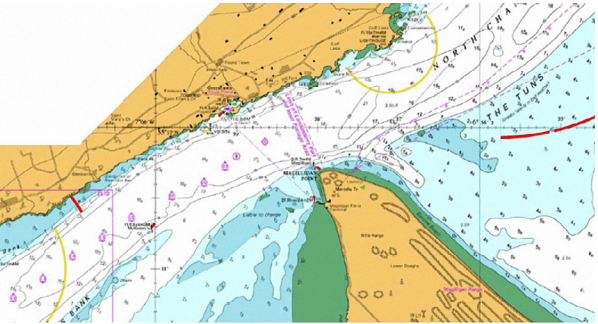
A strong northwesterly wind was blowing at windforce 7 to 8 at the time, and the vessel was sailing with the ebb tidal current. Because of the weather and local sea conditions, the pilot boat asked the Thun Liffey to change heading to starboard, in order to create a lee for the pilot boat. This would enable the pilot boat to come alongside in calmer waters, and allow the pilot to transfer safely. On board the Thun Liffey this request was complied with. The strong wind approaching the vessel at an angle from the port however meant that after the pilot had disembarked, the boat was not able to turn back to port quickly enough, whereupon it ran aground on a sandbar.

Eventually the vessel was refloated at high tide with tugboat assistance, and subsequently anchored nearby. An inspection by divers revealed no damage that would influence the seaworthiness of the ship.

Location of the grounding of the Thun Liffey.

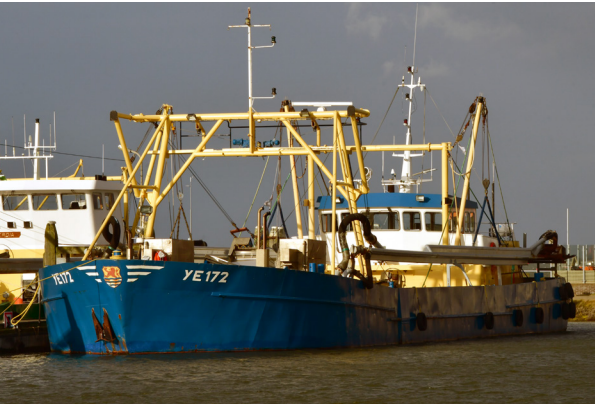
Early in the morning, the Dutch fishing boat YE-172 Piet Hein was sailing on the North Sea above Ameland, when she experienced rudder problems. The skipper then decided to run the boat aground, off the coast of Ameland. With the ship high and dry, the problems were repaired. As the tide rose, the boat once again floated free and continued its journey.

YE-172 Piet Hein.

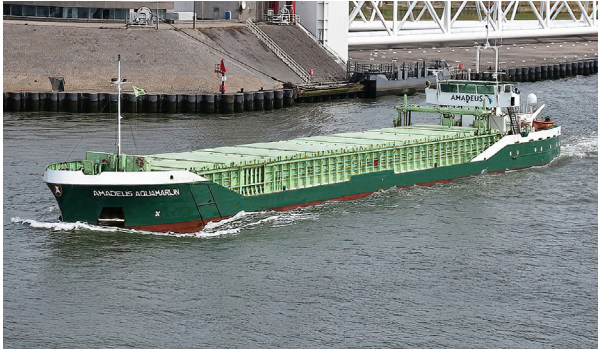
Amadeus Aquamarijn. (Source: De Bock Maritiem)

In the afternoon, the British-flagged fishing vessel TH-7 Amadeus experienced problems with the gearbox of its propulsion system. At that time, the boat was sailing on the North Sea, off the island of Vlieland. Following a failed attempt to repair the gearbox, the boat was towed into the port of Harlingen.

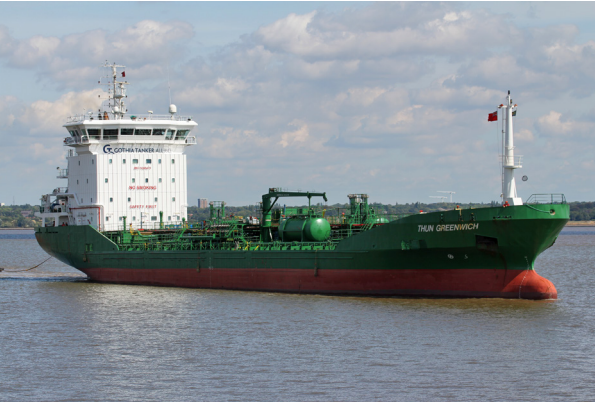
The Dutch oil/chemical tanker Thun Greenwich experienced engine problems while en route to Asnaes in Norway, when the main engine shut down automatically during the course of the morning. Due to the loss of propulsion, the ship started to drift. The chief engineer restarted the engine, and the ship was able to continue its journey. The cause of the problem was not identified.

The main engine once again shut down in the afternoon of the same day. Once again, the vessel began to drift, and it proved impossible to restart the main engine. A tugboat reached the Thun Greenwich in the evening of 17 January and towed the ship to the port of Leirvik. Once in port, an inspection of the main engine revealed that air had found its way into the lubricating oil system. This caused a temporary loss of lubricant, resulting in the overheating of the cylinders.

Thun Greenwich. (Source: Andy Mahon)

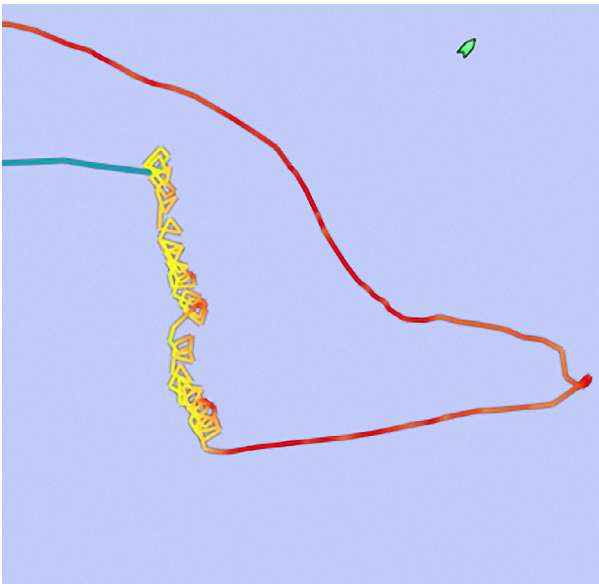
After slightly less than thirty minutes, the Dutch Coastguard made contact with the vessel, because at the time it was travelling in the opposite direction of the shipping lane. After contacting the captain, the Dutch Coastguard decided to deploy the emergency towing vessel Guardian, to offer assistance. A second tugboat later relieved the Guardian and towed the Escape to Rotterdam. In port, it was determined that the tiller from the flap had broken off, causing a complete loss of control over the rudder. The vessel was allowed to continue its journey, following repairs.

Track of the Escape following rudder problems.
